STS-107 Image Analysis Team Final Report

This Appendix contains NSTS-37384, STS-107 Image Analysis Team Final Report in support of the *Columbia* Accident Investigation, 30 June 2003.

STS-107 Image Analysis Team
Final Report
in support of the
***Columbia* Accident Investigation**

June 30, 2003

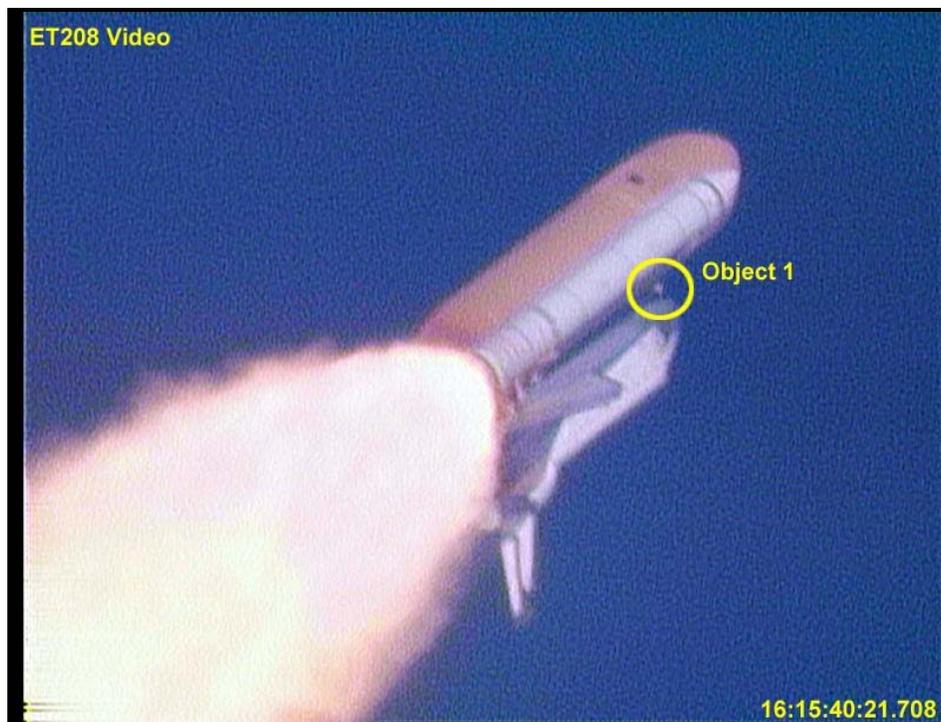
A single piece of light-colored debris was first seen on ET-208 imagery near the ET/Orbiter -Y bipod attach area at 016:15:40:21.674 UTC. Figure 4.3.2.1a is a good view of the debris after it becomes more clearly visible. The debris traveled outboard in a -Y direction (Orbiter structural coordinate system) before falling aft. Figure 4.3.2.1b shows the debris just after it struck the wing (the moment of impact was between video images). The location of the debris was mapped from frame to frame to build a trajectory from the approximate source to impact as viewed by Camera ET-208, shown in Figure 4.3.2.1c.

Figure 4.3.2.1a ET-208 View of the debris near point of origin

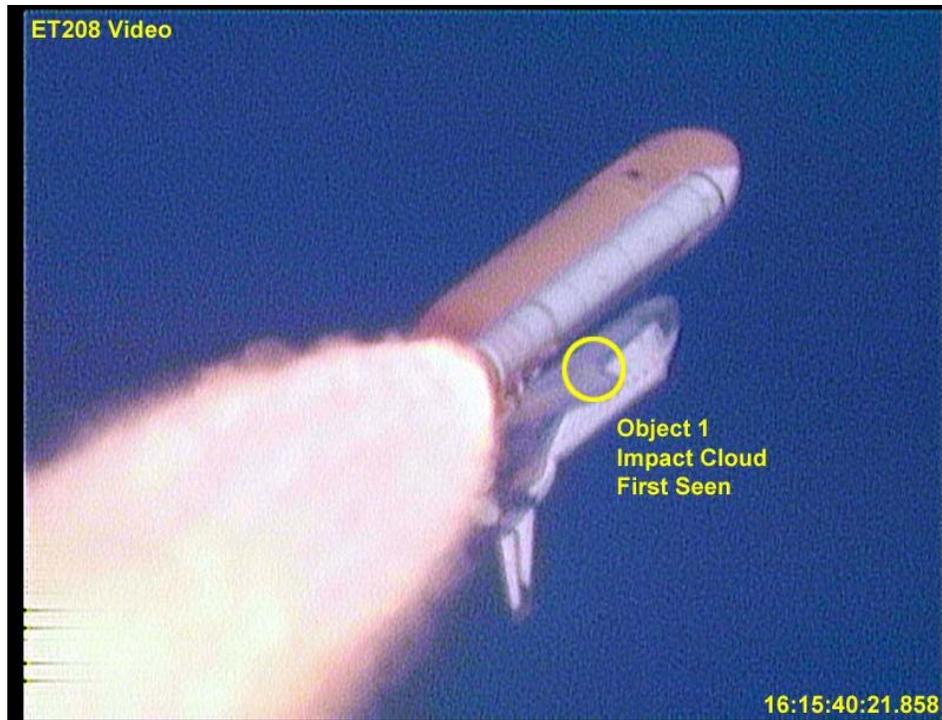
Figure 4.3.2.1b ET-208 View of the debris at 016:15:40:21.858 UTC just after impact with the underside of the leading edge of left wing

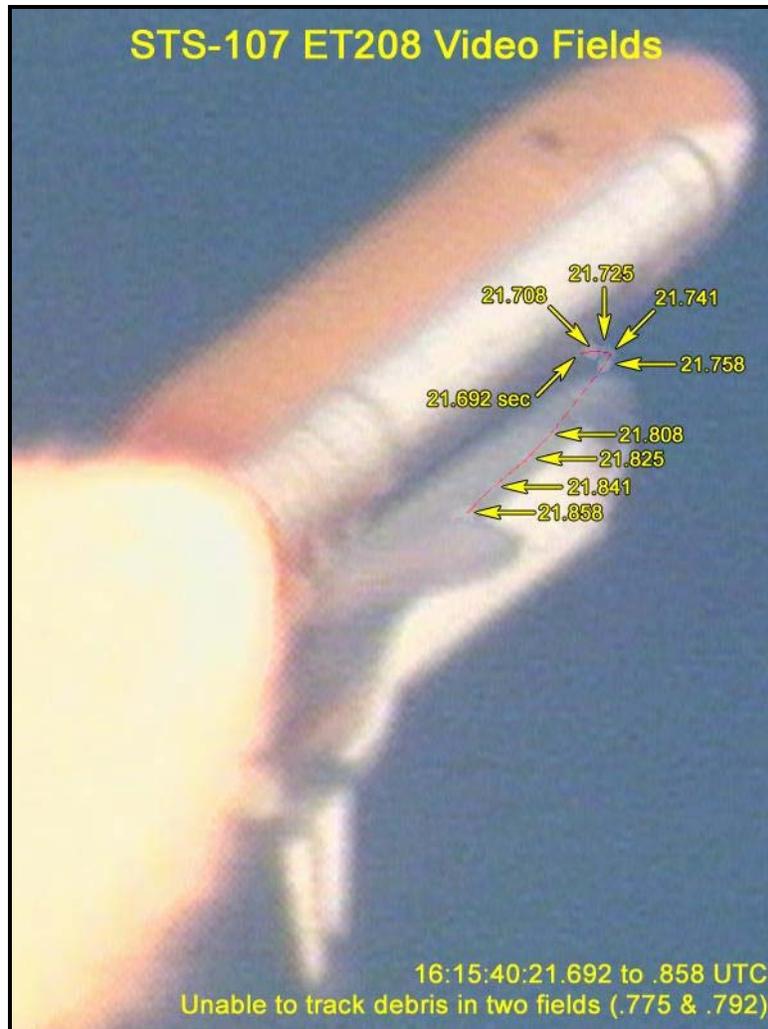
Figure 4.3.2.1c ET-208 Composite with trajectory of debris (times are in seconds after 16:15:40 UTC)

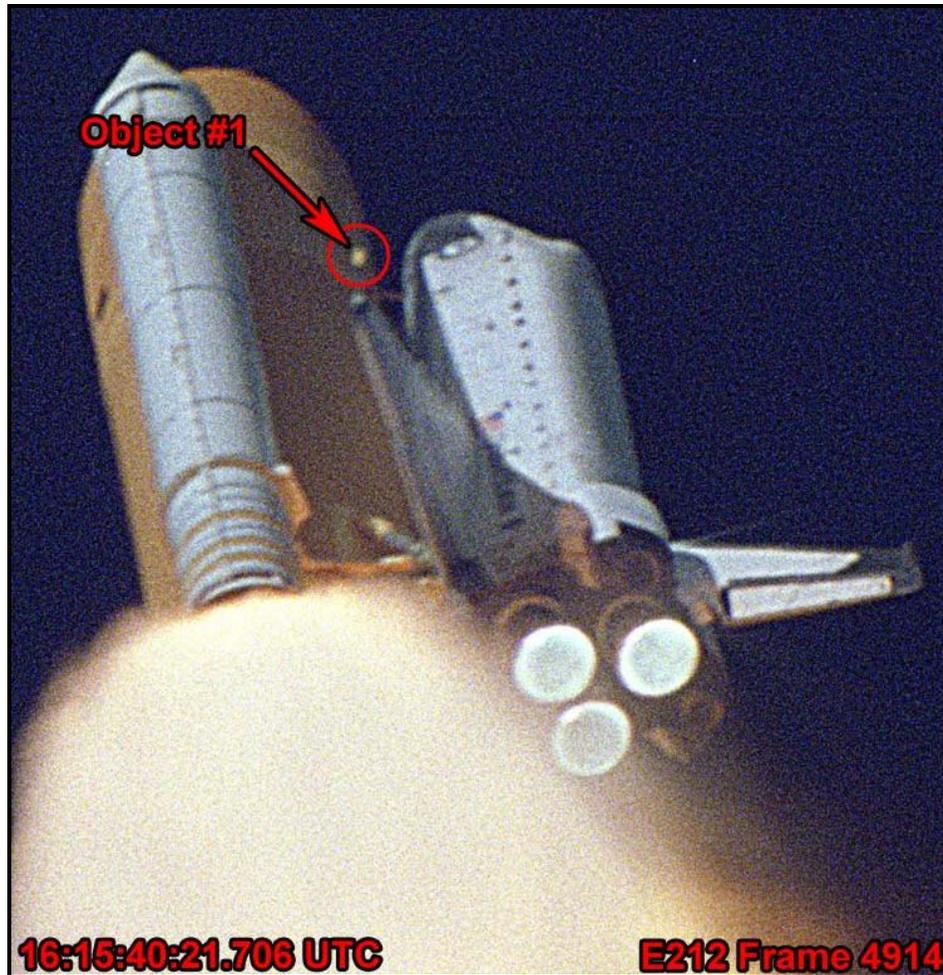
Figure 4.3.2.1d Debris object in full illumination (E-212, Frame 4914)

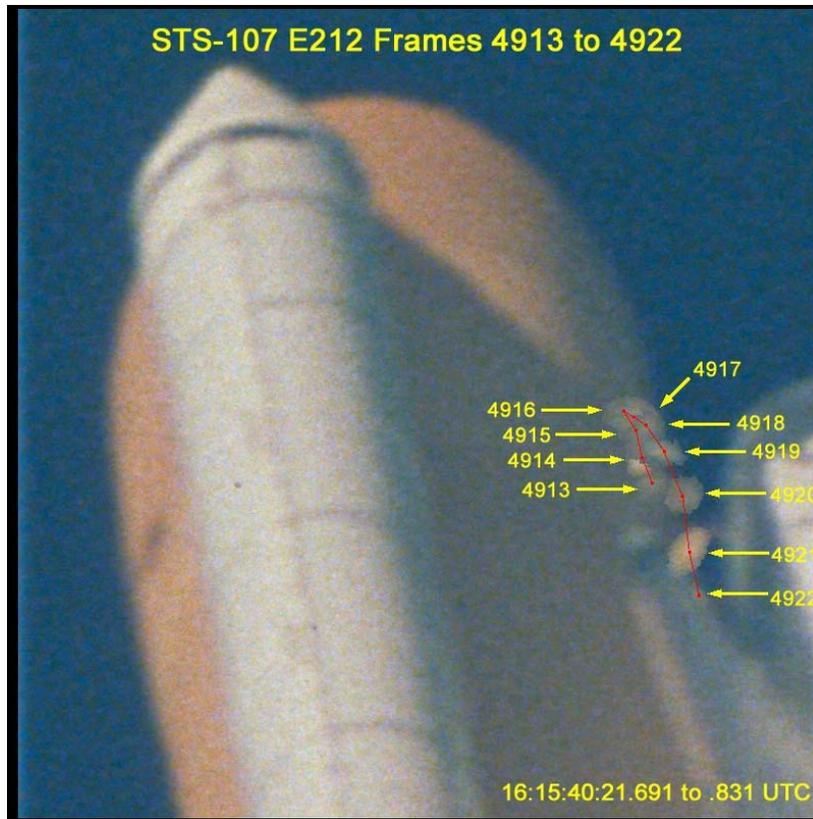
Figure 4.3.2.1e Composite image showing the trajectory of the major piece of debris (Object 1) mapped from camera E-212, frames 4913 through 4922.

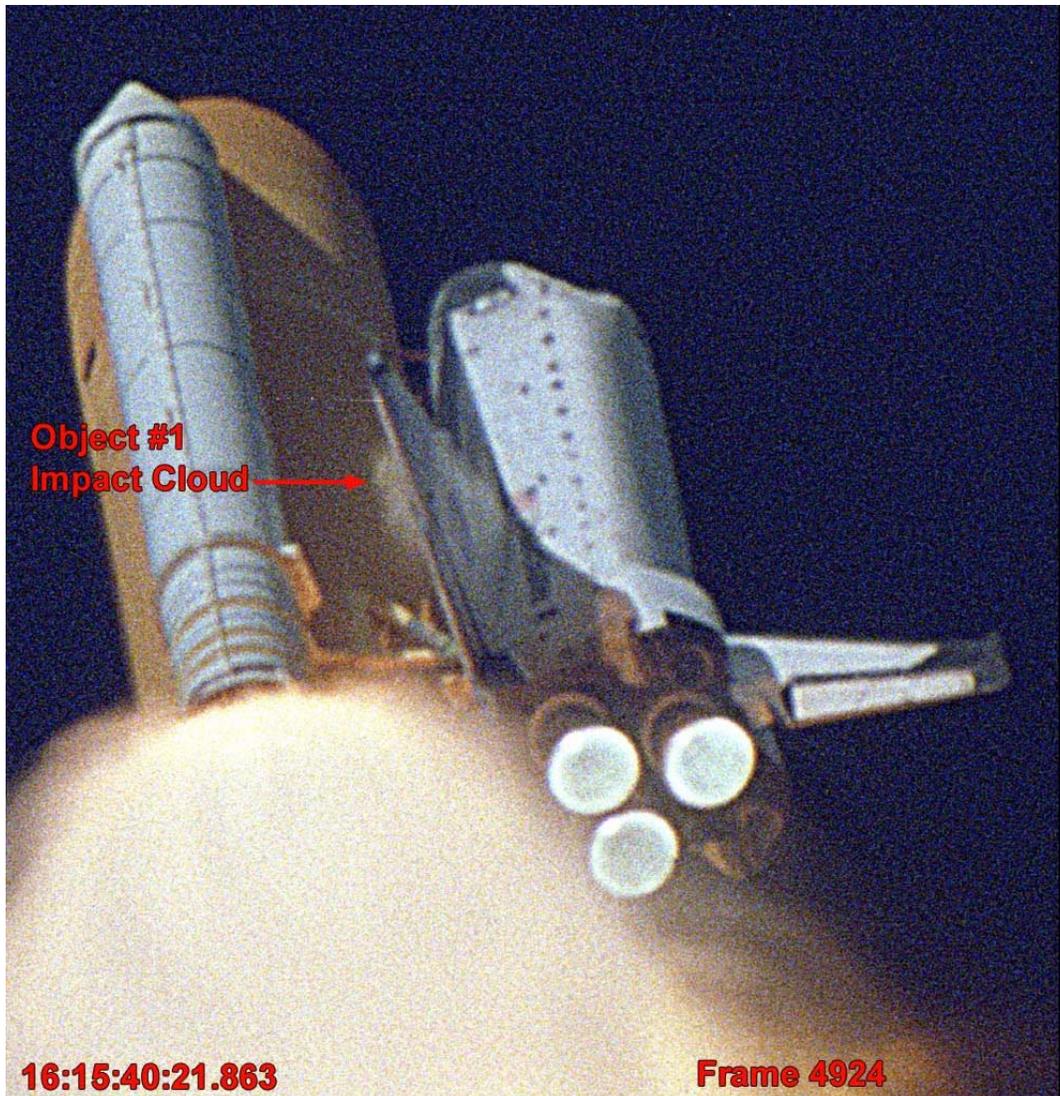
Only Object 1 was confirmed to impact the left wing. There is no conclusive evidence of more than one debris impact to the Orbiter. A large, light-colored cloud, which emanated from the underside of the left wing due to debris impact (Figure 4.3.2.1f), was first observed at 016:15:40:21.863 UTC. Within the post-impact cloud, at least two large pieces of debris were observed and measured (see Section 4.3.2.6). There is no conclusive visual evidence of post-impact debris flowing over the top of the wing.

Figure 4.3.2.1f Debris impact cloud seen on E-212 (Frame 4924)

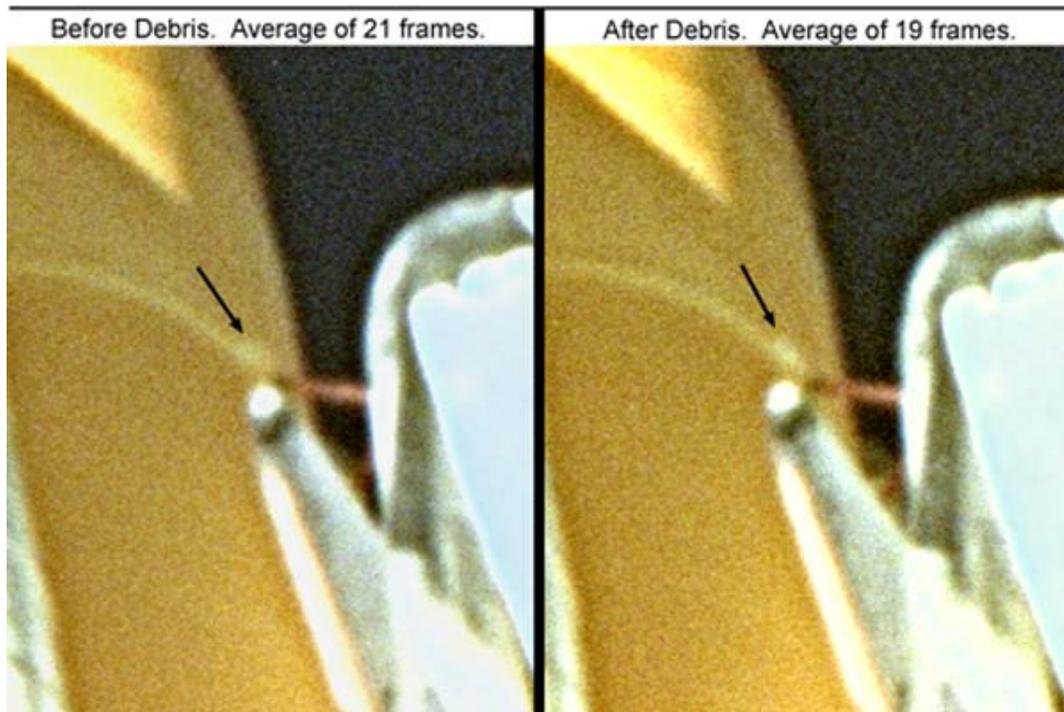
Figure 4.3.2.2a Enhanced images of the ET forward bipod ramp area before and after the debris shedding event

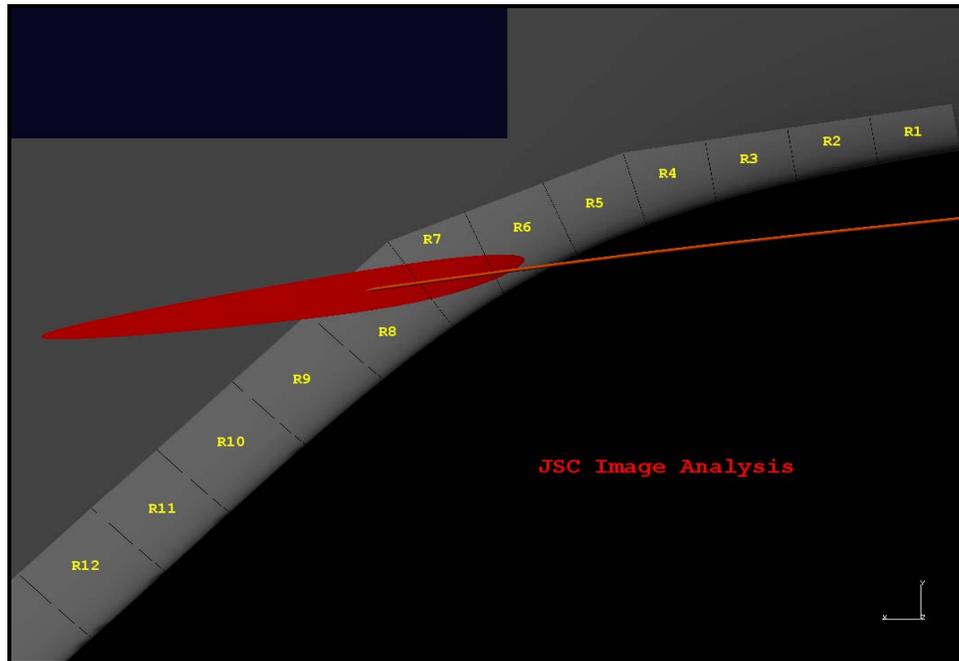
acreage aft of the leading edge panels, no damage to the tiles was observed in the imagery (see Section 4.3.2.7). Figure 4.3.2.5b shows the impact area on the Orbiter left wing as predicted by one example trajectory analysis.

Figure 4.3.2.5b Debris trajectory analysis — impact area on Orbiter left wing. A 1-foot-radius, trajectory tube projected onto the left wing, showing probable impact to the panel 6, 7, 8 area.

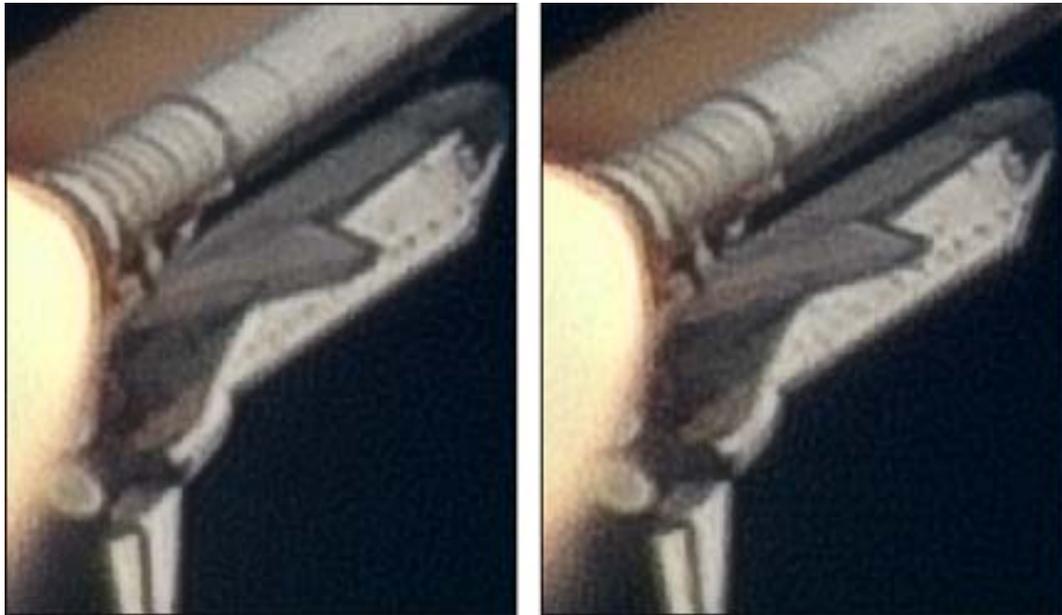
No visible damage to the left wing was detected in the imagery from camera ET-208, which was determined to be the camera with the best view of the debris impact. Figure 4.3.2.6a shows frame-averaged image enhancements of the underside of the left wing from before and after the impact event. There is no conclusive, detectable change in the impact area. In the “before” image, a relatively bright area on the wing is observed just aft of the leading edge, which is attributed to an area of lighter-colored tile acreage, as verified in the Orbiter close-out photos. The “after” image shows a slight brightening to this area, but in the noise level of the image. The brightening may be attributed to a lighting effect caused by slight changes in the Orbiter orientation, or is simply an artifact of the image processing.

A constraint to this analysis is the low resolution of the ET-208 imagery; a damage area smaller than an area of approximately 2 feet by 1 foot (in Orbiter X and Y respectively) would be undetectable in the imagery.

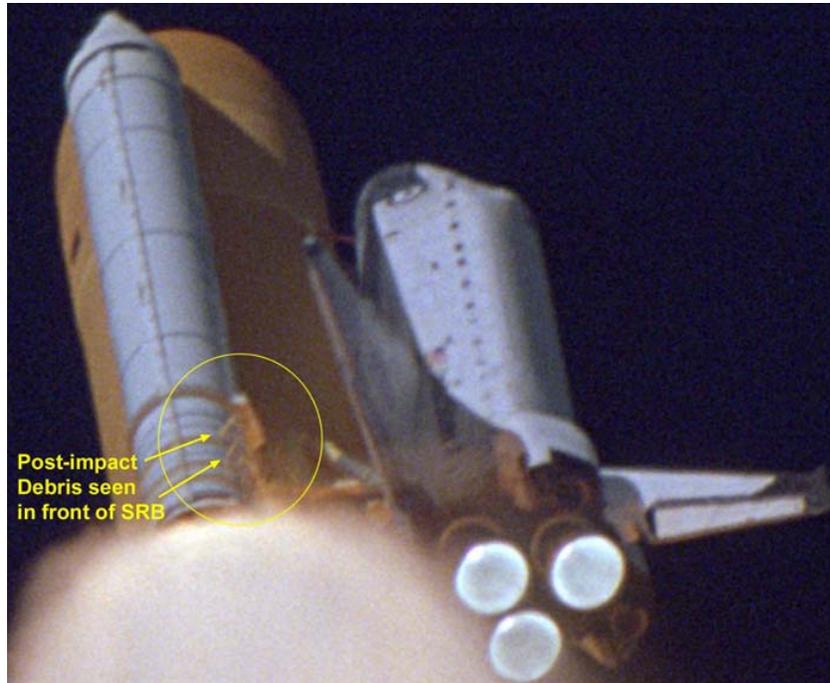
Figure 4.3.2.6b Post-impact debris fragments (E-212 frame 4927)

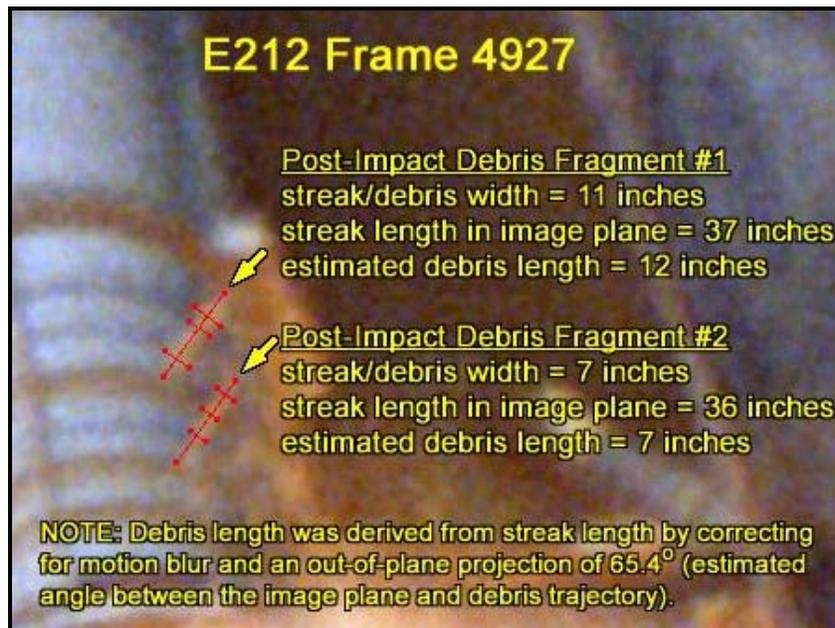
Figure 4.3.2.6c Post-impact debris size measurements

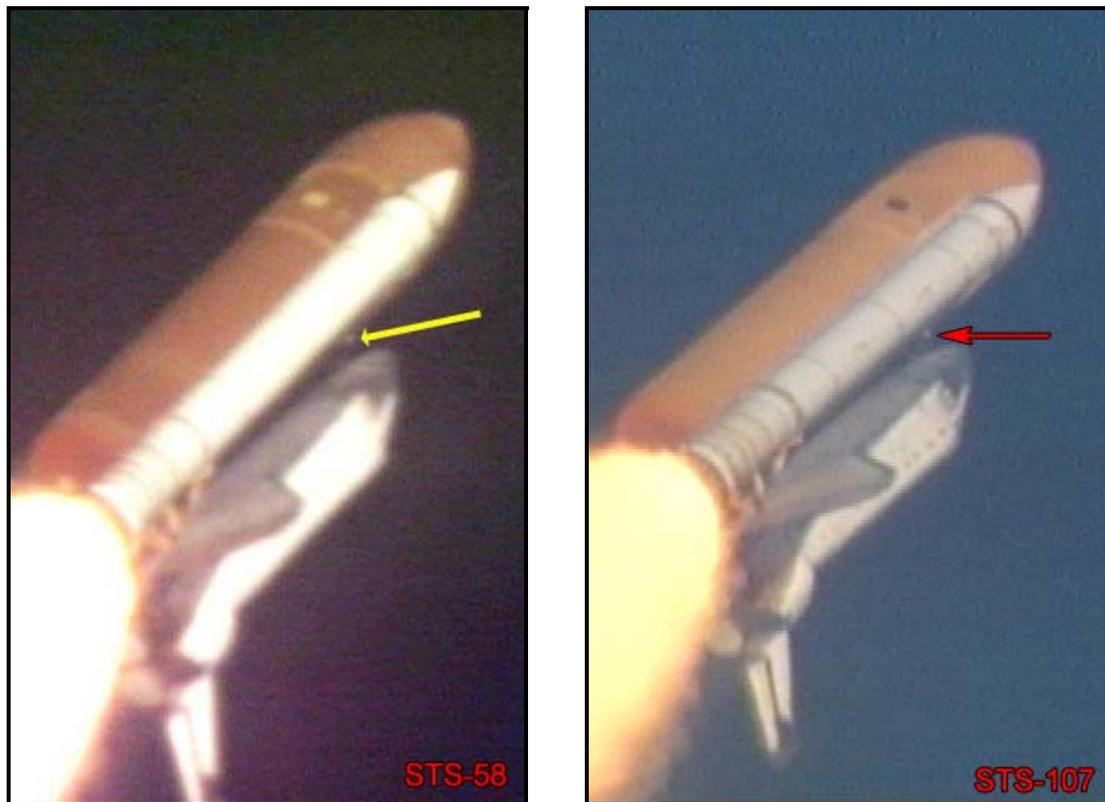
Figure 4.4.1 Comparison of bright spot near bipod on STS-58 and STS-107

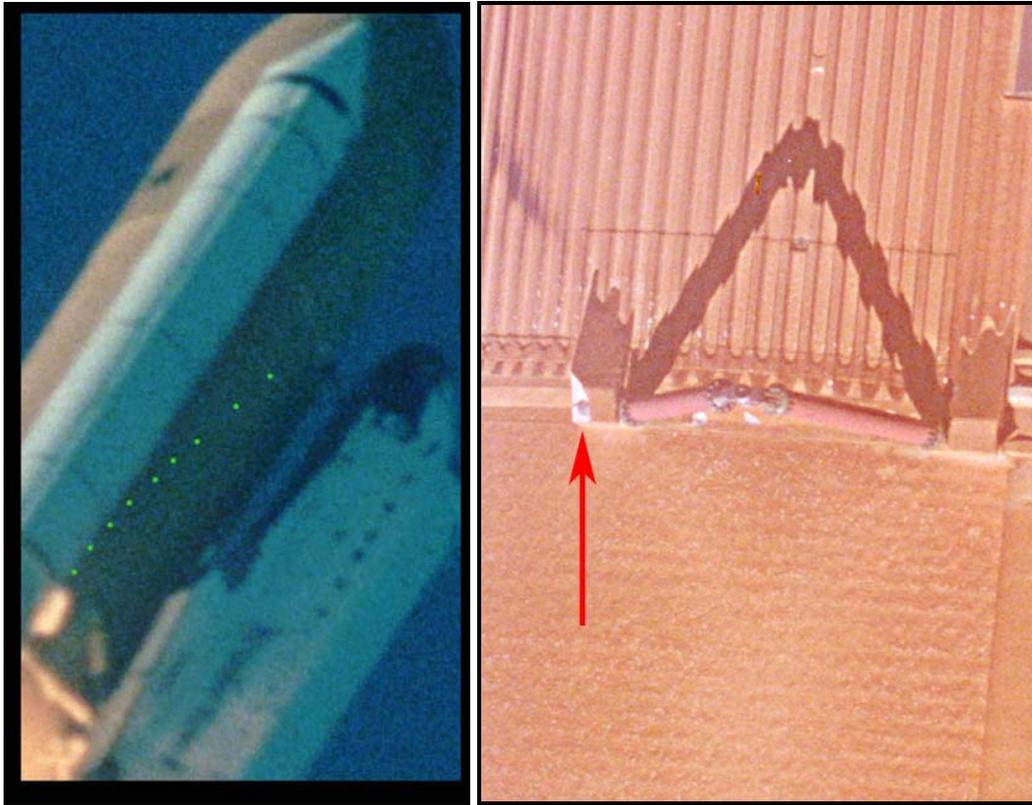
When the ET imagery from the on-board umbilical well camera was examined after landing, it revealed that a large portion of the ramp adjacent to the ET/Orbiter -Y bipod attach was missing and bipod substrate material was visible. The damaged area was measured on the film to be approximately 6 x 12 inches (Figure 4.4.5.1).

Figure 4.4.5.1 STS-112 debris trajectory and umbilical well image of damage near ET bipod ramp

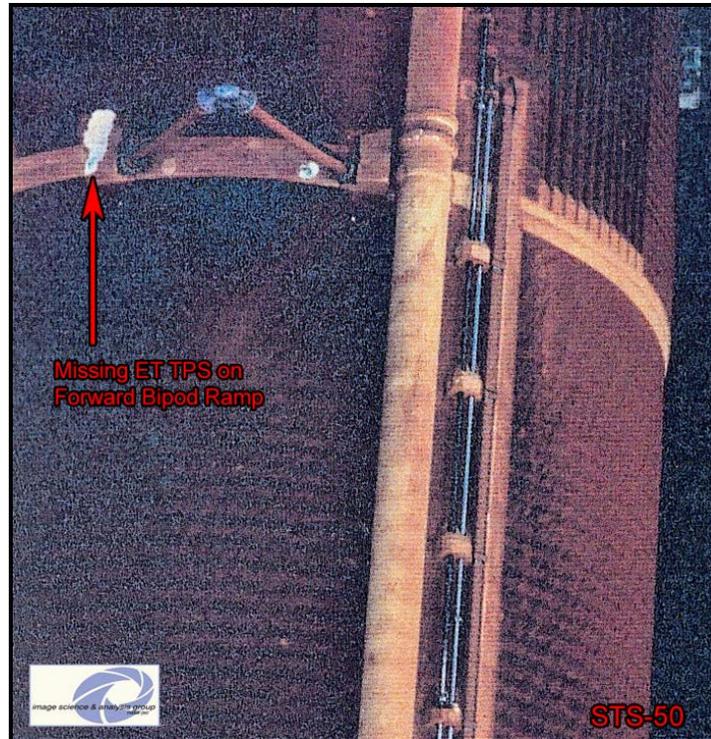
Examination of the STS-50 umbilical well imagery revealed that approximately 60 percent of the ramp adjacent to the ET/Orbiter -Y bipod attach was missing (Figure 4.4.5.2a). The damage area was of sufficient depth that a portion of the bipod spindle housing appeared to be exposed. A portion of the intertank acreage foam at the leading edge of the ramp was also missing. The damage site measured approximately 26x10 inches. Because clouds and haze obscured the STS-50 long range launch tracking camera views, no debris events were recorded on the STS-50 launch imagery that correlated to the damaged ET/Orbiter -Y bipod ramp.

Figure 4.4.5.2a STS-50 ET damage recorded on umbilical well camera

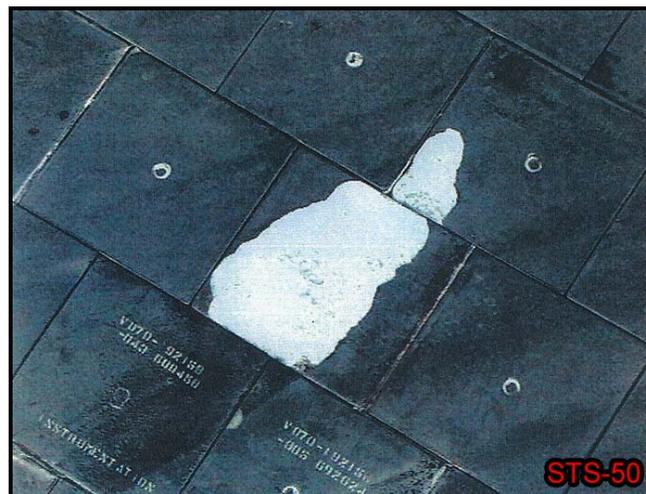
During the post-landing Orbiter inspection, KSC reported that a 9 x 4.5 x 0.5 inch damage site was found on the Orbiter lower left wing surface tiles (outboard of the left umbilical well) that may have been caused by the loss of the ET foam (Figure 4.4.5.2.b).

Figure 4.4.5.2b Detailed view of wing tile damage, STS-50

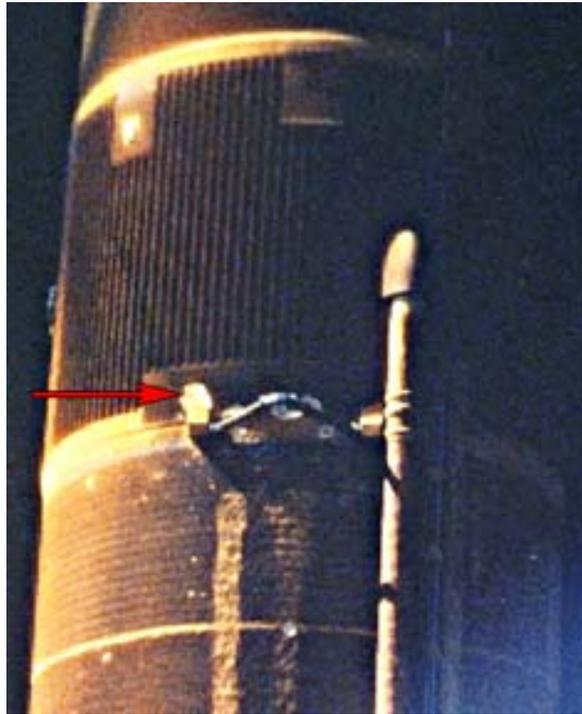
During the STS-32 launch, the launch tracking cameras KTV-5 and E-207 documented a large piece of debris near the SRB exhaust plume at approximately 83.9 seconds MET. The source of this debris was not imaged, however the time of this event was similar to the time of the STS-107 debris strike. After landing, the STS-32 on-board umbilical well camera film revealed five large divots on the External Tank intertank TPS just forward and between the ET/Orbiter-Y and +Y bipod attach ramps (Figure 4.4.5.3).

Figure 4.4.5.3 Image from STS-32 on-board umbilical well camera film showing damage to ET intertank TPS

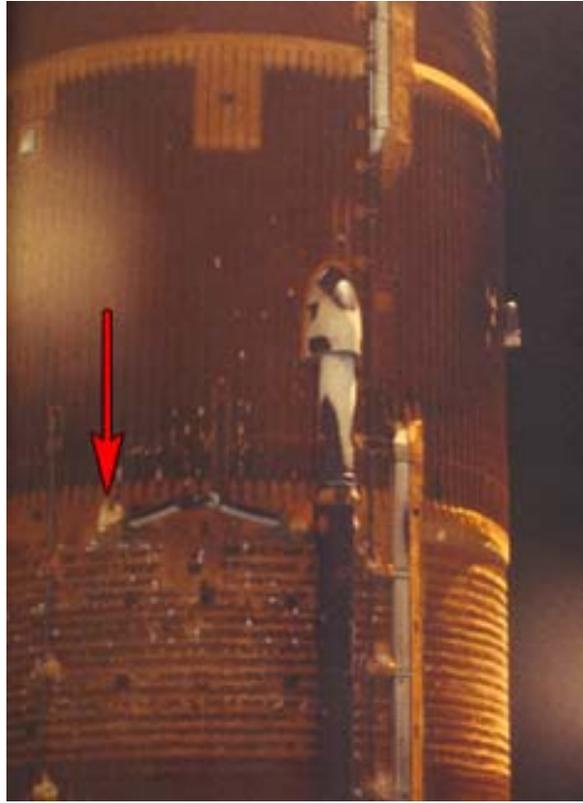
A portion of the STS-7 ET/Orbiter-Y bipod attach ramp was observed to be missing on the on-board umbilical well camera films (Figure 4.4.5.4). The damaged area was estimated to be approximately 18 x 12 inches in size using the umbilical photography. The bipod spindle was not exposed. It is not known if any launch debris was seen on STS-7 that was correlated to the missing bipod ramp.

Figure 4.4.5.4 Image from STS-7 On-board Umbilical Well Camera Film Showing Damage to ET -Y Bipod Ramp

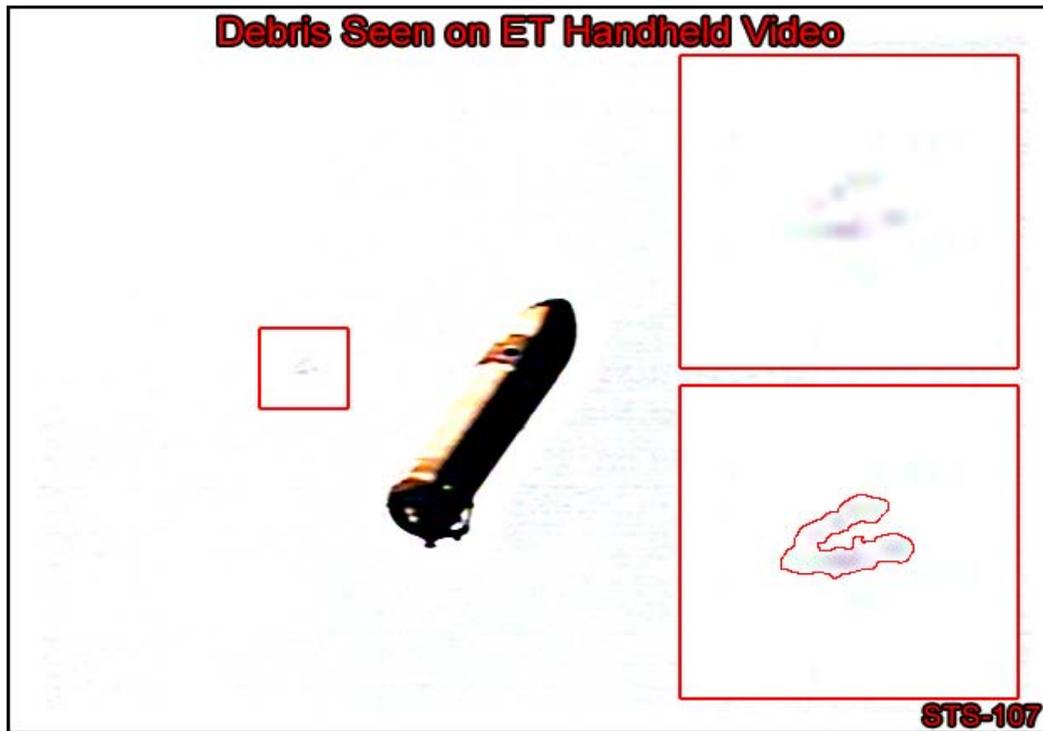
Figure 5.3.1 View from the STS-107 downlink video of the External Tank and the debris, including an enhancement of the debris on the right side of the frame.

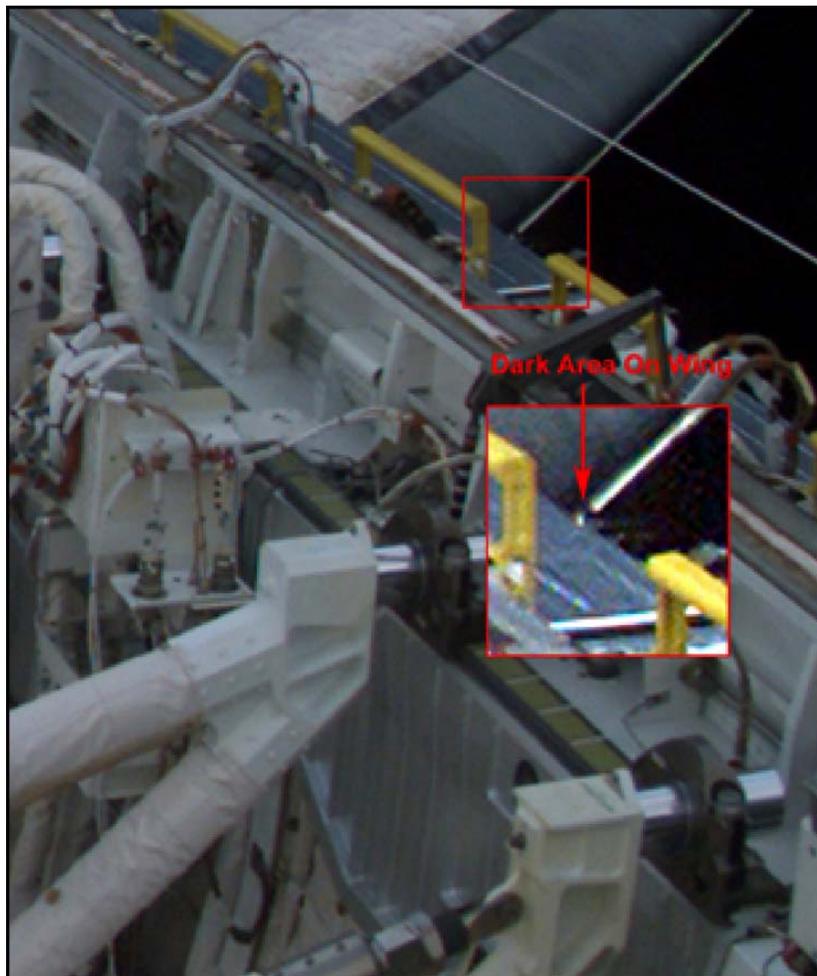
Figure 5.3.2.3a Dark spot seen on Columbia's left wing

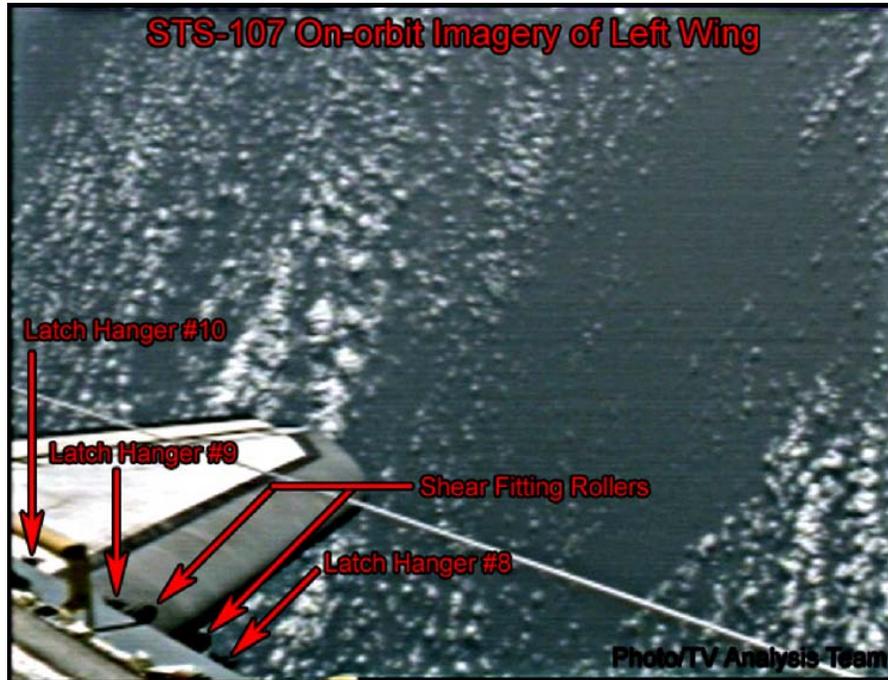
that the dark feature was a portion of the payload bay latch mechanism, which extends to the side of the latch and partially obscures the leading edge of the wing in the view. The latches and rollers were identified and labeled as seen in Figure 5.3.2.3b. The same feature was observed in a previous mission image (STS-68) when the Shuttle was in a similar orientation and with a similar view and lighting of the left wing.

Figure 5.3.2.3b Payload bay door latches/rollers superimposed on Orbiter left wing

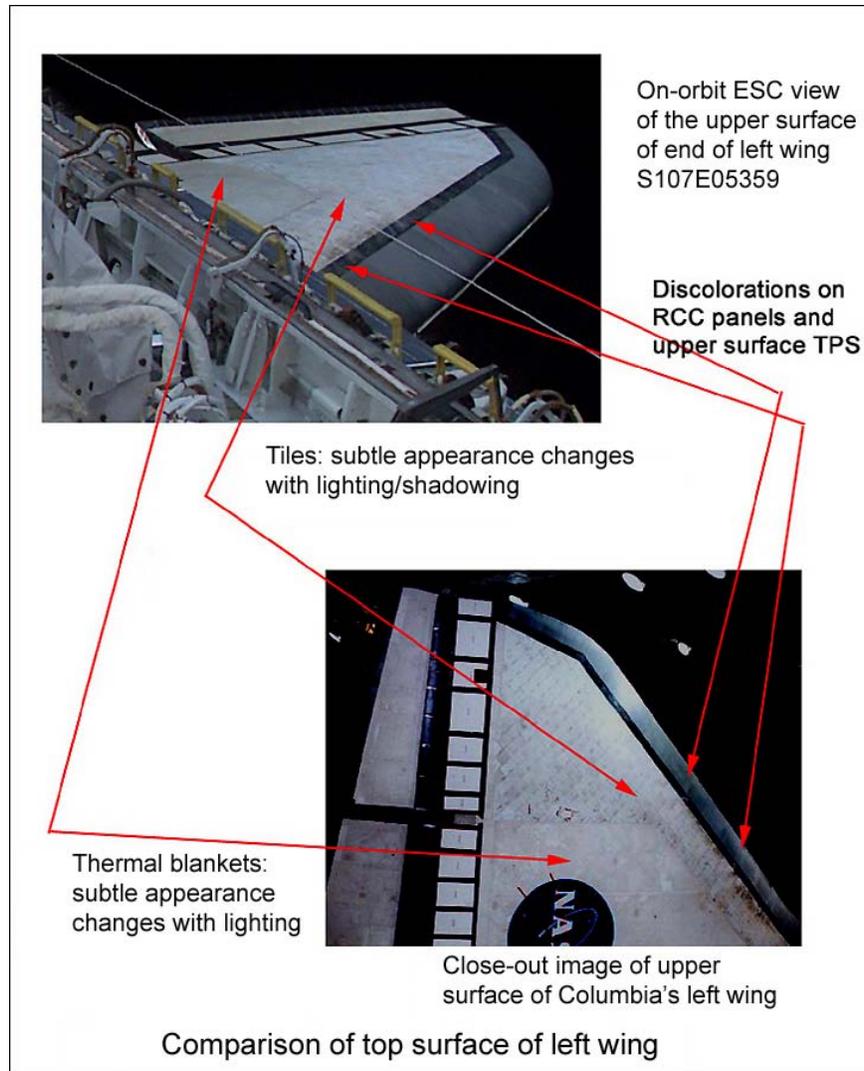
Figure 5.3.2.4a On-orbit and pre-launch views of left wing discolorations

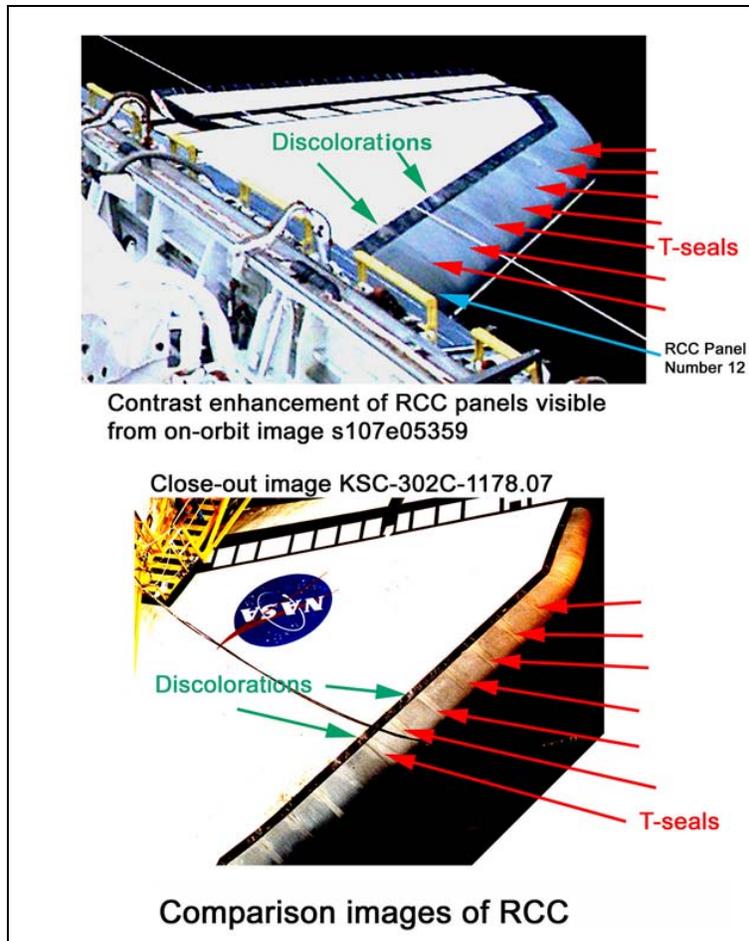
Figure 5.3.2.4b No detectable changes on left wing RCC panels, T-seals

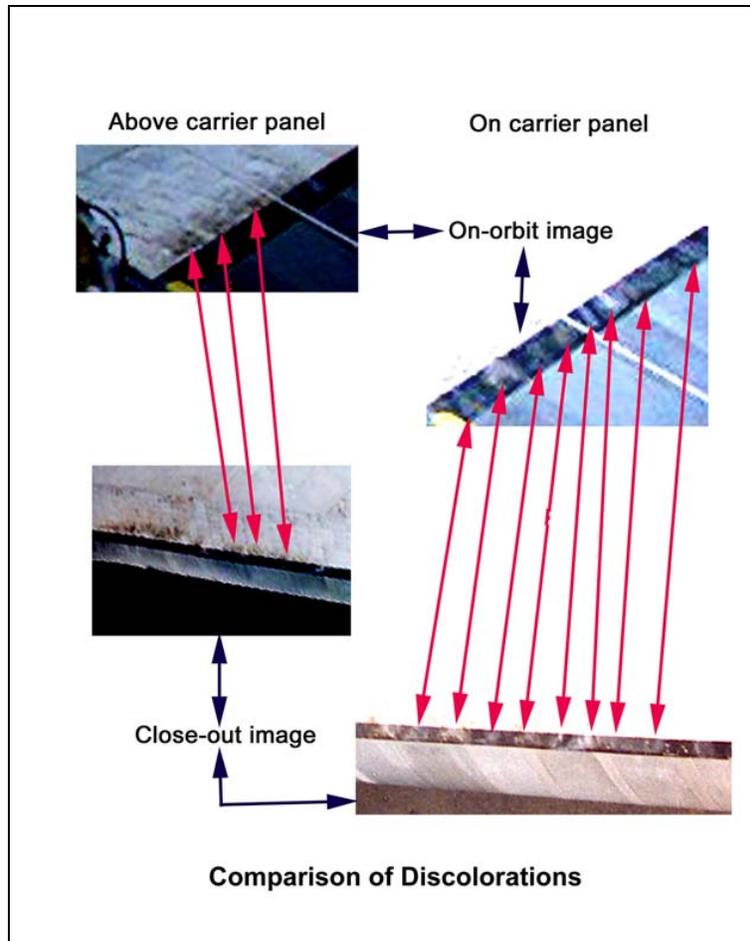
Figure 5.3.2.4c Discolorations on Columbia’s left wing carrier panels and adjacent tile surfaces

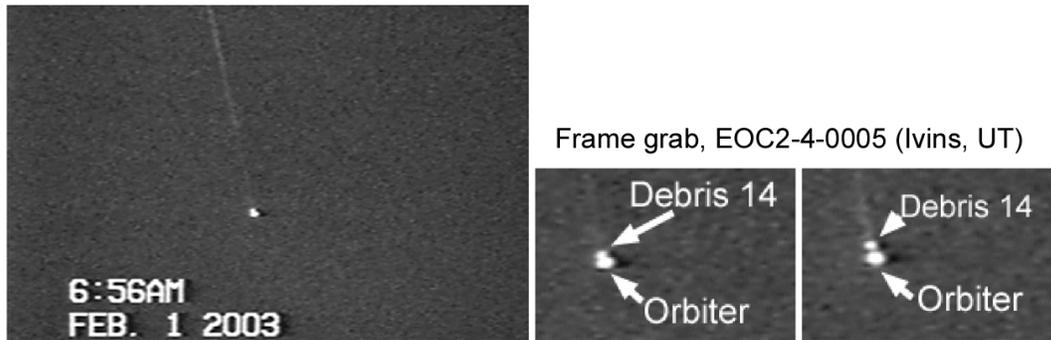
Figure 6.1 Example of full frame grab of a typical re-entry video, and an enhancement showing the separation of debris 14 at 13:55:58 UTC.

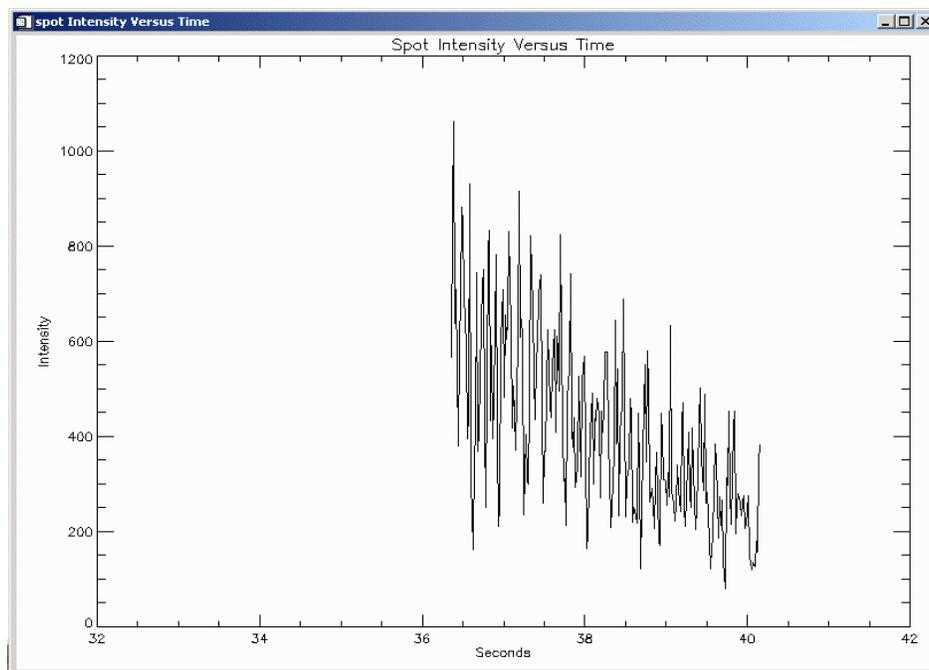
Figure 6.3.5a Debris 6 intensity versus time (seconds after 13:54:00 UTC). The debris intensity decreased over the measurement interval. The light curve suggests that the debris was ablating by approximately 2% per second.

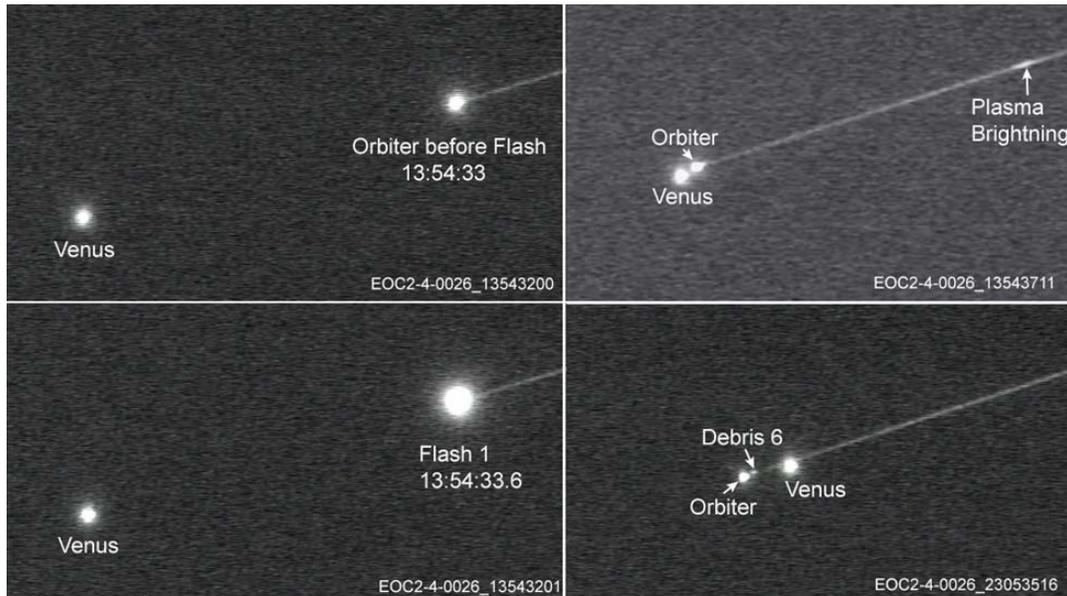
Figure 6.3.6a Frame grabs from the Sparks, NV video illustrating the Flash 1 event and the separation of Debris 6 from the luminous envelope of the Orbiter as it crosses Venus

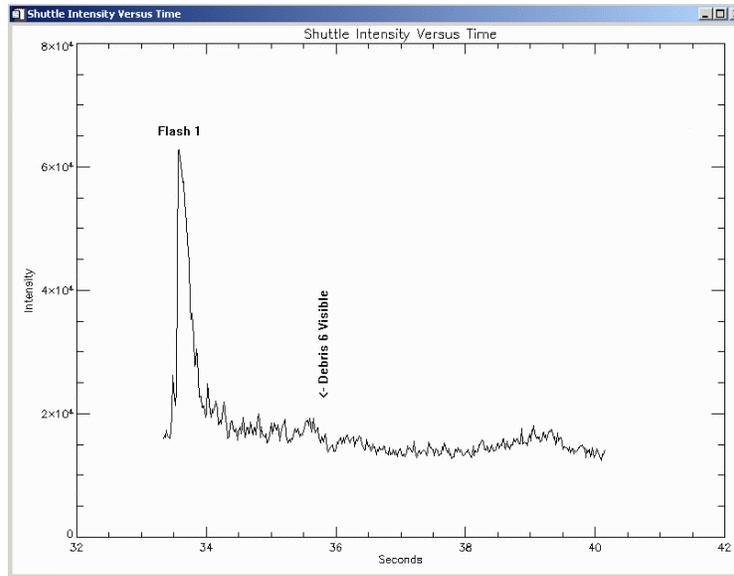
Figure 6.3.6b Preliminary Orbiter light curve from the Springville, CA video. The Orbiter signature remains bright after the flash, until Debris 6 is observed to separate from the Orbiter.
