### 3 ASSESSMENT OF THE CAIB RECOMMENDATIONS

### 3.1 CAIB Recommendation 3.2-1 – External Tank Debris Shedding

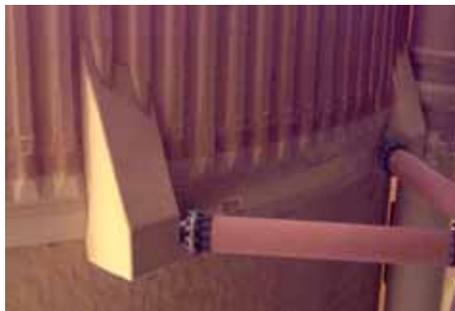
A bipod ramp like the one shown here was the debris that doomed *Columbia* on her last flight. These ramps have been completely eliminated from the modified External Tanks.

After the STS-112 bipod ramp foam loss event, the ET Project began developing concepts to redesign the bipod ramp; this activity was still under way at the time of the STS-107 accident. The dissection of bipod ramps conducted for the *Columbia* accident investigation indicated that defects resulting from a manual foam spray operation over an extremely complex geometry could produce foam loss.

The most visible change to the External Tank was the elimination of the bipod ramps on the forward ET attach point and the installation of heaters in the same area. The loss of one of these foam ramps was responsible for the loss of *Columbia*.

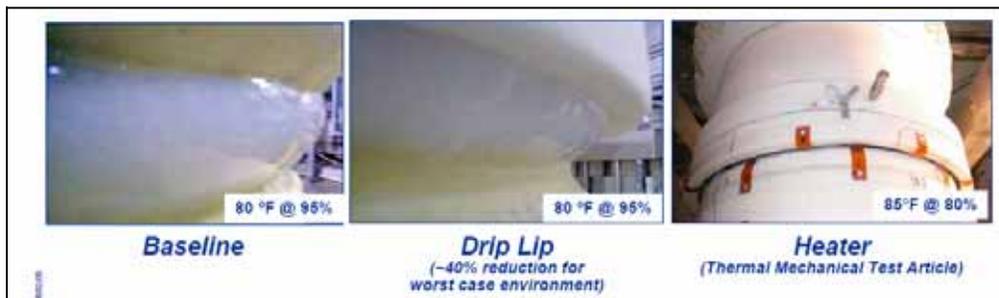
Initially, NASA selected a “drip lip” to reduce ice formation on the three LO2 feedline bellows. The drip lip diverts condensate from the bellows and significantly reduces ice formation. However, since the drip lip alone was not sufficient to completely eliminate the ice, NASA continued to pursue complementary solutions. By April 2005, analysis of the ice formation, estimates of the liberated ice, and transport analyses identified the residual ice at the forward LO2 feedline bellows location as an unacceptable debris source; therefore, additional reduction of ice at the forward location was required before return to flight and resulted in moving the launch date from May 2005 to July 2005.

Three photos showing ice accumulation on the forward LO2 feedline bellows. The drip lip was initially chosen for return to flight, but ultimately the heater was installed to further mitigate the problem.

During the delay, NASA installed a heater in the forward LO2 bellows cavity to reduce ice formation to an acceptable level. Bonding of the heaters required removal and replacement of a 3-inch wide strip of foam along the existing drip lip and LO2 feedline surface. The heater has been installed in the tanks that will be used for STS-114, STS-121, and all future flights. No modifications other than the drip lips have been implemented for the mid and aft bellows for STS-114; NASA continues to assess other ice mitigation techniques for these locations for future flights.

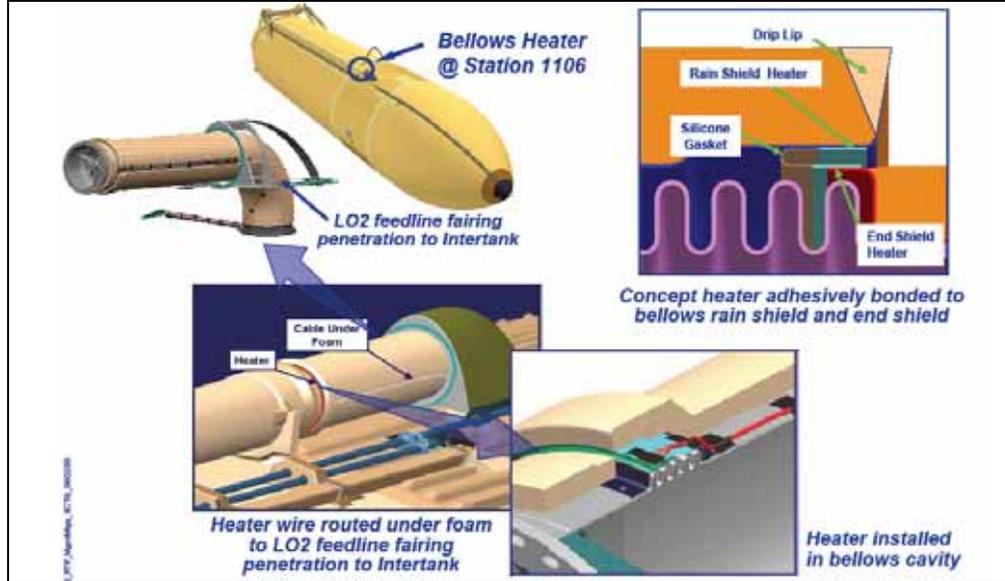
Details of the bellows heater installation. This heater was installed at the Michoud Assembly Facility on the third post-Columbia ET (ET-119), but was retrofitted at the Kennedy Space Center on the first two tanks (ET-120 and 121).

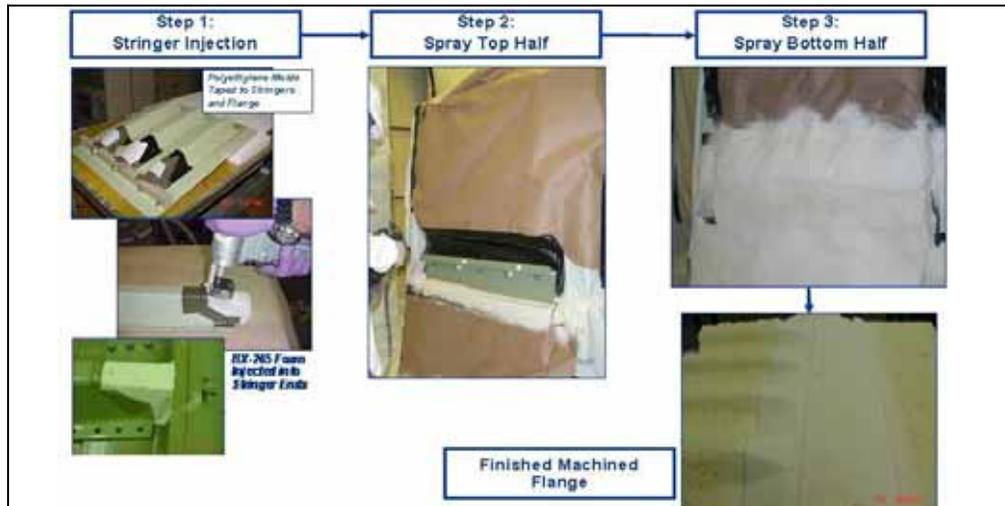
NASA determined the primary root cause of foam loss in the intertank/LH2 tank flange area was the gaseous nitrogen used as a safety purge in the intertank coming into contact with the extremely cold hydrogen tank dome and condensing into liquid. The liquid nitrogen migrated through intertank joints, fasteners, vent paths, and other penetrations into the foam and then filled voids in the foam caused by variability in the manual foam application. During ascent, the LN2 returned to a gaseous state, pressurizing the voids and causing the foam to detach. With this knowledge, NASA evaluated the LH2/intertank closeout design to minimize foam voids and nitrogen leakage from the intertank into the foam.

The new three-step enhanced closeout process for the LH2 intertank area.

The solution ultimately chosen for this area was replacement of the existing intertank closeout with a three-step enhanced closeout process. NASA is relying on the enhanced process in the LH2 intertank area to reduce the presence of defects within the foam to reduce or eliminate void formations in the area of the flange joining the LH2 tank to the intertank.

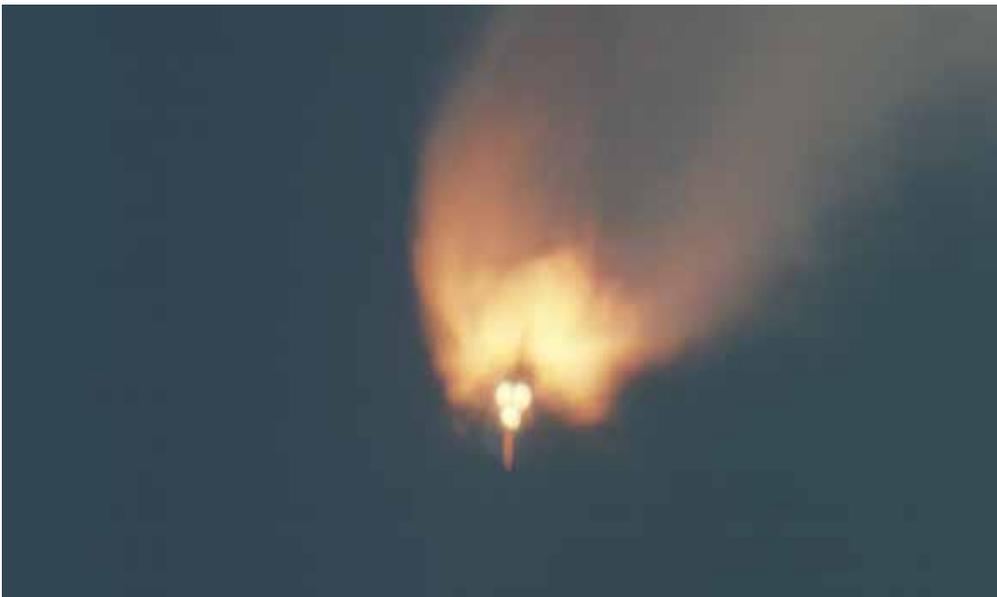
Of the dozen ground-based camera sites used to obtain images of the Space Shuttle during ascent, five were normally used to track the vehicle from liftoff until it was out of view. Due to view angles and atmospheric limitations, two sites did not capture the STS-107 debris event. Of the remaining three sites positioned to “see” at least a portion of the event, none provided a clear view of the actual debris impact to the wing. The first site lost track of *Columbia* during ascent, the second site was out of focus – because of an improperly maintained lens – and the third site captured only a view of the upper side of the left wing. The CAIB noted that camera problems had also hindered the *Challenger* investigation 17 years earlier. Although the initial debris strike during STS-107 was discovered via image analysis, NASA’s post-launch evaluation of the impact was hampered by the lack of multiple views from high-resolution, high-speed ground cameras. The CAIB also found the quality of existing imagery – of all recent Space Shuttle launches – to be less than ideal.

Long-range tracking camera (E-207) photo of STS-95 in October 1998 at SRB separation shows the resolution limitations of ground tracking.
