Other Factors Considered

4.1 FAULT TREE

4.2 REMAINING FACTORS

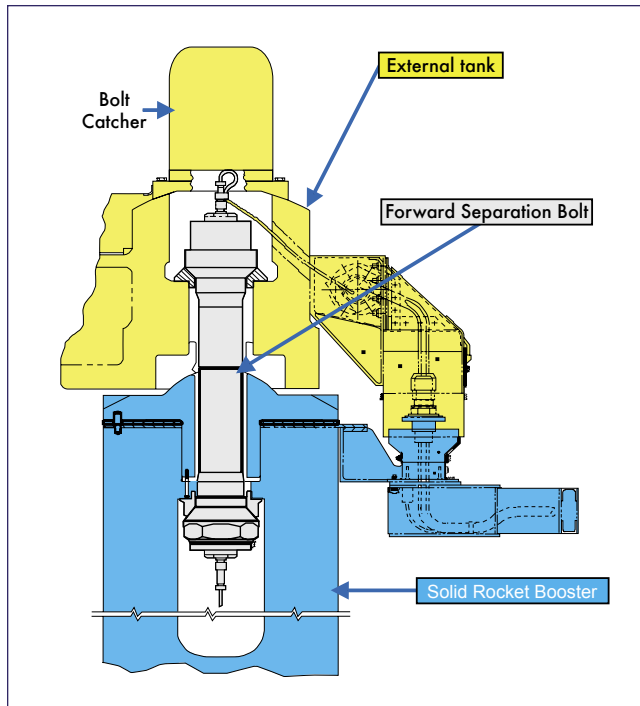
Figure 4.2-1. A cutaway drawing of the forward Solid Rocket Booster bolt catcher and separation bolt assembly.

Due to these testing deficiencies, the Board recognized that bolt catchers could have played a role in damaging *Columbia*’s left wing. The aluminum dome could have failed catastrophically, ablative coating could have come off in large quantities, or the device could have failed to hold to its mount point on the External Tank. To determine whether bolt catchers should be eliminated as a source of debris, investigators conducted tests to establish a performance baseline for bolt catchers in their current configuration and also reviewed radar data to see whether bolt catcher failure could be observed. The results had serious implications: Every bolt catcher tested failed well below the expected load range of 68,000 pounds. In one test, a bolt catcher failed at 44,000 pounds, which was two percent below the 46,000 pounds

generated by a fired separation bolt. This means that the force at which a separation bolt is predicted to come apart during flight could exceed the bolt catcher’s ability to safely capture the bolt. If these results are consistent with further tests, the factor of safety for the bolt catcher system would be 0.956 – far below the design requirement of 1.4 (that is, able to withstand 1.4 times the maximum load ever expected in operation).

- R4.2-1 Test and qualify the flight hardware bolt catchers.

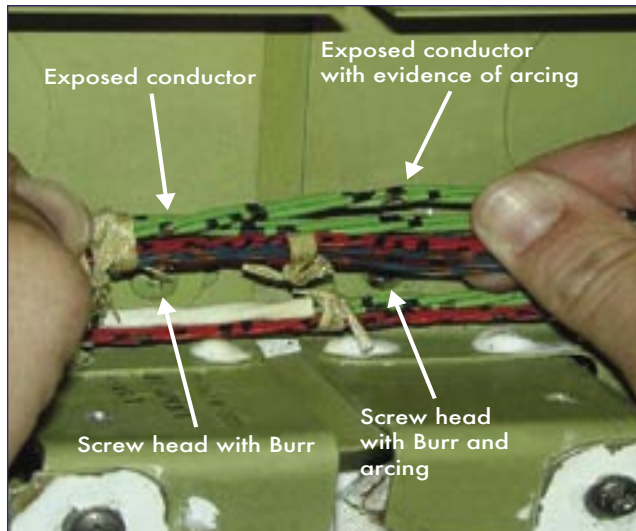
Despite its positive properties, decades of use have revealed one significant problem that was not apparent during its development and initial use: Kapton insulation can break down, leading to a phenomenon known as arc tracking. When arc tracking occurs, the insulation turns to carbon, or carbonizes, at temperatures of 1,100 to 1,200 degrees Fahrenheit. Carbonization is not the same as combustion. During tests unrelated to *Columbia*, Kapton wiring placed in an open flame did not continue to burn when the wiring was removed from the flame. Nevertheless, when carbonized, Kapton becomes a conductor, leading to a "soft electrical short" that causes systems to gradually fail or operate in a degraded fashion. Improper installation and mishandling during inspection and maintenance can also cause Kapton insulation to split, crack, flake, or otherwise physically degrade.² (Arc tracking is pictured in Figure 4.2-2.)

Figure 4.2-2. Arc tracking damage in Kapton wiring.

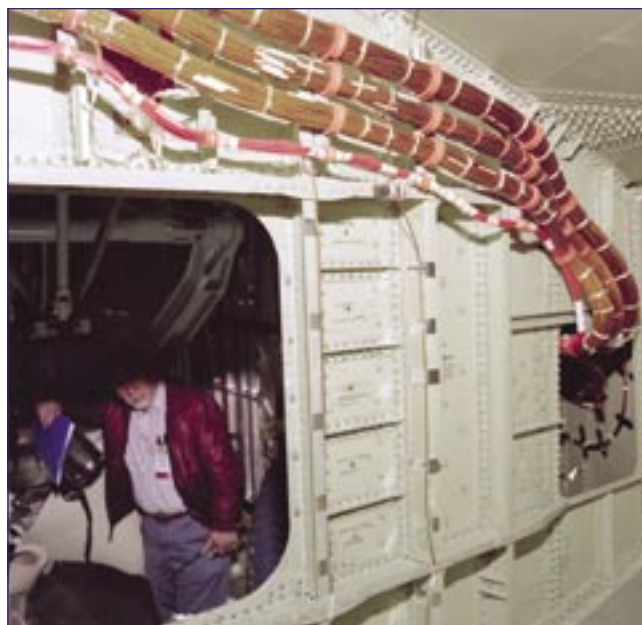
Figure 4.2-3. Typical wiring bundle inside Orbiter wing.

A typical wiring bundle is shown in Figure 4.2-3. Wiring nonconformances are corrected by rerouting, reclamping, or installing additional insulation such as convoluted tubing, insulating tape, insulating sheets, heat shrink sleeving, and abrasion pads (see Figure 4.2-4). Testing has shown that wiring bundles usually stop arc tracking when wires are physically separated from one another. Further testing under conditions simulating the Shuttle's wiring environment demonstrated that arc tracking does not progress beyond six inches. Based on these results, Boeing recommended that NASA separate all critical paths from larger wire bundles and individually protect them for a minimum of six inches beyond their separation points.⁴ This recommendation is being adopted through modifications performed during scheduled Orbiter Major Modifications. For example, analysis of telemetered data from 14 of *Columbia's* left wing sensors (hydraulic line/wing skin/wheel temperatures, tire pressures, and landing gear downlock position indication) provided failure signatures supporting the scenario of left-wing thermal intrusion, as opposed to a catastrophic failure (extensive arc tracking) of Kapton wiring. Actual NASA testing in the months following the accident, during which wiring bundles were subjected to intense heat (ovens, blowtorch, and arc jet), verified the failure signature analyses. Finally, extensive testing and analysis in years prior to STS-107 showed that, with the low currents and low voltages associated with the Orbiter's instrumentation system (such as those in the left wing), the probability of arc tracking is commensurately low.

R4.2-2 As part of the Shuttle Service Life Extension Program and potential 40-year service life, develop a state-of-the-art means to inspect all Orbiter wiring, including that which is inaccessible.
