# COLUMBIA

## ACCIDENT INVESTIGATION BOARD

REPORT VOLUME II  
OCTOBER 2003

<b>CAIB TECHNICAL DOCUMENTS CITED IN THE REPORT</b>
	Reader's Guide to Volume II ..... 5
Appendix D.a	Supplement to the Report ..... 9
Appendix D.b	Corrections to Volume I of the Report ..... 19
Appendix D.1	STS-107 Training Investigation ..... 21
Appendix D.2	Payload Operations Checklist 3 ..... 31
Appendix D.3	Fault Tree Closure Summary ..... 75
Appendix D.4	Fault Tree Elements – Not Closed ..... 121
Appendix D.5	Space Weather Conditions ..... 133
Appendix D.6	Payload and Payload Integration ..... 145
Appendix D.7	Working Scenario ..... 159
Appendix D.8	Debris Transport Analysis ..... 235
Appendix D.9	Data Review and Timeline Reconstruction Report ..... 273
Appendix D.10	Debris Recovery ..... 303
Appendix D.11	STS-107 Columbia Reconstruction Report ..... 317
Appendix D.12	Impact Modeling ..... 361
Appendix D.13	STS-107 In-Flight Options Assessment ..... 391
Appendix D.14	Orbiter Major Modification (OMM) Review ..... 413

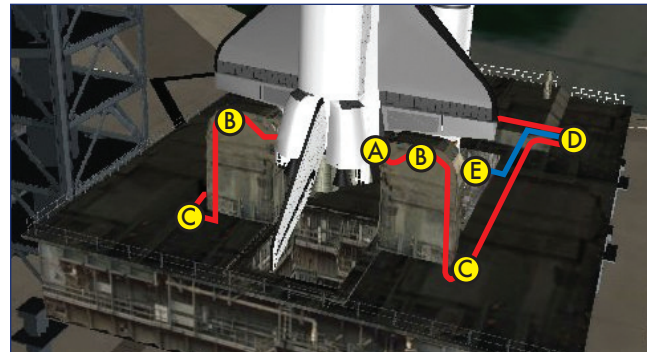
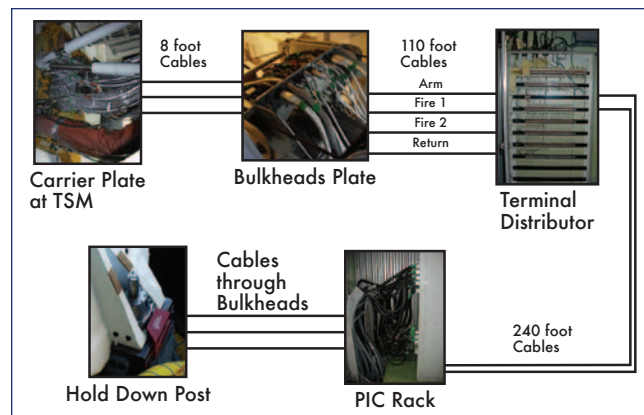
Figure S-1: Hold-Down Post/External Tank Vent Arm Systems diagram with nomenclature below (Note: This figure was not included in the final report Section 10.9; it is provided here for clarity.)

The signal to fire the HDP/ETVAS begins in the General Purpose Computers and goes to both of the Master Events Controllers (MECs). (See Figure S-1 for system routing.) MEC 1 communicates this signal to the A system cable, and MEC 2 feeds the B system. The cabling then goes through the Mobile Launch Platform mast to the Pyrotechnics Initiator Controllers (PICs; there are 16 PICs for A and B Hold-Down Posts, and 4 for A and B External Tank Vent Arm Systems); it then goes to each Solid Rocket Booster and Hold Down Post External Tank Vent Arm System. The A system is hard-wired to one of the initiators on each of the four nuts (eight total) that hold the Solid Rocket Booster to the Mobile Launch Platform. The B system cabling is hard-wired to the secondary initiator on each nut. The A and B systems also send a duplicate signal to the External Tank Vent Arm System. Either Master Events Controller will operate if the other or the intervening cabling fails. To verify cabling integrity, a continuity and ohms check is performed before each launch.

A post-launch review of STS-112 indicated that the A system Hold-Down Post and ETVAS PICs did not discharge. Initial troubleshooting revealed no malfunction, leading to the conclusion that the failure was intermittent. An extensive analysis was initiated, with some 25 different potential fault chains considered as the source of the A-system failure.

- NASA should evaluate a redesign of the Hold-Down Post Cable, such as adding a cross-strapping cable or utilizing a laser initiator, and consider advanced testing to prevent intermittent failure.
