Volume IV

Appendix F.2

“Follow the TPS”: An Analysis of What Occurred to the Thermal Protection System (TPS) During the Flight of Shuttle Columbia on STS 107

Executive Summary

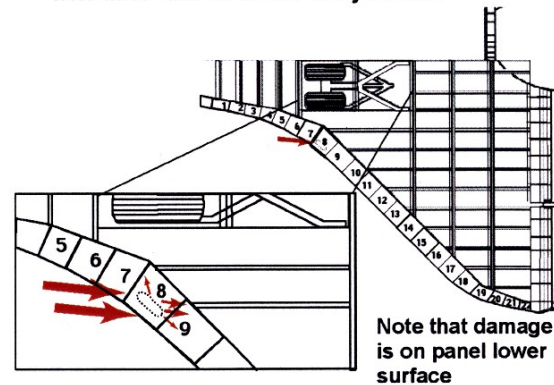
Figure 6: Hypothesized Entry Damage and Initial Entry Heating at Entry Interface.

Testing at Southwest Research Institute and associated analysis has shown (Reference 3) that a strike of debris on the RCC from the ET bipod (briefcase-sized, weighing about 1.7 lbs) striking the WLSS at speeds of 770 ft/sec can cause severe damage. Damage observed included RCC panel cracking, cracking of T-Seals, displacements of both panels and seals and the formation of holes as large as 16 inches by 16 inches.

Airflow direction (large arrows) is up into hole at 40° due to Orbiter entry attitude

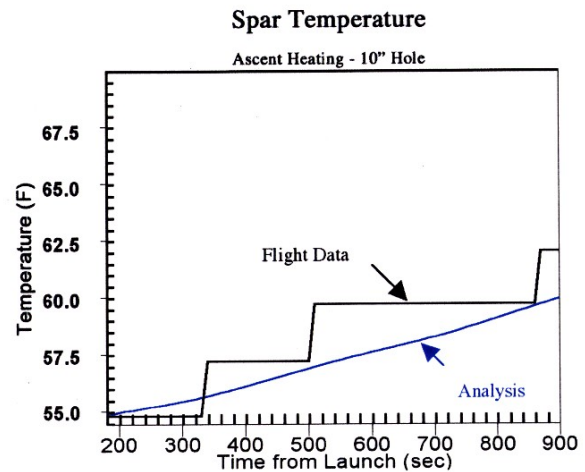
Figure 7: Data from OEX Thermocouple VO 9T9895 and Thermal Analysis by NASA (Reference 12).

One piece of evidence that corroborates that there was a breach in the wing at EI comes from the MADS/OEX thermocouple located behind the spar at the Panel 9 location. As discussed in References 4 and 12, there was “out-of-family” heating at this location during the STS 107 ascent. Figure 7 shows the time history of the measured thermocouple signal and the comparison of NASA’s thermal analysis (Reference 12) of the ascent event. As indicated on the figure, the “stepped” curve is the flight data while the blue-colored, smooth curve is the result of the NASA analysis. Note that the temperature readings are not large, owing to the facts that ascent heating is small, relative to that for entry, and that the thermocouple is behind the spar and the spar insulation. Detail of thermocouple locations will be discussed later.

NASA’s thermal analysis of the signal between 200 -> 900 seconds after launch suggests that ascent heating due to a hole of 6 – 10 inches in diameter in the wing leading edge can account for this anomalous heating. While this is not conclusive evidence that a breach existed after the foam strike at 82 seconds into the launch, it is quite consistent with the hypothesis.

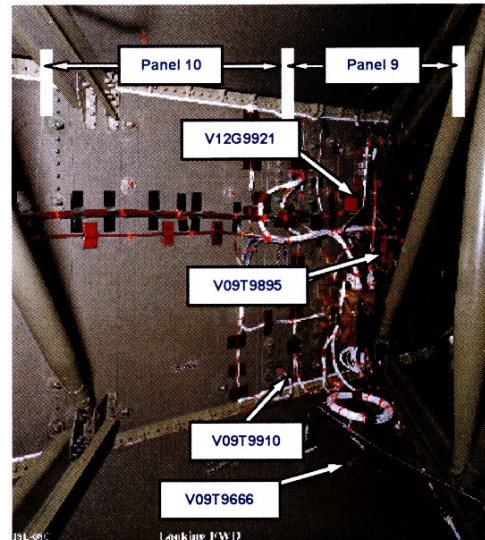
Figure 9: Photograph of Rearward Side of Columbia's Left Hand Wing Spar, Looking Forward. OEX Sensor Locations are Depicted.

Figures 9 and 10 depict the physical location of the MADS/OEX sensors in the Panel 9/10 area of Columbia's left wing. Figure 9 is a photograph of the backside of the wing spar, looking forward. The approximate locations of RCC Panels 9 and 10 are shown near the top of the photograph. Fortunately, this region of the wing on Columbia was instrumented for the Orbiter Experiments (OEX) activity early in the Shuttle Program, and the instruments were still operational and recording data during STS 107. Data from four sensors are extremely valuable in helping understand the temporal events leading up to the failure of the wing leading edge system: V12G9921, a strain gage mounted to the spar; V09T9895, a thermocouple mounted to the back of the spar at the Panel 9 location; V09T9910, a thermocouple mounted to the clevis which held RCC Panel 9 in place (under an "earmuff" which insulated the clevis); and V0T9666, a thermocouple mounted in a tile in the lower wing, near the tile surface, close behind the number 9 carrier panel tiles. V09T9910 is imbedded in the RCC mounting hardware, which secures the panel to the spar.

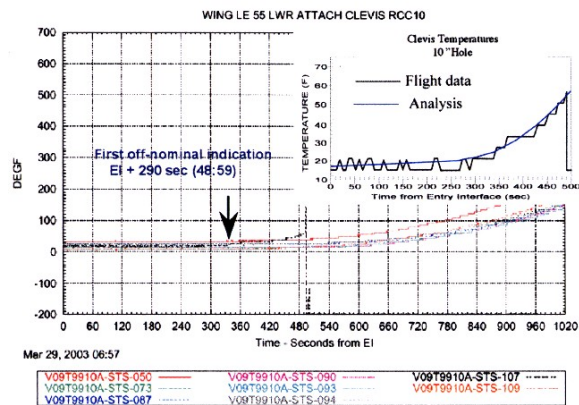
Figure 12: OEX/MADS STS-107 Flight Data and Thermal Analysis (Reference 12).

Figure 12, prepared in the same format as Figure 11 displays the time history of a thermocouple imbedded in the clevis fastener at the lower edge of the RCC located between Panels 9 and 10. The temperature changes recorded on the RCC clevis during STS 107 entry, appear to be quite small, but it is noted that this thermocouple is highly insulated and attached to a large thermal mass.

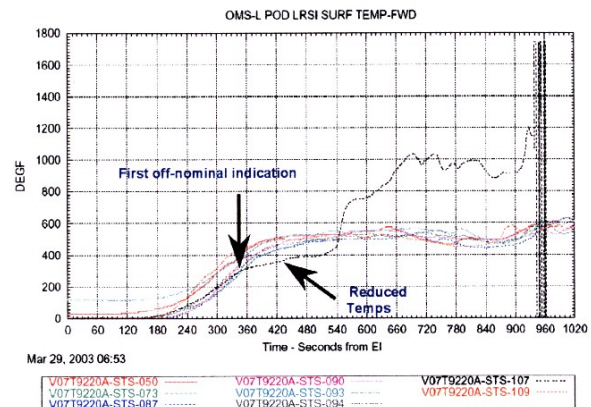
Figure 13: Off-nominal OMS Pod Temps.

Figure 13 shows temperature histories from the left-hand Orbital Maneuvering Systems (OMS) Pod. Again, data from other, similar flights is shown. As can be seen, below nominal temperatures were recorded, starting at about 340 seconds after EI. The following figure explains that this is likely due to a modification to the normal flow field by damage in the wing leading edge. Note also from this figure that at about 540 seconds from EI, the temperature abruptly increases, to values well beyond that for a normal entry.

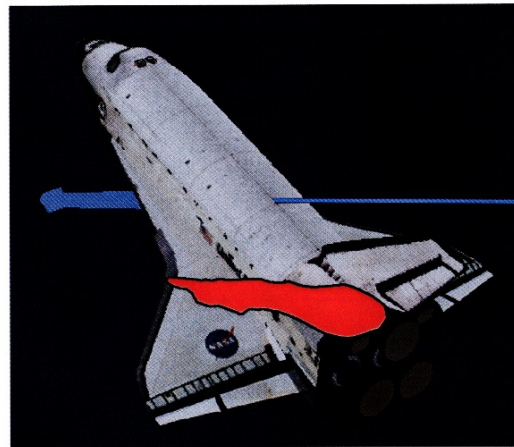
Figure 16: Entry Plume is Possibly Affected by Damaged Structure Accounting for Communications Dropout.

Figure 16 depicts a possible explanation for some of the early (near 13:50:00) communication dropouts observed during Columbia's entry. As known from many years of experience with entry of vehicles, small amounts of charged species (electrons and ions) between an antenna and the receiver can cause communication signal attenuation and even its total loss. As shown in the figure, a possible explanation for some of the early signal attenuation could have been electrons and ions, along with molten materials from the wing hardware, being entrained in the flow and transported to locations between the antennae behind Columbia's cockpit and the receiving TDRS communications satellite.

At the request of the authors, D. Potter of Sandia National Lab performed a scoping study (Reference 15) which shows that melting aluminum would provide charged species concentrations in sufficiently large quantities for signal attenuation in the 13:50:00 -> 13:50:30 period. However, to date (July 2003) analysis by NASA has failed to provide an understanding of how the flow behind Columbia could have provided a pathway to place the charged species and/or molten metal between the antennae and the receiving satellite. Darling (Reference 4) has pointed out that the communications drop out occurred at times quite close to several major debris shedding events and to the breach of the LW spar. However, a definitive link between the two is still conjectural.

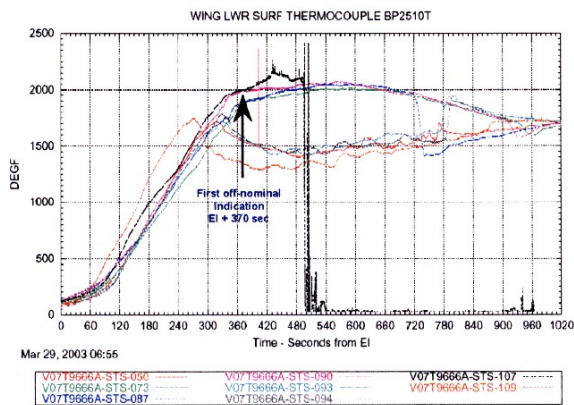
Figure 18: OEX/MADS STS-107 Flight Data.

Figure 18 displays the temperature recording from the thermocouple VO7T9666A located in a lower wing tile, near the wing leading edge, behind Panel 9. This sensor location was shown above in Figures 9 and 10. As can be seen, there is an off-nominal heating trend in this thermocouple starting at EI + 370 seconds (GMT 13:50:19).

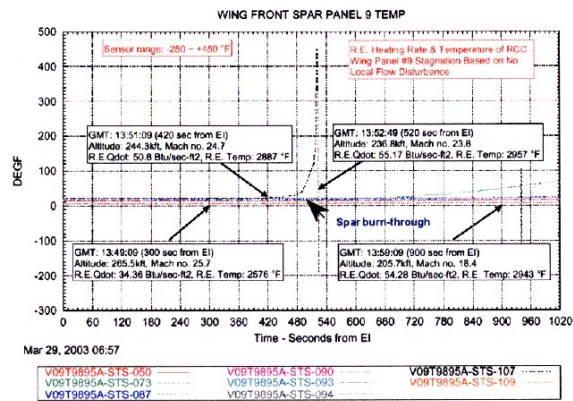
Figure 20: OEX/MADS STS-107 Flight Data.

Figure 20 displays the temperature recordings from thermocouple V0T9895A, located on the inside of the spar, behind Panel 9, as discussed in Figures 9 and 10 above. These data are quite valuable in understanding the progression of damage to the wing leading edge. As seen, the first off-nominal indication begins at 420 seconds after EI, GMT 13:51:09 with a very slight increase in temperature. Later discussion of this figure will focus on the burn through of the spar.

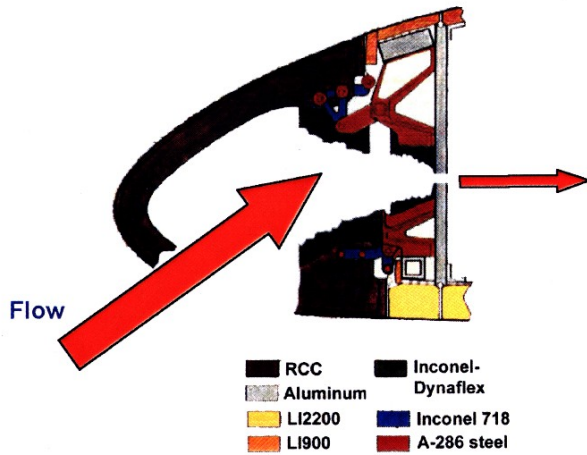
Figure 22: Spar Breach Occurs at EI + 487 Seconds.

the back of the spar behind Panel 9. This rapid increase at EI + 487 seconds strongly suggests an appearance of a plume of superheated air and that spar penetration had occurred. According to study (Reference 13 and 19) by NASA, this timing for spar burn-through is consistent

with a thermal analysis for a 6 -> 10 inch diameter hole in the RCC Panel 8, failure of the leading edge wire harnesses and bit flips observed in the wheel well.

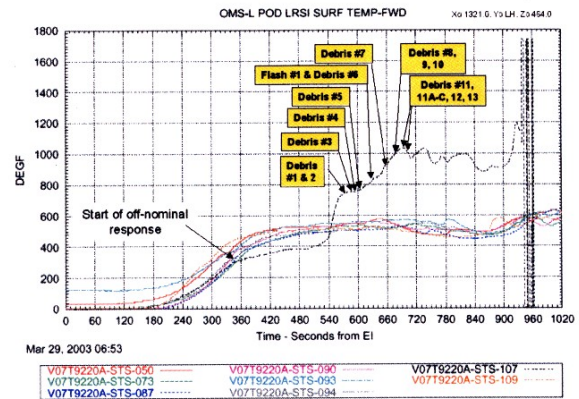
Figure 24: Left OMS Surface Temp Response Indicating the Progression of Damage.

Figure 24 displays the time history of thermocouple V07T9220A located on the OMS Pod. The observation made by NASA (Reference 16) is that from 13:53:29 -> 13:55:29 (EI + 560 -> 680 seconds), there are continual off-nominal increases in OMS Pod temperatures that correlates with the timing of debris sightings 1-13 during the flight. This correlation clearly suggests increasing damage is occurring to the left wing, specifically to the TPS and its substructure.

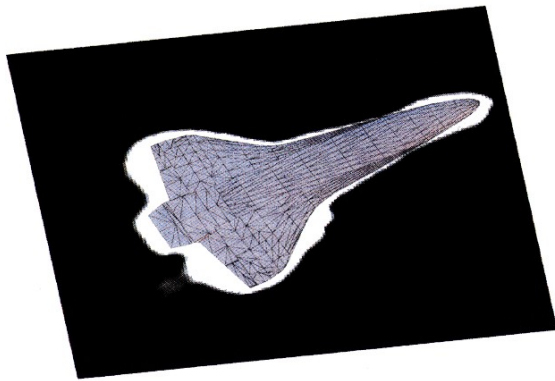
Figure 25: Starfire Photo from Kirtland AFB. GMT 13:57:14. Model Scaling and Orientation Based on Telemetry from NASA. The Columbia Model was Provided by NASA.

The left wing has two apparent "bulges" on the leading edge and two corresponding wakes behind the wing. The authors believe that these are due to the following: hot flow and burning material ejected upward over the wing leading edge from the Panel 8 area; and a large plume of hot gases and burning material and debris ejected upward from the breach in the top surface of the wing aft and outboard of the Panel 9/10 area.

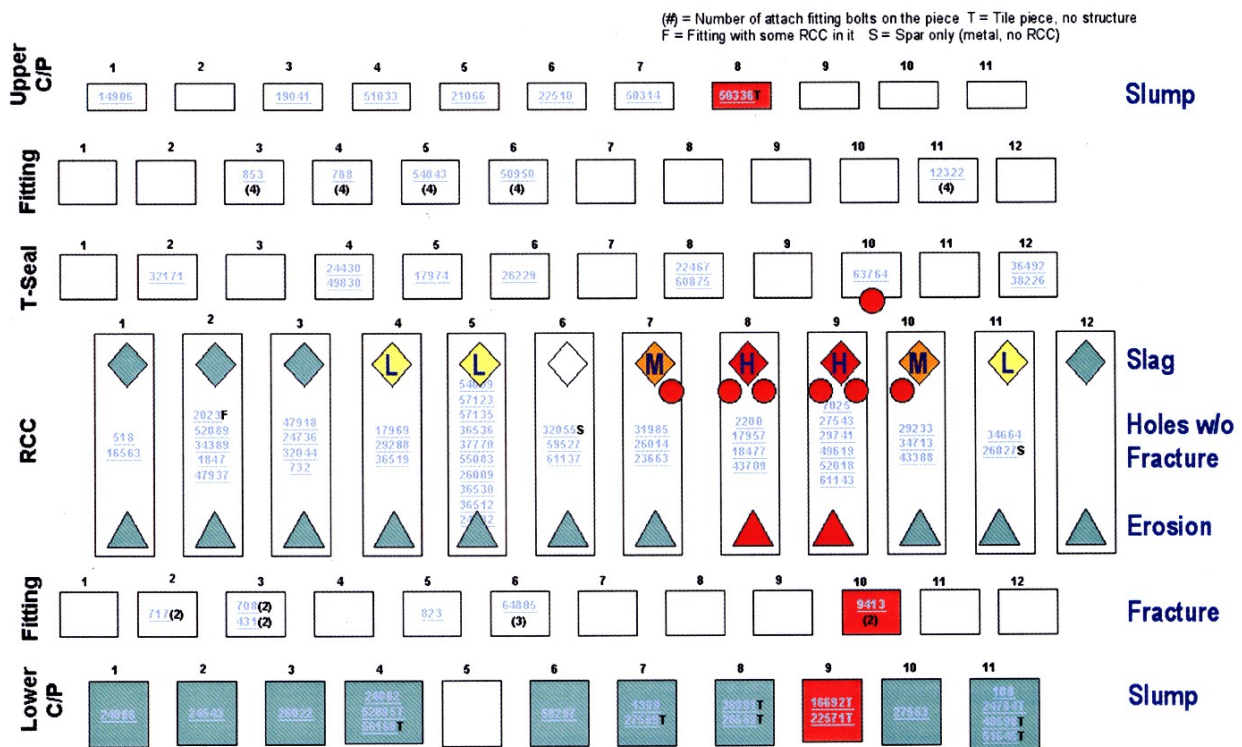
Figure 27: Left Hand Wing Debris Points to Breach in RCC Panel 8/9 Area (Reference 20).

Note that one upper carrier panel tile from Panel 8, depicted by a "red" rectangle was slumped, showing evidence of prolonged heating. The paucity of upper carrier panel tiles in the 8/9/10 area may have been caused by hot gases exiting from the LW cavity volume through the vents between the upper rear portion of the RCC

For "Slag" the diamond symbol was used: Red (H) means heavy slag, Orange (M) means medium slag, Yellow (L) means light slag, Green (no letter) means none or very light slag. "Holes without fractures" refers to the unbroken holes in the RCC, interpreted as evidence that the Inconel fasteners melted out. Here, red circles indicate that prolonged heating occurred. Red triangles depict significant RCC erosion. Green triangles indicate no RCC erosion. "Fractures" indicate the possible evidence of hot-shortcracking of the A286 carrier panel attach bolts (as evidenced by intergranular fracture) as an indicator of prolonged high temperature exposure (Reference 20/Appendix, by L. Korb). The red square represents the only such finding among these debris.

Only lower carrier Panel 9 tiles showed the heavy slumping (red box). All other lower carrier panel tiles found as of 4/30/03 had no evidence of prolonged heating (Green).

In general, Figure 27 shows accumulated evidence that **only** the RCC Panel 8/9 region suffered PROLONGED heating. There is only one area on either wing where the attachment holes in the rear of the RCC panel flanges and ribs are intact (no fractures through the holes) and the attachment metal parts have been melted out. This is in the Panel 8/9 area of the left wing, indicating extreme heating conditions that completely melted out the Inconel fittings and in some cases even severely eroded the RCC mounting holes. All of the other recovered mounting holes in the RCC have either been fractured (the metal parts torn out) or the metal parts are still attached.

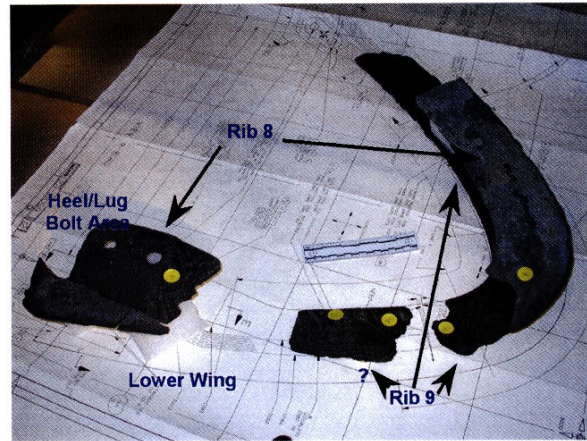
Figure 28: RCC Panel 8/9 Ribs (Outboard View).

The photograph in Figure 28 is an outboard view of recovered parts of RCC ribs from Panels 8 and 9. For perspective, four recovered parts of the outboard rib of Panel 8 are shown sitting on white foam blocks: one upper part of rib 8, and three parts from the lower part of the rib 8 heel/lug bolt area. Two recovered parts from the inboard, upper rib of Panel 9 are shown laying on their full-scale drawing. A third part, placed on the drawing, not identifiable, is likely also from the inboard rib 9 in the location shown. Lack of positive identification of this part is indicated by the ? mark written on the yellow tag. These parts show heavy ablation, and the RCC LW LESS Panel 8/9 area is the only location found with this feature. Ablation features are labeled using yellow tags with the letter "A." The ablation patterns facing the camera on this side of the rib parts strongly suggests that superheated air had been flowing inside the wing, in a generally outboard direction. This indicates significant and prolonged flow from the Panel 8 area into the Panel 9 and outboard regions of the wing inside the RCC-LESS channel. Edges of the ribs are sharpened to a near "knife-edge" (0.05 inches compared to undamaged thickness of 0.365 inches), with a flat side away from the flow direction. Because of the durability of RCC and the extent of the ablation, this flow probably was sustained inside the RCC-LESS cavity area for hundreds of seconds. This type of damage is the result of oxidation (ablation) of the RCC carbon substrate. The following figure shows the same parts from an inboard view.

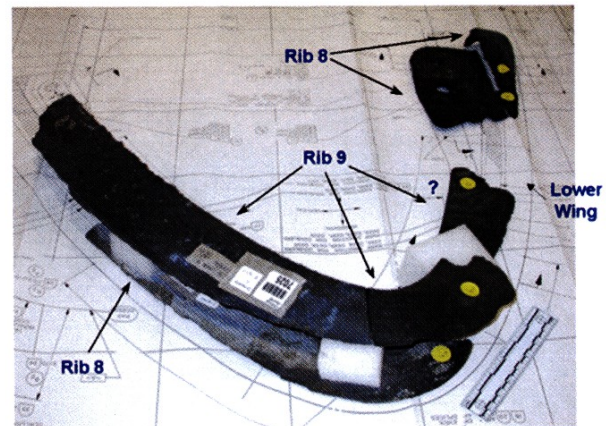
Figure 29: RCC Panels 8/9 Ribs (Inboard View).

Figure 29 is a photograph showing an inboard view of recovered parts of RCC ribs from Panel 8 and 9. Here, the two recovered and identified parts of the inboard rib of Panel 9 are sitting on white foam blocks. The recovered parts from the outboard rib of Panel 8 described in Figure 28 are now shown lying on their full-scale drawing. Note that the yellow tags here are labeled "NA," meaning not ablated and verifying the statements made in the discussion of Figure 28.

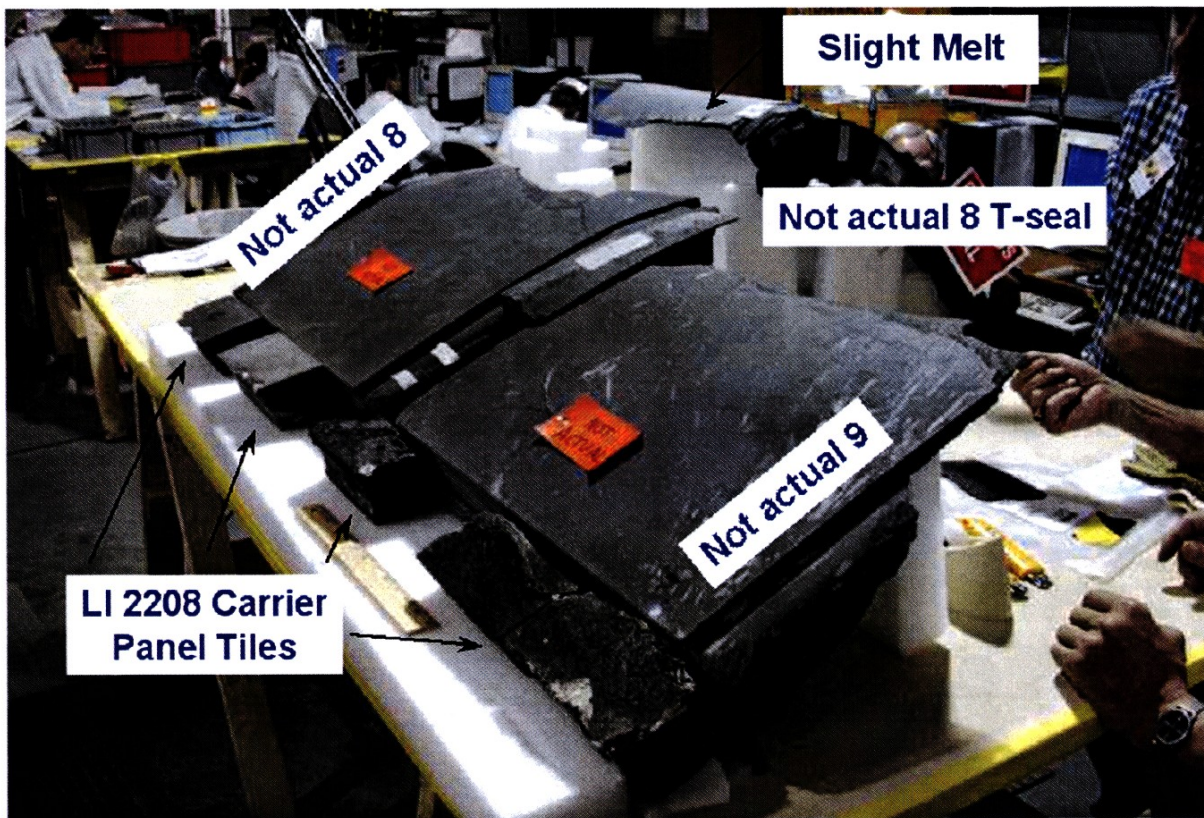
Figure 30: Reconstructed RCC Panel 8/9 Area.

As discussed earlier in describing Figure 19, streamline patterns determined by CFD show that flow out of this lower RCC Panel 8/9 juncture area directly affect the thermocouple V07T9666A, located in the lower tile field, close behind RCC Panel 9. This flow relationship, strongly suggests the above nominal temperatures recorded by this thermocouple were caused by the flow out of the lower Panel 8/9 juncture, which also eroded the lower Panel 9 carrier panel tiles. The flow out of this slot, into a relatively high-pressure area (but below the pressure at the inlet breach) was probably the only outlet available to the large volume of ingested gases once the flow-through of the RCC vent slots was choked. The traces in Figure 18 suggest that this started at EI + 370 seconds and persisted until spar burn-through at approximately EI + 487 seconds.

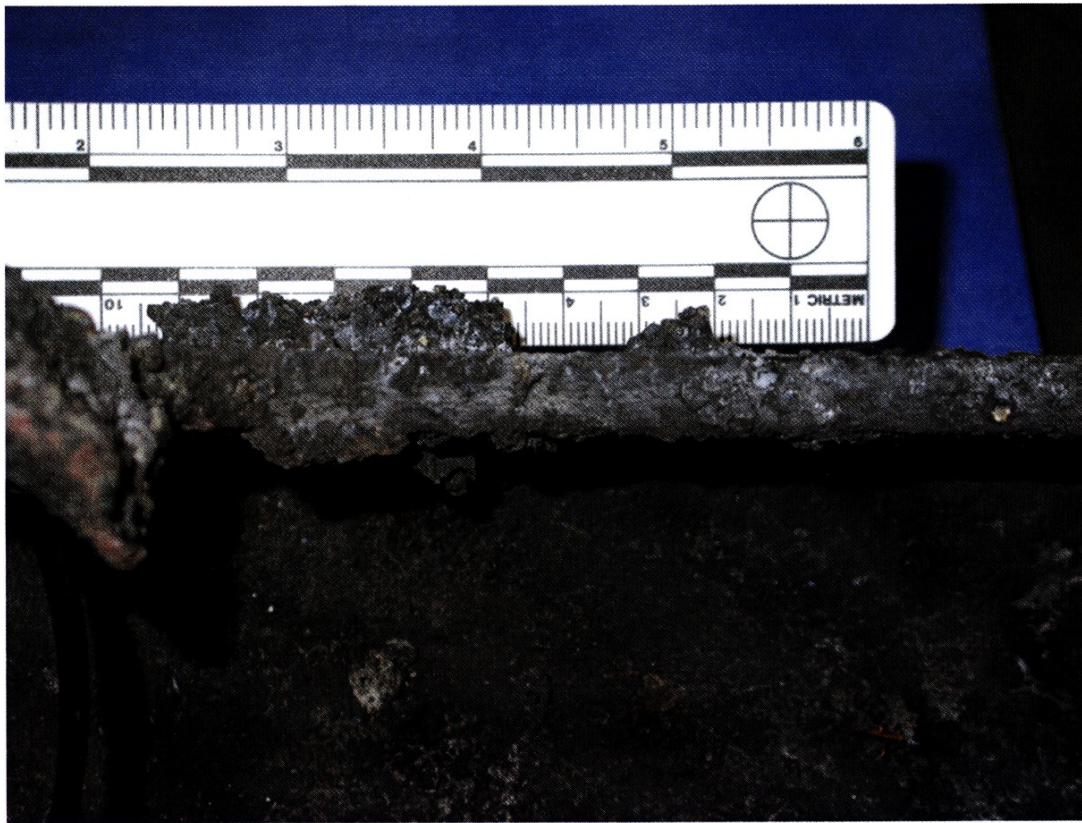
Figure 32: Slag Deposits on Upper Edge of Panel 8 on the RCC Side of the Vent.

The authors believe that in addition to a breach in Panel 8, the upper part of the T-seal between Panels 8 and 9 must have been missing or severely misaligned for a major part of the entry. This is required to account for the severe erosion of the upper RCC Panel 8 outboard and Panel 9 inboard ribs shown in Figures 28 and 29 and discussed above. Flow patterns of the recovered upper Panel 8, suggest this happened as discussed in Reference 20.

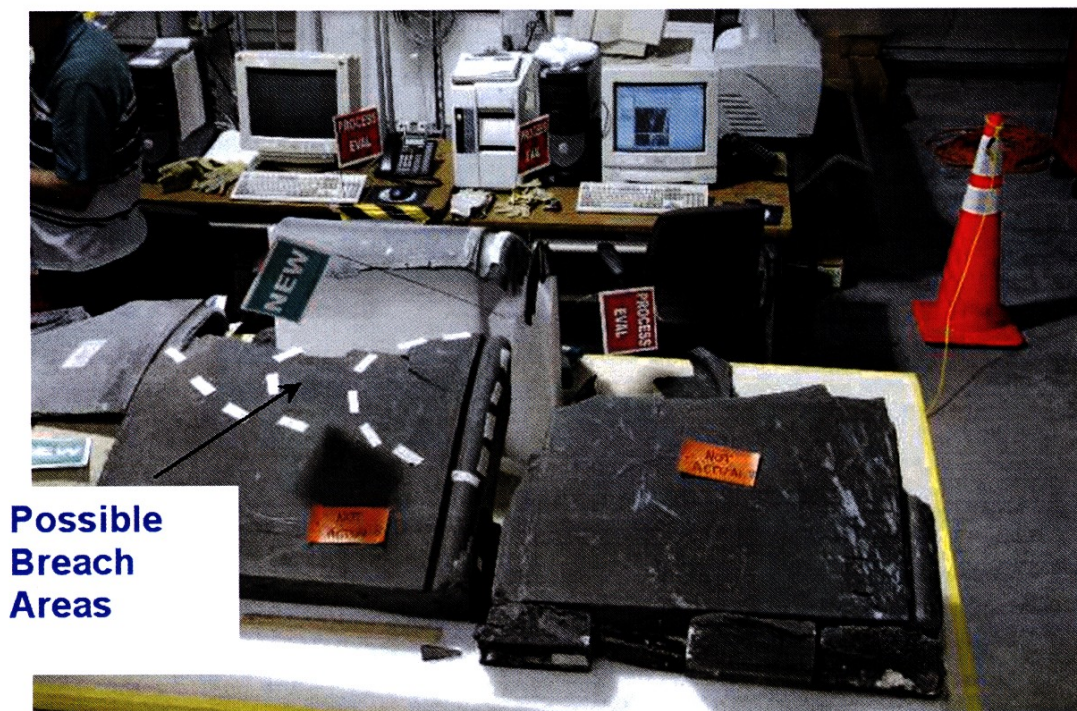
Figure 33: Probable Initial Breach in Panel 8.

Figure 33 shows the probable initial breach location on the lower Panel 8 area. The size of the hole is difficult to determine, but could be bounded by the three dotted locations outlined by white tape. Analysis by NASA discussed above suggests the damage is consistent with a hole of 6 → 10 inches in diameter. All of these are consistent with the flow patterning seen on the debris and the Computational Fluid Dynamics flow calculations to be discussed below. The authors note that areas this large would be consistent with the “piece” shown by DoD radar observations that “left” Columbia on day two of its orbital maneuvers. A part of a broken T-seal (possibly from Panel 8, located between Panels 8 and 9) could also account for the “piece” observed leaving the shuttle on day two of orbital operations. Note that on this photograph, the two recovered Panel 8 carrier panel tiles are not shown.

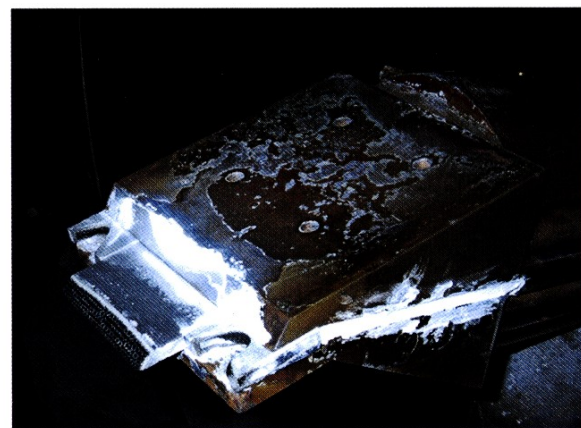
Figure 44 (b): Post-test Photograph Showing Knife-edges in Both RCC Test Article and Closeout.

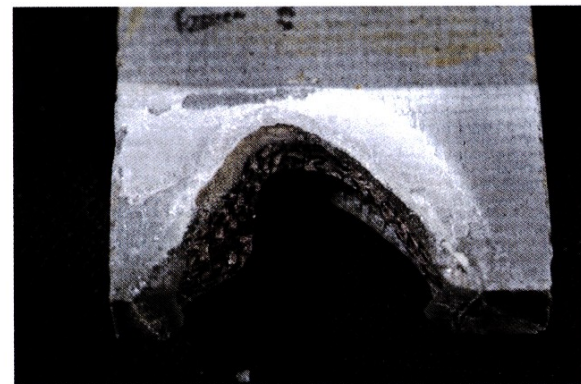
Figure 44 (c): Close Up, Post-test Photograph Showing Knife-edges in the RCC Closeout.
