Volume IV Appendix F.5

Space Shuttle STS-107 Columbia Accident Investigation, External Tank Working Group Final Report – Volume 1

This report summarizes the results of the analysis, design, production, and performance of External Tank (ET-93), performed by the External Tank (ET) Working Group (ETWG), as part of the STS-107 *Columbia* Accident Investigation.

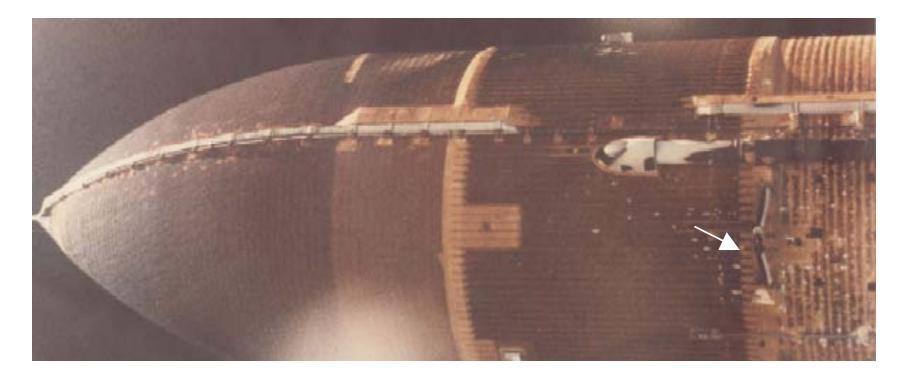
Figure 5.3.3.2-1. STS-7/ET-6

Assessment of post-flight imagery has shown five prior occurrences of bipod ramp TPS loss. All instances of ramp loss were isolated to the -Y (left hand) ramp. The first occurrence, STS-7/ET-6 (Figure 5.3.3.2-1), showed a large portion (18 in. x 12 in.) of the bipod ramp missing. The TPS area had an estimated weight of 0.6 lb. This TPS loss event was attributed to a repair in the forward edge of the ramp. Following this occurrence of TPS loss, the ramp repair criterion was limited to a maximum of 3 sq. in. on the forward face of the bipod ramp.

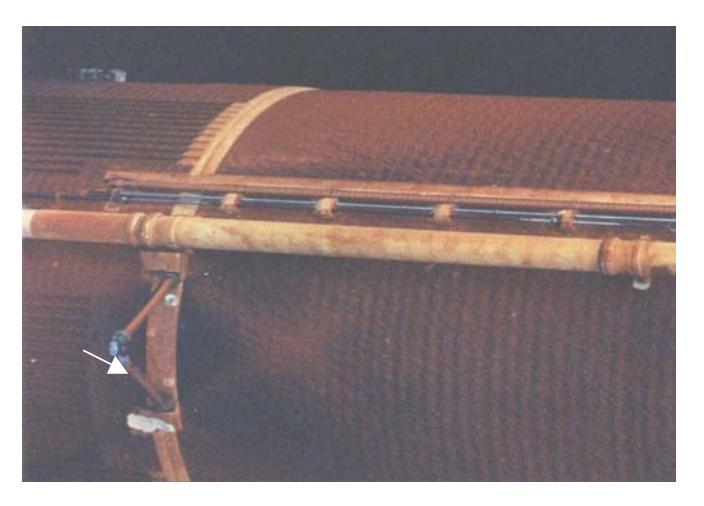
Figure 5.3.3.2-2. STS-50/ET-50

The TPS loss event on STS-50/ET-50 encompassed the majority of the bipod ramp, measuring 26 in. x 10 in. and weighing 0.98 lb (Figure 5.3.3.2-2). This loss was attributed to voids/debonds in the Isochem bond layer of the non-vented two-tone TPS area. ET-50 was the last ET built with this intertank TPS configuration.

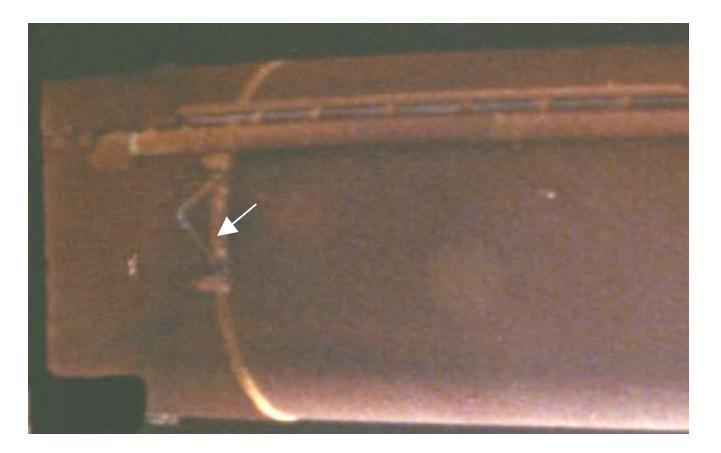
Figure 5.3.3.2-3. STS-52/ET-55

On STS-52/ET-55, the TPS loss was estimated to be 8 in. x 4 in., weighing 0.02 lb. (Figure 5.3.3.2-3)

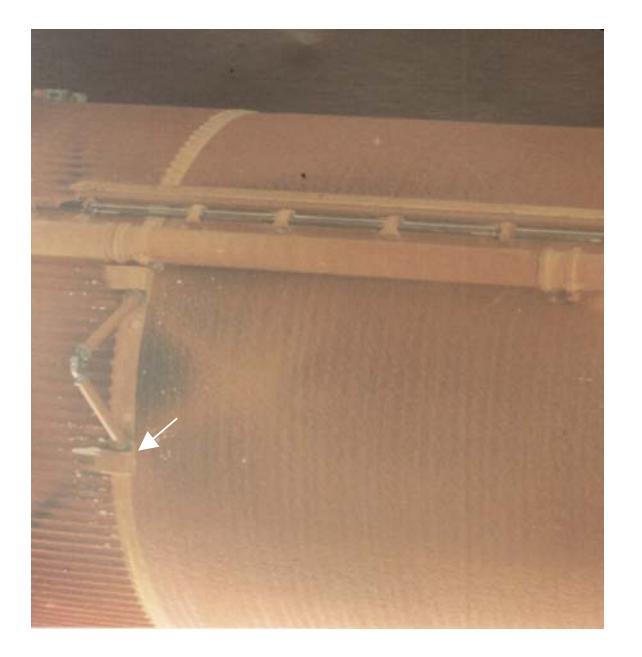
Figure 5.3.3.2-4. STS-62/ET-62

On STS-62/ET-62, there was a small divot in the aft face of the ramp measuring approximately 3 in. x 1 in. and weighing 0.001 lb. (Figure 5.3.3.2-4)

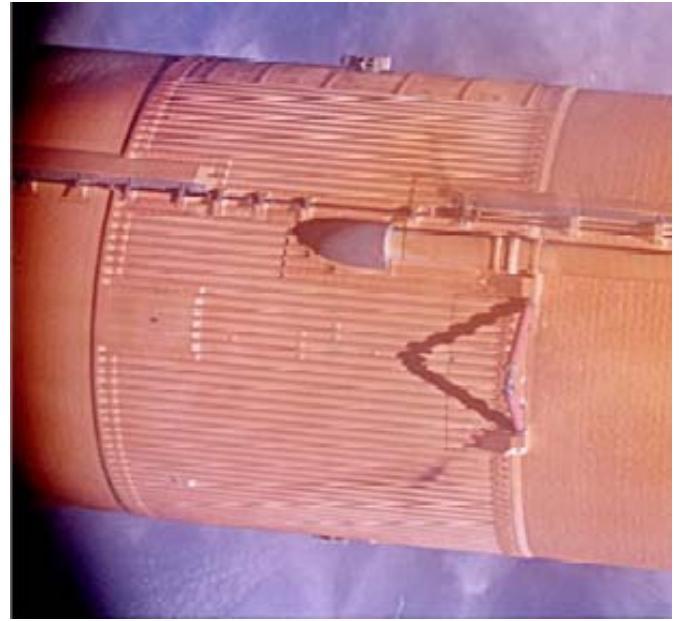
Figure 5.3.3.2-5. STS-112/ET-115

On STS-112/ET-11, the TPS loss location and shape was similar to that observed on STS-52 (Figure 5.3.3.2-5). The TPS loss on STS-112 was estimated to be 7 in. x 12 in. with a mass of 0.3 lb.

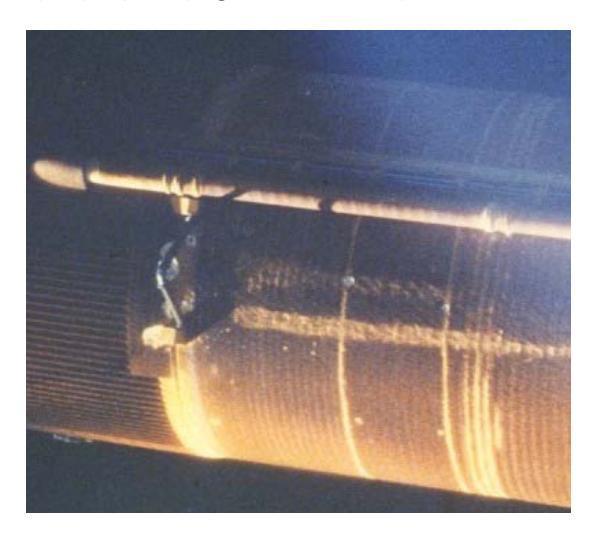
Figure 5.3.3.5-1. STS-32R/ET-32 Post-Separation Photograph

Post-separation umbilical camera films showed several large divots in the area of the bipods. Two of the divots, measuring 12 to 14 in. in diameter, were located between the bipods just forward of the intertank-to-LH2-tank flange. A third divot, approximately 14 in. in diameter, was located between the bipod ramps and extended into the intertank-to-LH2-tank flange. The largest divot, measuring 28 in. wide, surrounded the forward part of the -Y (LH) bipod (Figure 5.3.3.5-1).

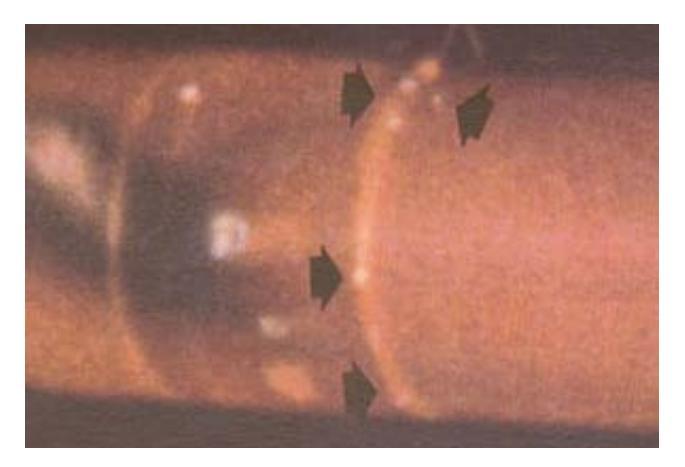
Figure 5.3.3.5-2. STS-35/ET-35 Post-Separation Photograph

Post separation umbilical camera films showed five divots on the left side (-Y axis) of the intertank-to-LH2-tank flange closeout and five divots on the right side of the closeout (+Y axis). The largest divots ranged from 8 to 10 in. in diameter (Figure 5.3.3.5-2). Divots from this area (previously observed on other ETs) did not show a correlation with an increased level of Orbiter tile damage.

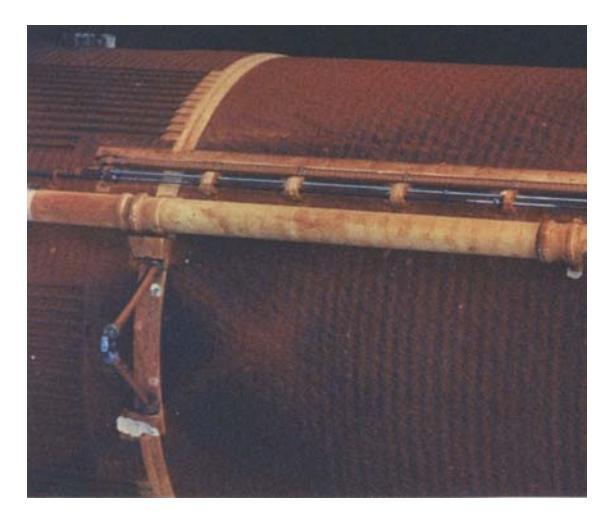
Figure 5.3.3.5-4. STS-50/ET-50 Post-Separation Photograph

Y bipod ramp was missing with a 24 in. by 8 in. divot. The second location was the +Y jack pad closeout, measuring 4.5 in. sq., located just below the right bipod strut (Figure 5.3.3.5-4). The TPS surface under the bipod ramp was the intertank two-tone TPS configuration. The jack pad is a Polymer Development Laboratories (PDL) closeout of a tooling mount used to jack the Orbiter into place for mate at KSC.

The most probable cause of the bipod ramp TPS loss was related to debonds/voids in the Isochem bond layer of the two-tone TPS configuration. This area was not vented because of proximity to the cryogenic zone. Following this occurrence of TPS loss, the vented area on remaining ETs with Intertank two-tone TPS (ET-48/STS-46, ET-49/ST-53, and ET-45/STS-47) was revised to add vent holes just forward of the ramp to acreage interface (Figure 5.3.3.5-5).

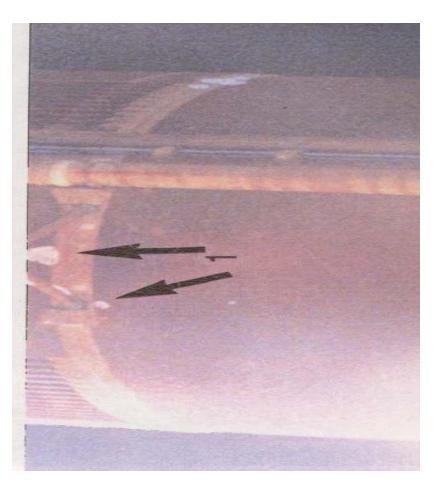
Post-separation umbilical camera films showed a divot approximately 14 to 16 in. in diameter on the intertank between the left and right bipod fittings just forward of the intertank flange closeout in the two-tone TPS area (Figure 5.3.3.5-6).

Figure 5.3.3.5-6. STS-47/ET-45 Post-Separation Photograph Minimal Orbiter tile damage was observed post-flight on OV-105 (STS-47). TPS loss of this type was not considered a safety of flight concern but one of Orbiter tile maintenance.

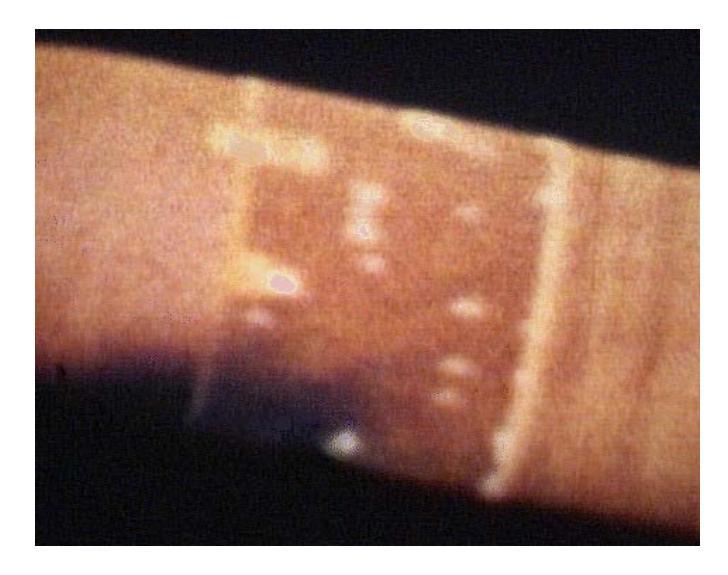
Figure 5.3.3.5-7. STS-56/ET-54 Post-Separation Photograph

Post separation crew handheld camera films showed 10 large, shallow divots on the –Z side of the intertank acreage (Figure 5.3.3.3-7). The divots were in a unique pattern, with two lines with 3 and 4 divots each. The magnitude of the TPS loss experienced on STS-56 was within the STS experience base.

The most probable cause of this TPS loss was not conclusively determined. The most likely scenario is rollover/crevicing anomalies in the TPS (Figure 5.3.3.5-8), and the effects in the flight environment. Differential pressure caused by aeroheating, flight loads, and panel flexure may have caused anomalies to propagate along the TPS knitlines (area between TPS spray passes), with shallow divots as the result.

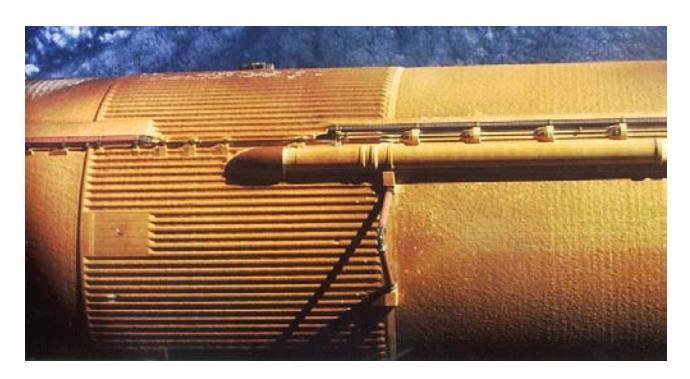
Figure 5.3.3.5-10. STS-87/ET-89 Post-Separation Photograph

Post-separation crew handheld camera films showed areas of missing TPS on the +Y and -Y thrust panels (Figure 5.3.3.5-10). Post-landing inspection also showed a significant increase in Orbiter tile damage: 308 damage sites on the Orbiter lower surface, with 132 sites greater than 1 in. The total number of lower surface damage site and the number of damage sites greater than 1 in. were out of family when compared to previous missions.

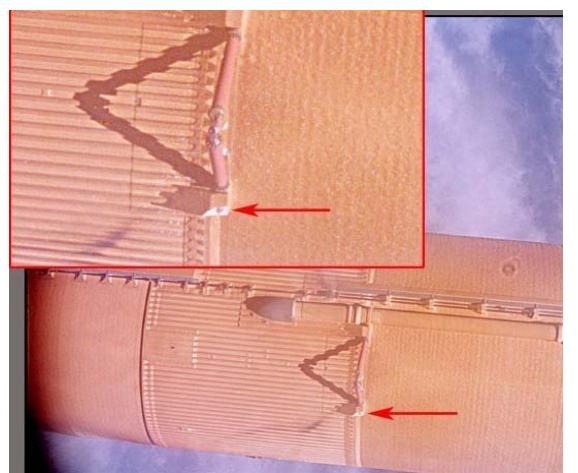
Figure 5.3.3.5-12. STS-112/ET-115 Post-Separation Photography

The most probable cause of this TPS loss occurrence was suspect subsurface void(s) during bipod ramp closeout coupled with launch environments. The most probable cause was presented at the SSP PRCB (S062151, Action # MSFC-ET/1-1) on December 19, 2002 and at that time, the Project identified the corrective action that was under evaluation. The proposed corrective action was to enhance the closeout configuration by eliminating the SLA under the TPS, thereby eliminating the potential for air entrapment (subsurface voids). The final corrective action was to have been presented at the SSP PRCB on February 6, 2003.
