COLUMBIA ACCIDENT INVESTIGATION BOARD (CAIB)/
NATIONAL AERONAUTICS AND SPACE ADMINISTRATION (NASA)
ACCIDENT INVESTIGATION TEAM (NAIT)

WORKING SCENARIO

FINAL VERSION: JULY 8, 2003

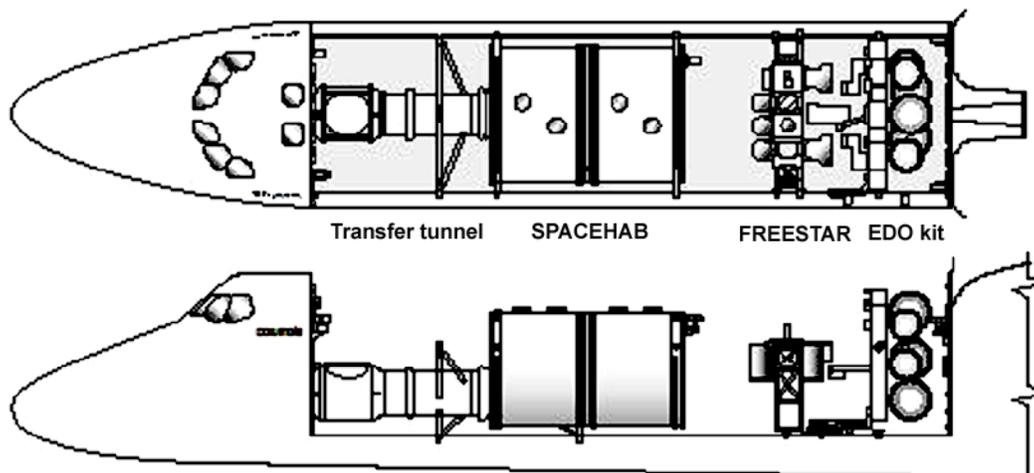
Figure 1-1. STS-107 payload bay configuration

STS-107 was the 113th mission in the Space Shuttle program and Columbia's 28th trip into space. These 28 missions spanned 22 years with the first being STS-1, launched on April 12, 1981. The STS-107 mission was a science research mission and the payload complement consisted of the Spacehab Double Research Module and the Fast Reaction Enabling Science, Technology, and Research (FREESTAR). The mission altitude was approximately 150 nautical miles with an inclination of 39 degrees. Figure 1-1 depicts the STS-107 payload bay configuration.

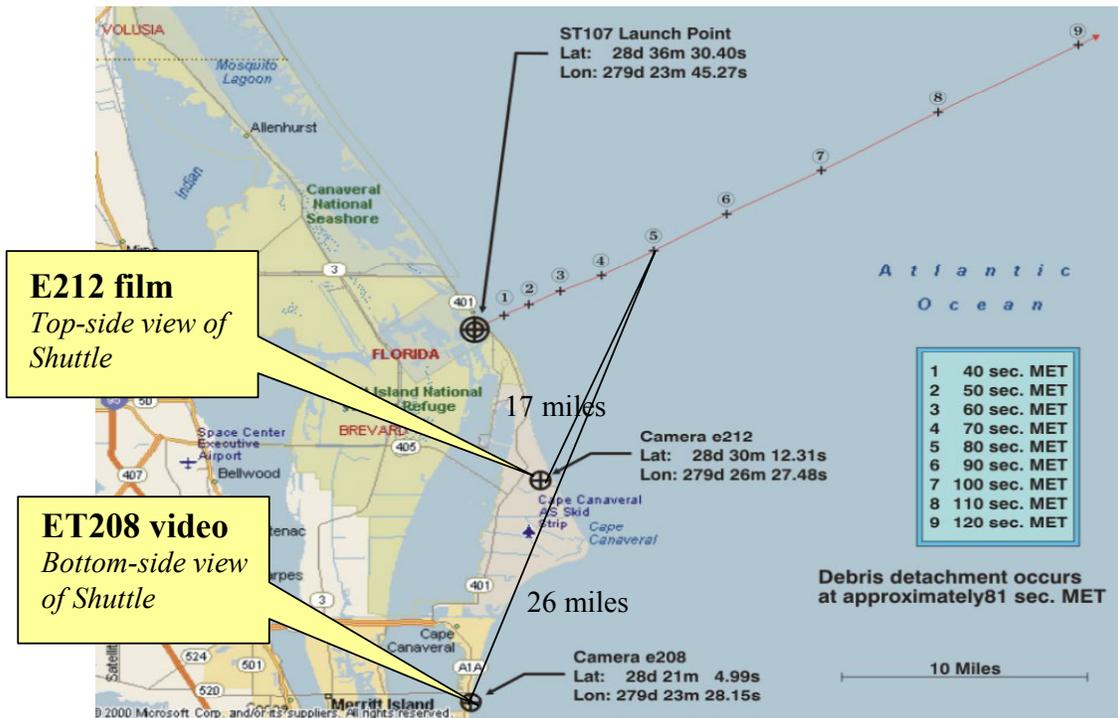
Figure 3-7. Camera geometry for ascent video analysis; note that video camera ET208 is at same location as film camera E208

The most useful video analysis was performed using two cameras that are part of the Eastern Launch Range imaging system. Camera E212 (film), located on the Cape Canaveral Air Force Station, was approximately 17 miles from the orbiter at the time of foam impact and Camera ET208 (video), located in Cocoa Beach, Florida, was 26 miles from the orbiter. The overall camera geometry relative to the launch pad and ascent flight path is shown in Figure 3-7. Camera E212 had a better view of the topside of the launch vehicle, while Camera ET208 had a better bottom side view. Figure 3-8 depicts the view from each of the camera systems. A third camera, E208 (film), also recorded the launch but was blurred and contained no useful data for the investigation. There are no Launch Commit Criteria (LCC) regarding cameras, or camera views for ascent, for either onboard or ground.

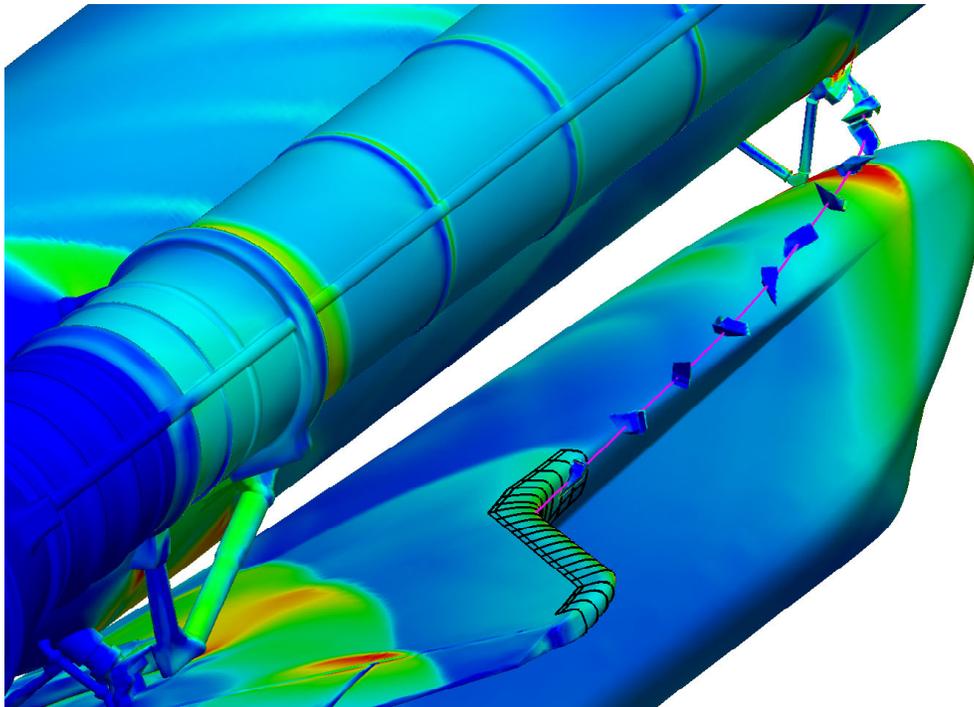
Figure 3-12. Sample CFD flow field with debris modeling

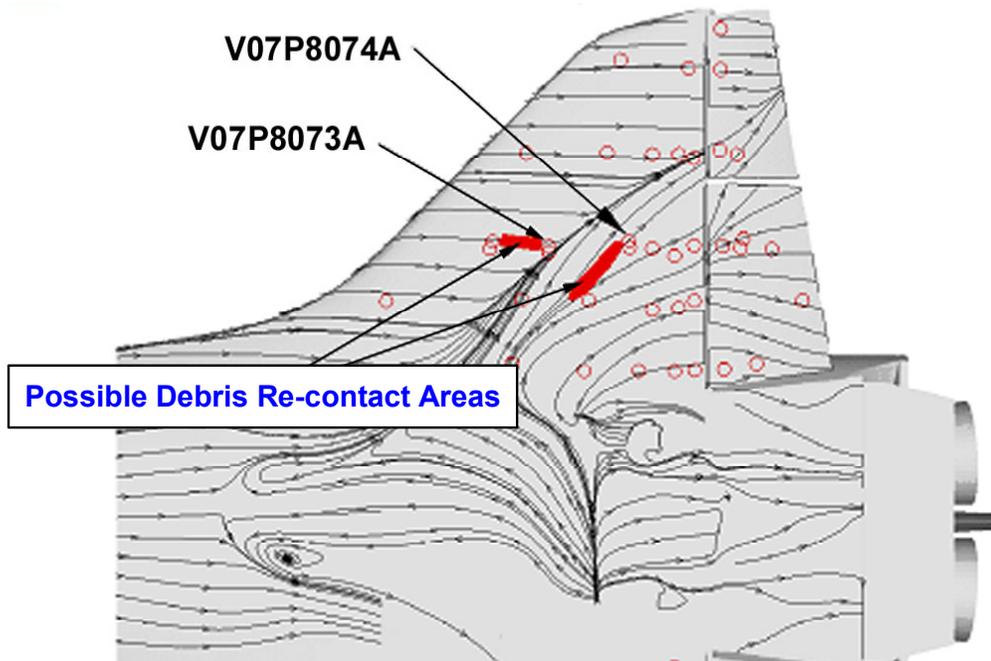
Figure 3-13. CFD surface flow with lower left wing pressure sensors

There are two other indications that the foam impact occurred in the panels 6 through 8 area. Two Modular Auxiliary Data System (MADS) lower surface pressure measurements behaved anomalously immediately after the time of the impact. Figure 3-13 shows the location of these measurements along with possible areas for post-impact debris re-contact in the vicinity of the sensors. The unusual behavior of one of the sensors is shown in Figure 3-14.

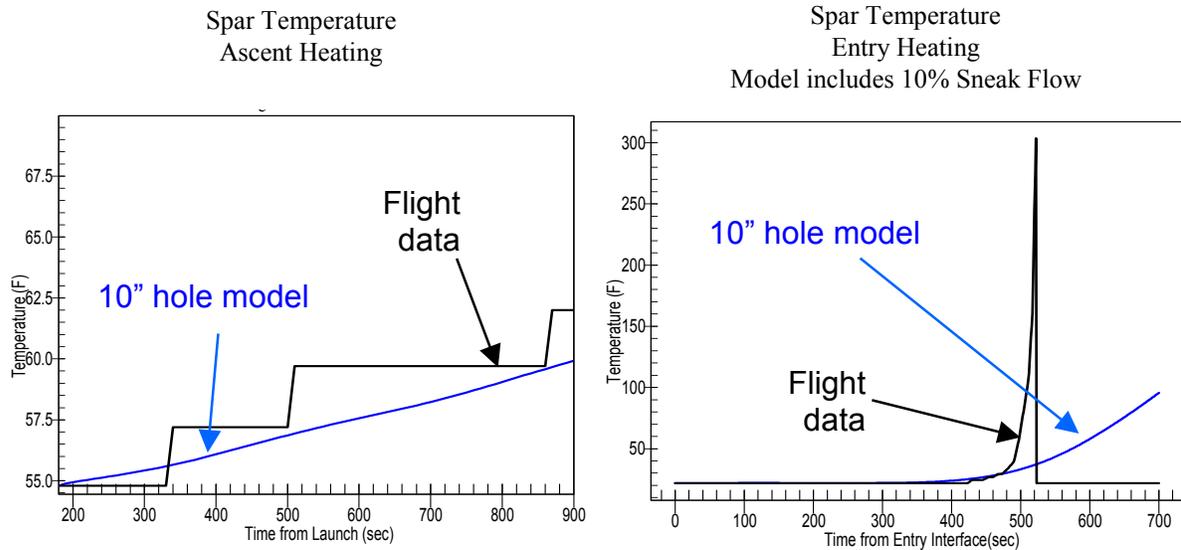
Figure 3-17. Correlation between simplified thermal math model and STS-107 ascent and entry flight data

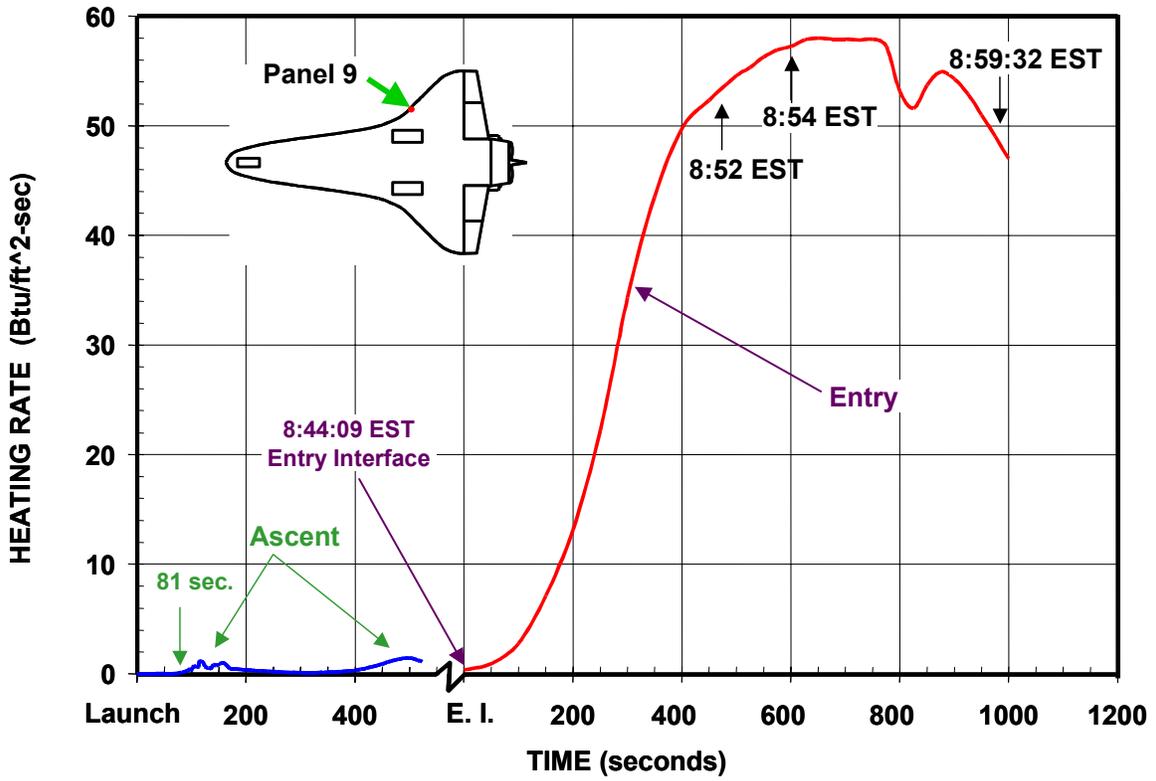
Figure 3-18. STS-107 ascent and entry heating environments on RCC panel 9

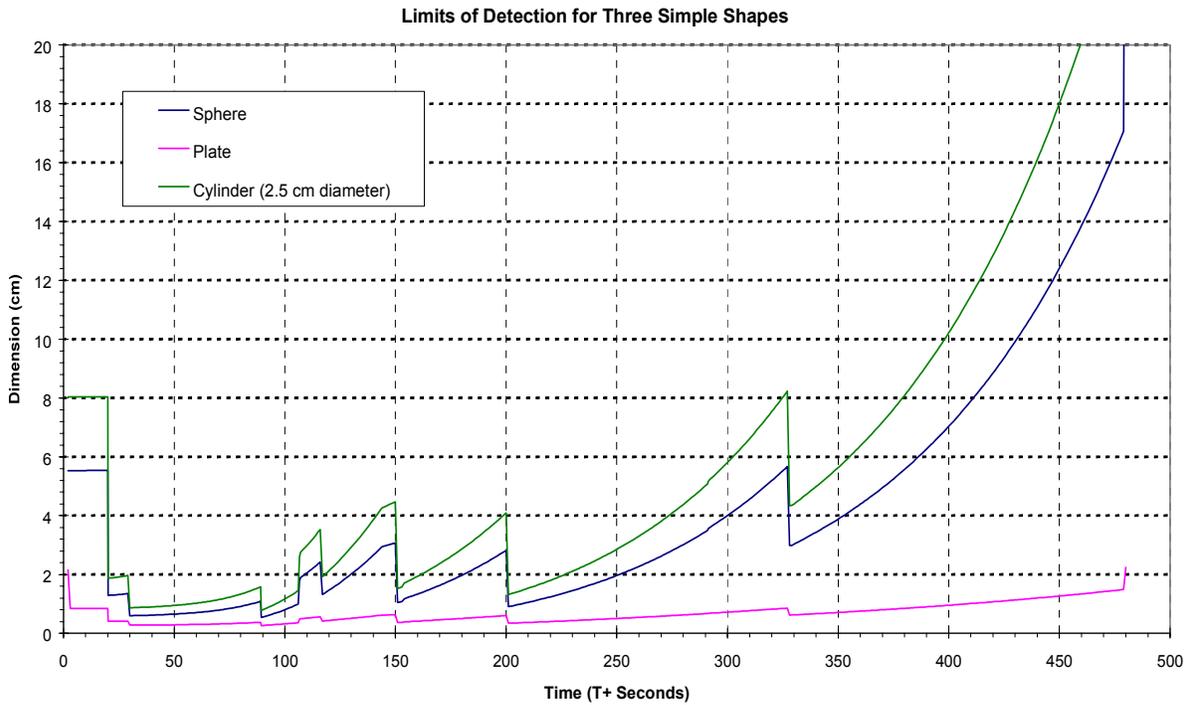
Figure 3-19. Limits of dimensional detectability for three simple shapes

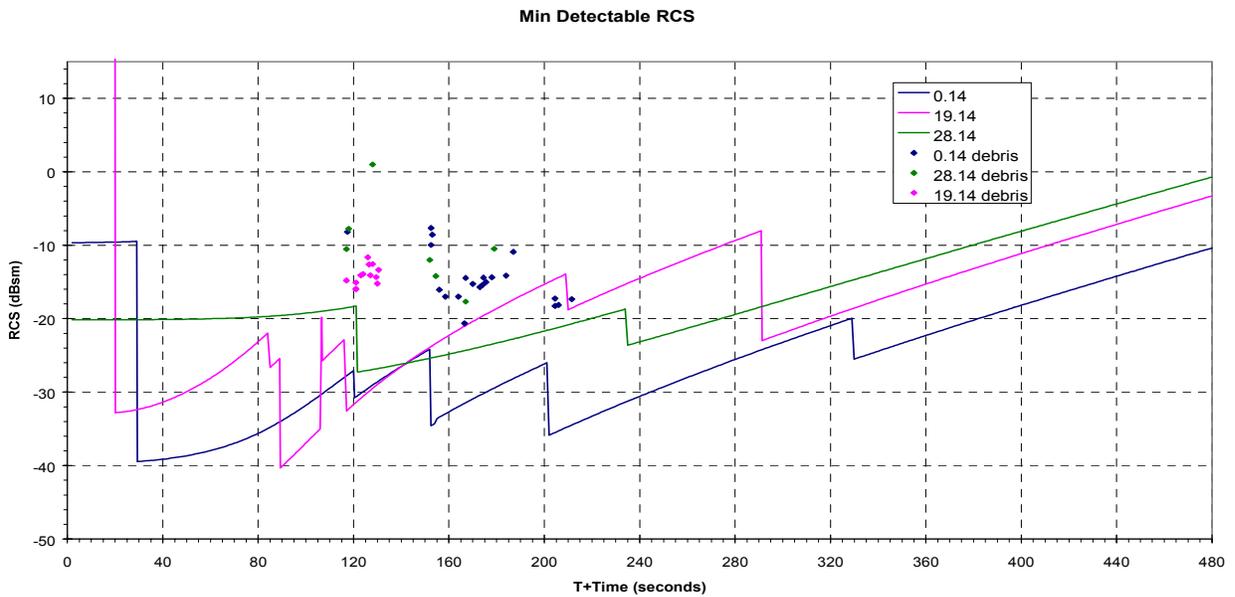
Figure 3-20. Limits of radar cross section (RCS) detectability and measured STS-107 debris for three radar source sites

From Table 3-3, debris item numbers 1 and 29 appear from 80.4 - 87 seconds and 81.6 - 86.1 seconds, respectively. This time coincides with the ET left bipod foam debris generation at 81.7 seconds. However, the low separation rate and relatively large RCS of the two radar objects indicate that they are most likely traveling with the vehicle and are flame (plume) artifacts. There are also several radar objects around the SRB separation time frame, ~126 seconds; however, the data are inadequate to determine the size, shape, or composition of the objects beyond that their moderate separation speed indicates solid objects being left behind. Some known debris objects at the time of SRB separation are the aft Booster Separation Motor (BSM) throat covers. It should be noted that the number and strength of the radar returns are typical as compared to previous Shuttle missions where no significant debris damage occurred.

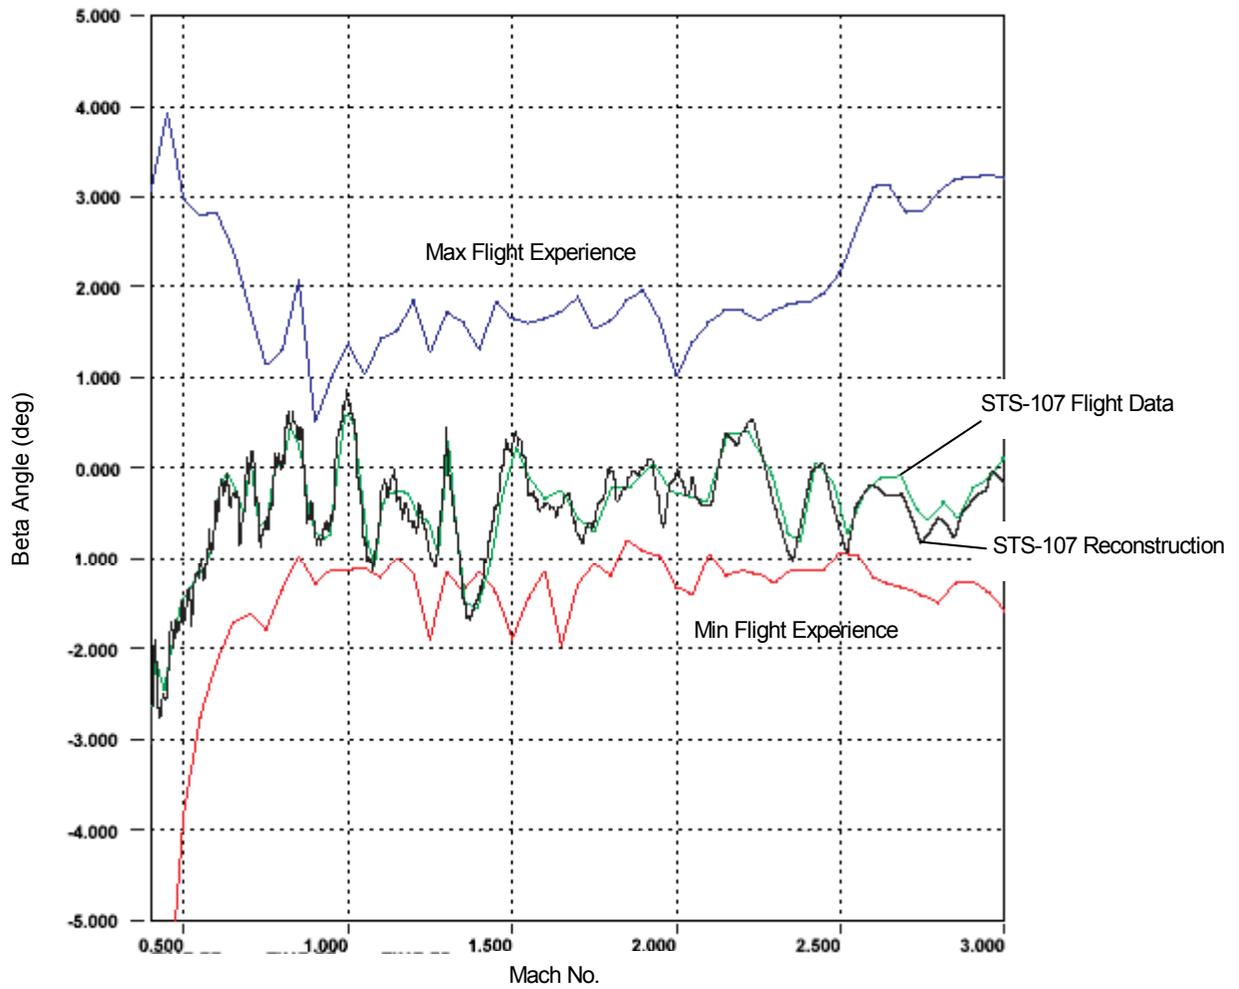
Figure 3-22. Side-slip angle

Several theories consider this wind shear event and the difference between the balloon data to be significant. A negative side-slip angle places the wind vector on the left side of the orbiter, pushing the orbiter to the right, changing the complex aerodynamic flow pattern characteristics in the left ET bipod area. To better understand the conditions on the ET left bipod, several studies were conducted. The studies (1) compared flight data for missions that had ET bipod foam liberation; (2) compared flight data for missions that flew a Light Weight Tank (LWT) in combination with ascent Performance Enhancements (PEs), a package of vehicle software and hardware changes designed to increase overall weight to orbit capability for the ISS; (3) analyzed external aerodynamic loads on the ET forward attach bipod ramp; and (4) studied integrated orbiter/ET vehicle loads.

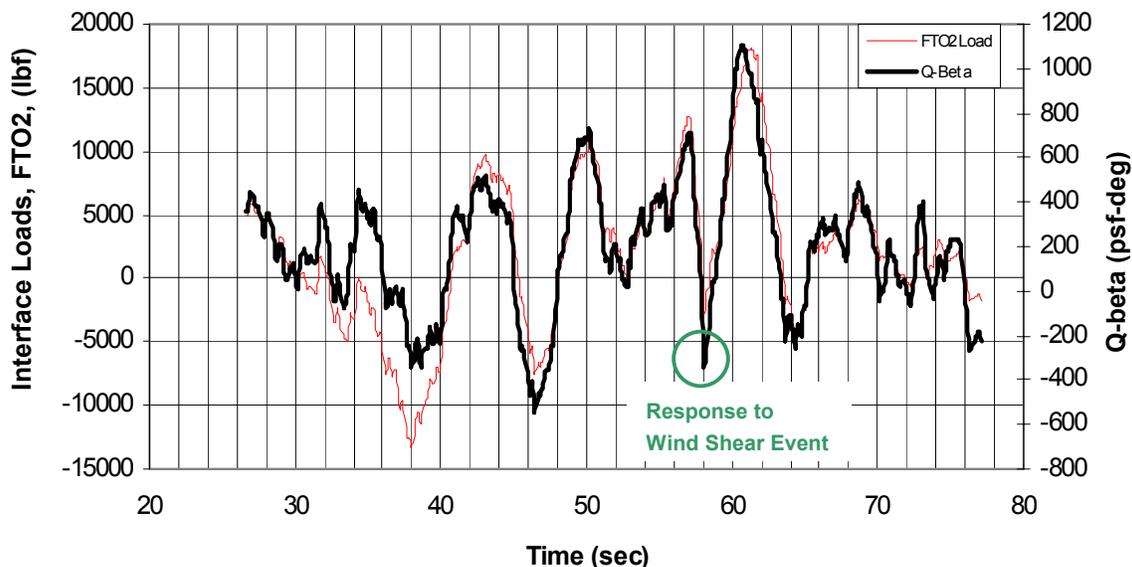
Figure 3-24. ET interface loads at forward attachment during wind shear and side-slip angle. Q-beta is side-slip angle multiplied by the dynamic pressure and represents the side-slip angle contribution of the interface load

The ET/orbiter interface loads were generated using reconstructed trajectory parameters that included the effects of wind shear/crosswind, side-slip angle, and ET liquid oxygen (LOX) slosh. The loads analysis demonstrated that the ET forward attach loads were within certification requirements at all times. The wind shear event had only a small effect on the overall ET loads relative to the required limits (as shown in Figure 3-24), as did the ET liquid propellant slosh (as shown in Figure 3-25). The resulting load from the wind shear event was of the same order magnitude as the roll maneuver and other first stage events prior to SRB separation.

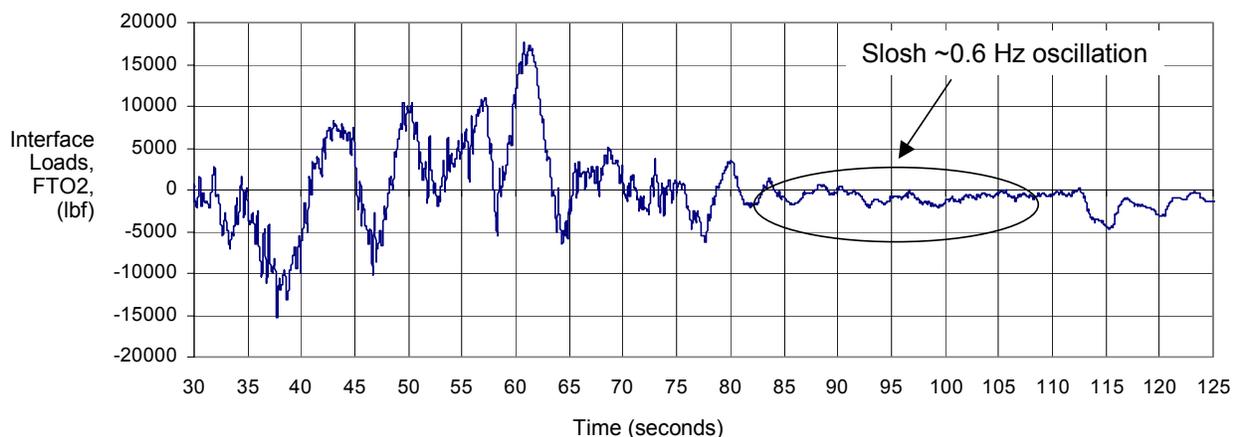
Figure 3-25. Slosh effect on ET interface loads

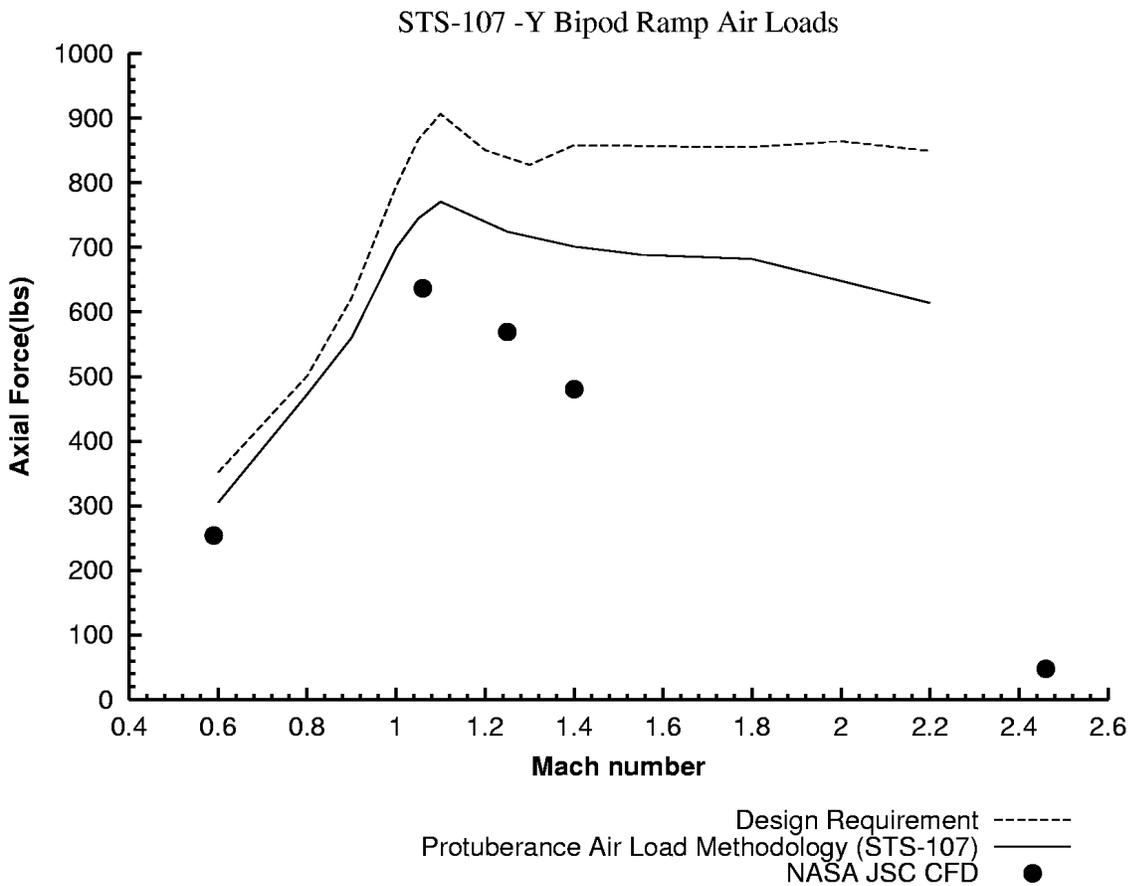
Figure 3-26. ET bipod axial aerodynamic loads

The external aerodynamic loads on the ET forward attach bipod were analyzed using a CFD simulation. The simulation produced axial, side-force, and radial loads as shown in Figure 3-26, Figure 3-27, and Figure 3-28, respectively. The CFD assessment of the bipod area indicated that the external air loads were below the design limit during the Hi-Q region and at the time of the bipod foam liberation.
