Volume IV
Appendix F.4
ET Cryoinsulation

ET cryoinsulation Power Point Slides presented 7 April 2003 at the CAIB Public Hearing: ET cryoinsulation, by Lee Foster and Scotty Sparks, MSFC.

CAIB Public Hearing: ET Cryoinsulation
Lee Foster / MSFC
Scotty Sparks / MSFC
April 7, 2003

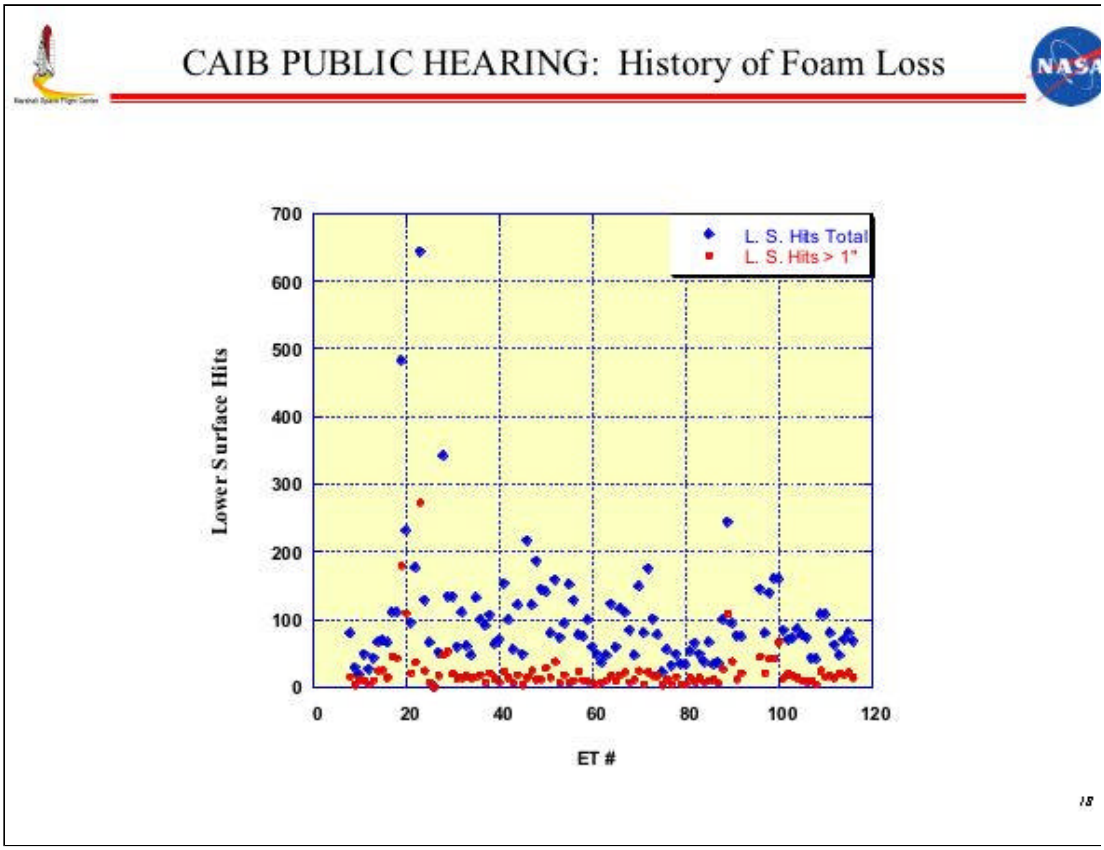
CAIB PUBLIC HEARING: History of Foam Loss
NASA
L. S. Hits Total
L. S. Hits > 1"
Lower Surface Hits
700
600
500
400
300
200
100
0
0
20
40
60
80
100
120
ET #
18

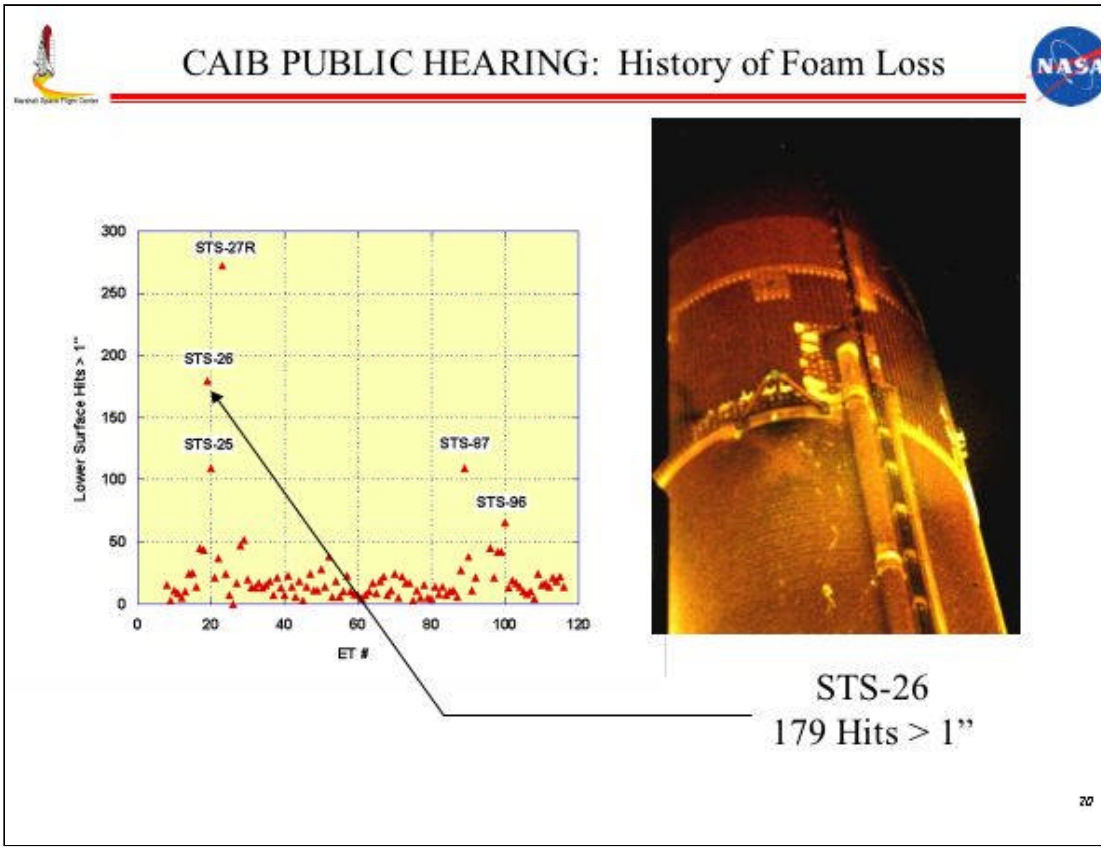
CAIB PUBLIC HEARING: History of Foam Loss
NASA
Lower Surface Hits > 1"
ET #
STS-27R
STS-26
STS-25
STS-87
STS-95
0
50
100
150
200
250
300
0
20
40
60
80
100
120
STS-26
179 Hits > 1"
20

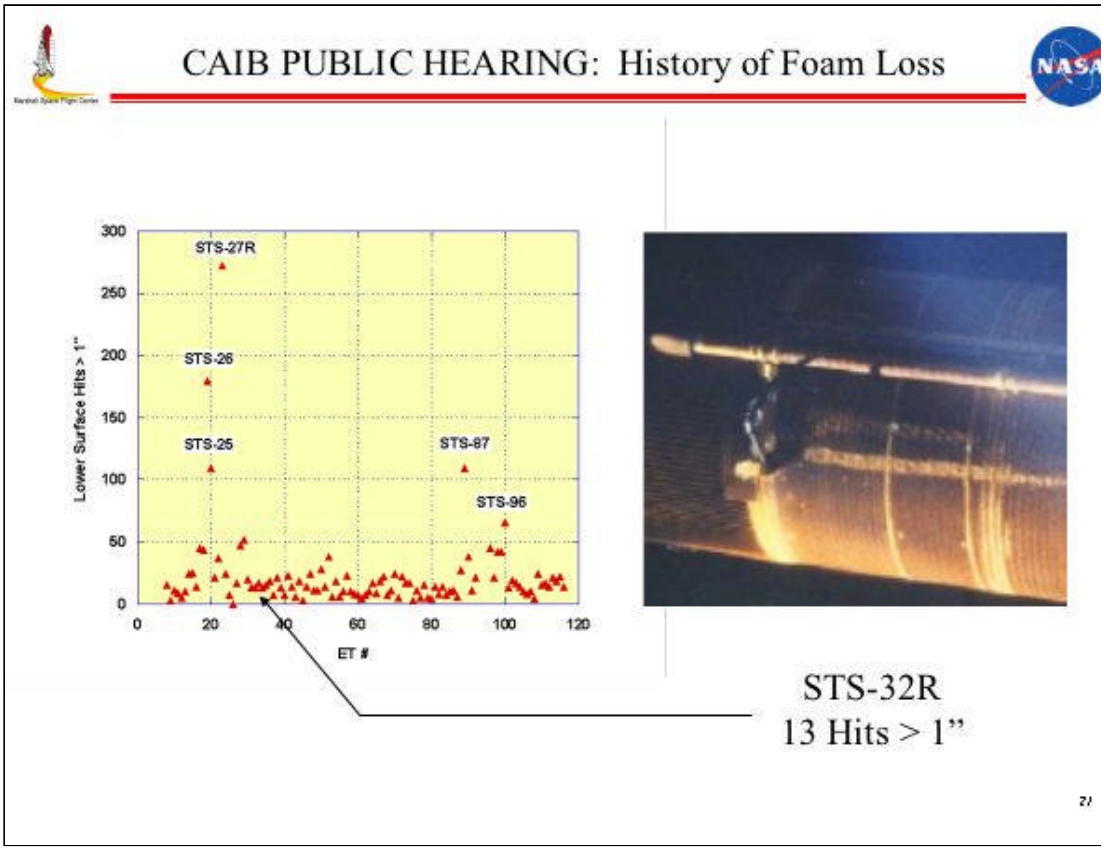
CAIB PUBLIC HEARING: History of Foam Loss
NASA
Lower Surface Hits > 1"
ET #
STS-27R
STS-26
STS-25
STS-87
STS-95
0
50
100
150
200
250
300
0
20
40
60
80
100
120
STS-32R
13 Hits > 1"

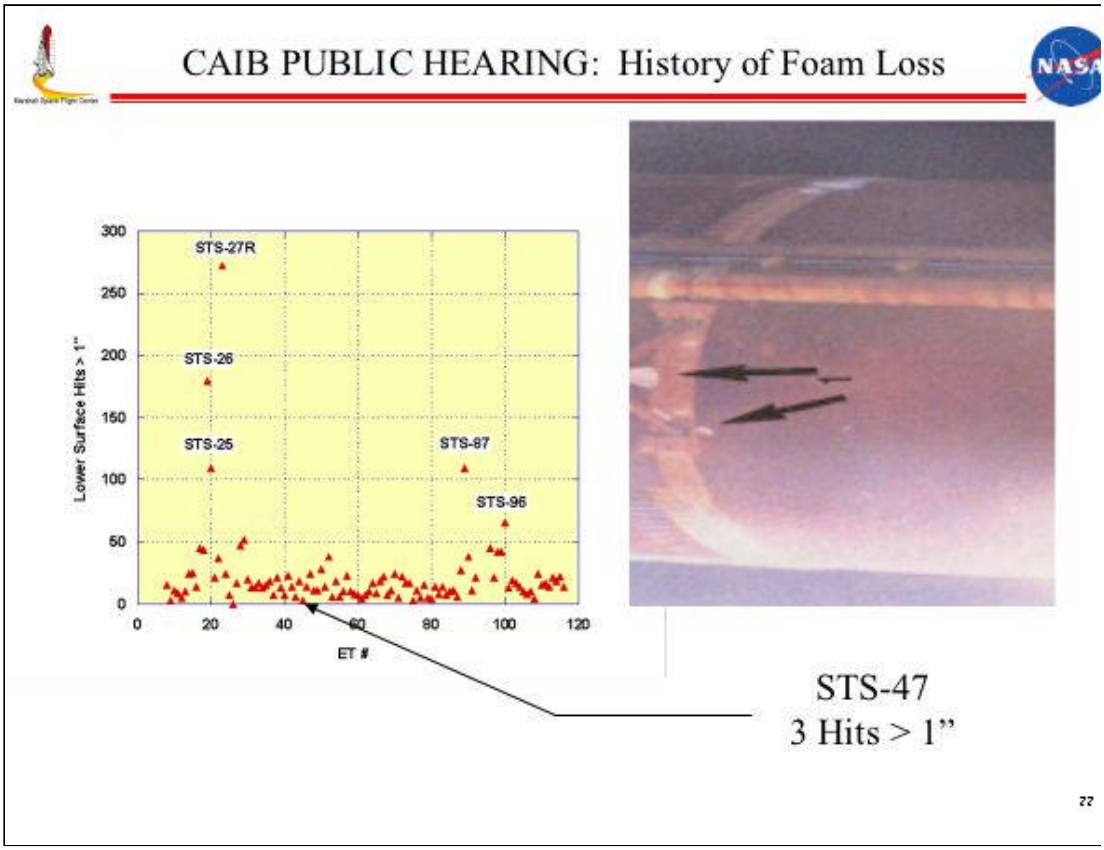
CAIB PUBLIC HEARING: History of Foam Loss
NASA
Lower Surface Hits > 1"
ET #
STS-27R
STS-26
STS-25
STS-87
STS-95
0
50
100
150
200
250
300
0
20
40
60
80
100
120
STS-47
3 Hits > 1"
22

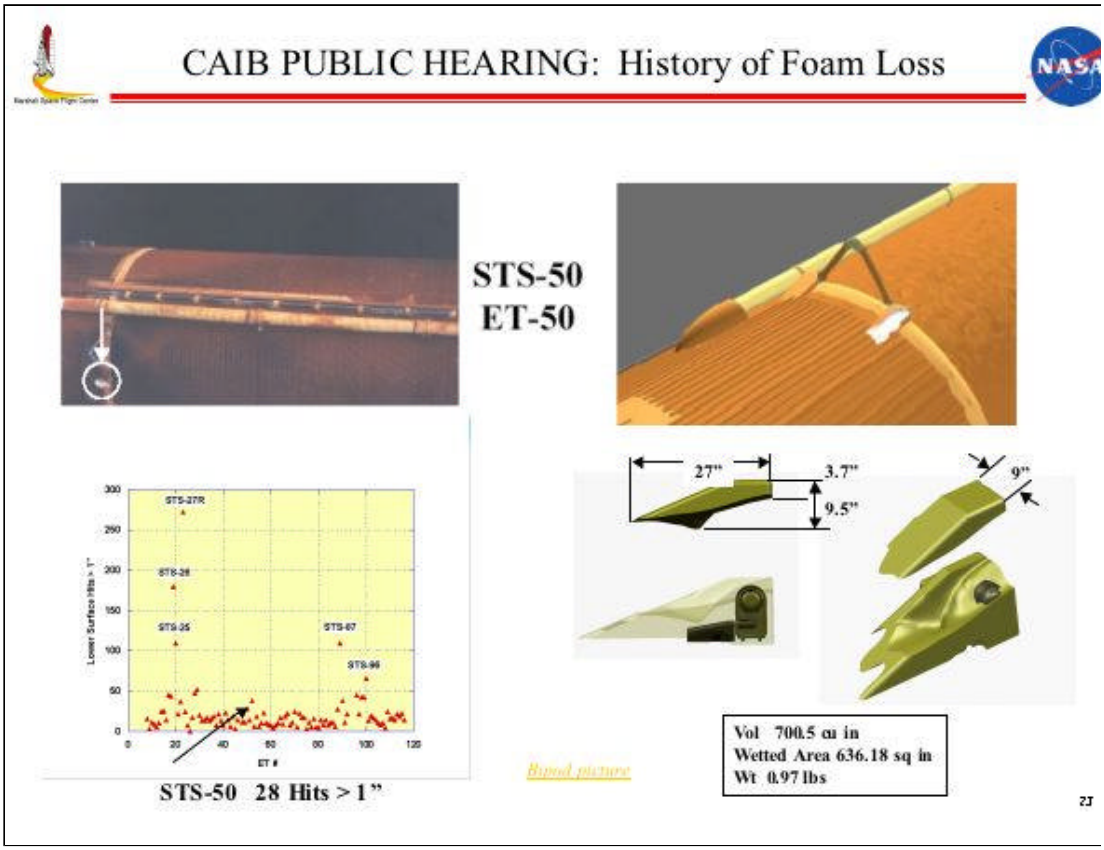
CAIB PUBLIC HEARING: History of Foam Loss
STS-50
ET-50
27"
3.7"
9.5"
9"
STS-50 28 Hits > 1"
Vol 700.5 cu in
Wetted Area 636.18 sq in
Wt 0.97 lbs

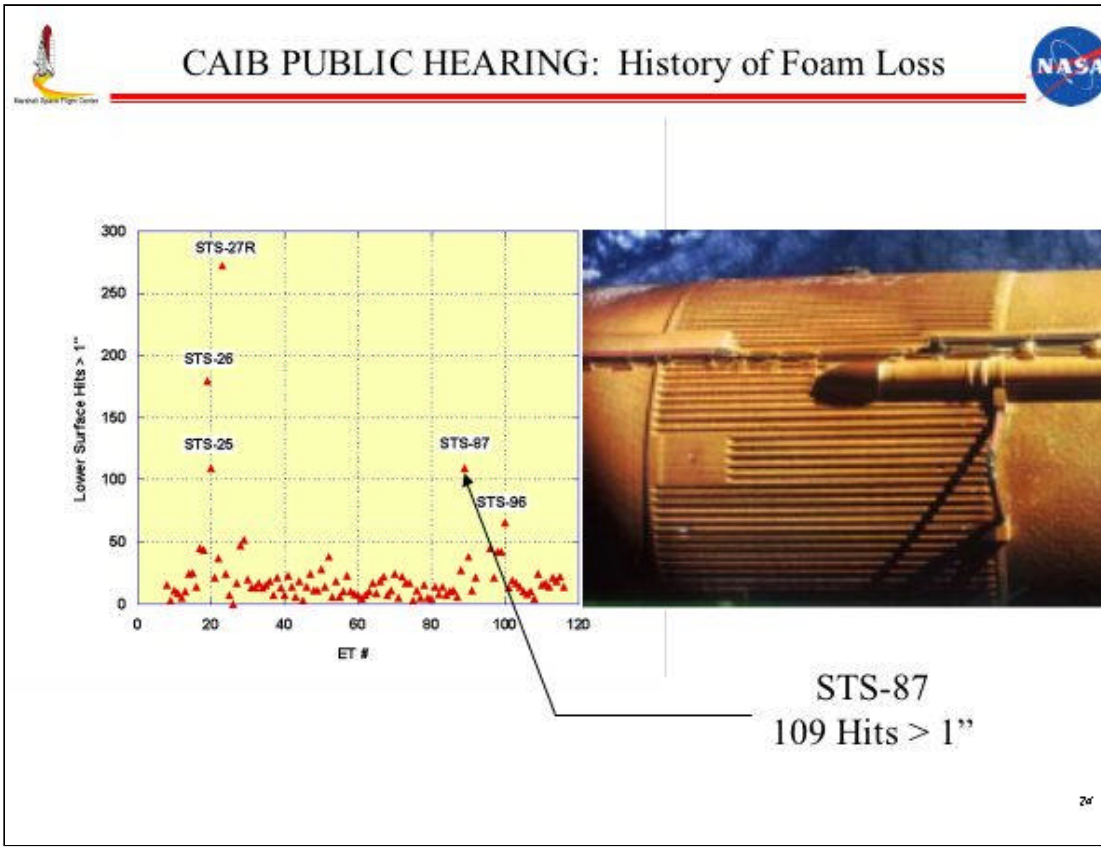
CAIB PUBLIC HEARING: History of Foam Loss
NASA
Lower Surface Hits > 1"
ET #
STS-27R
STS-26
STS-25
STS-87
STS-95
0
50
100
150
200
250
300
0
20
40
60
80
100
120
STS-87
109 Hits > 1"

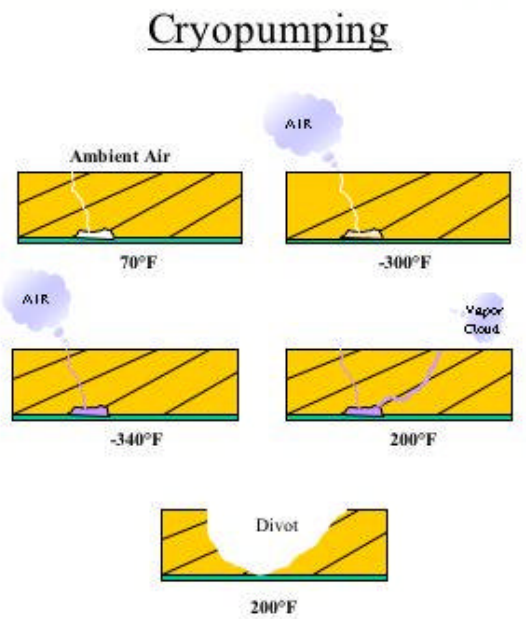
- Cryopumping Mechanism
  - Transformation from a gas to a liquid at cryogenic temperatures
  - Gases are condensed within a void or porous material at low temperatures

- Air in Cavities or Porous Material (SLA-561) Liquefies When in Contact With Structure Below -297°F for Oxygen and -320°F for Nitrogen
  - Pressure is Reduced Locally Due to Gas to Liquid Volume Change and More Air Will be "Sucked" Into Area

- Process Continues Until Cavity or Porous Material is Filled With Liquid Air
- Consequences of Cryopumping
  - No Detrimental Effects While Structure Remains Cold

- When Structure Warms, Liquefied Air Returns to Gaseous State With Local Pressure Increase
    - Gas Can Escape With No Detrimental Effect if Leak Path Large – Condensation Cloud May Be Visible at Leak Exit

- Pressure Can Crack TPS and Escape With No Divots – Condensation Cloud May Be Visible
    - Pressure Can Cause Divot if Leak Path Small

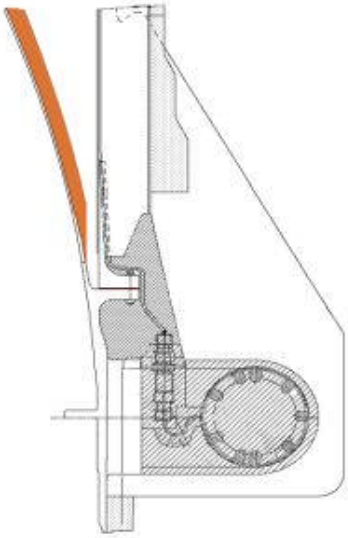
Bipod Schematic

Postulated Cryo-ingestion

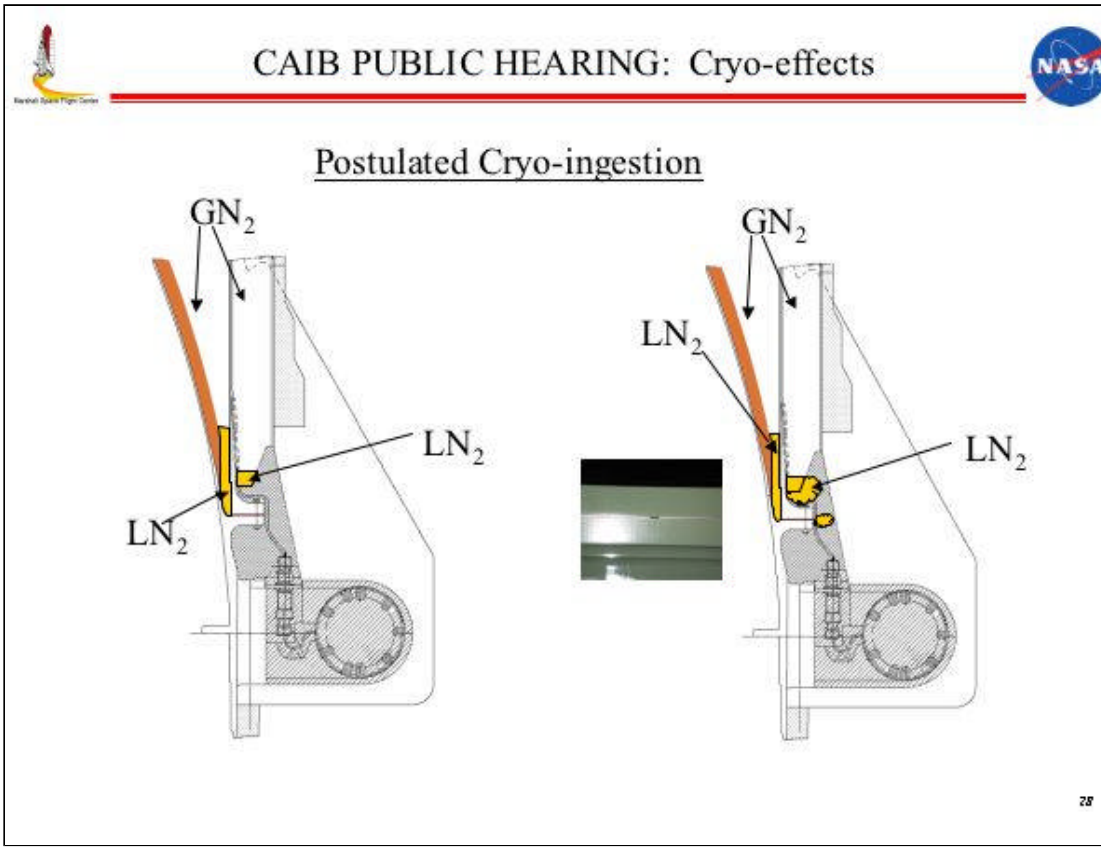
CAIB PUBLIC HEARING: Cryo-effects
NASA
Postulated Cryo-ingestion
GN2
LN2
LN2
GN2
LN2
LN2
28

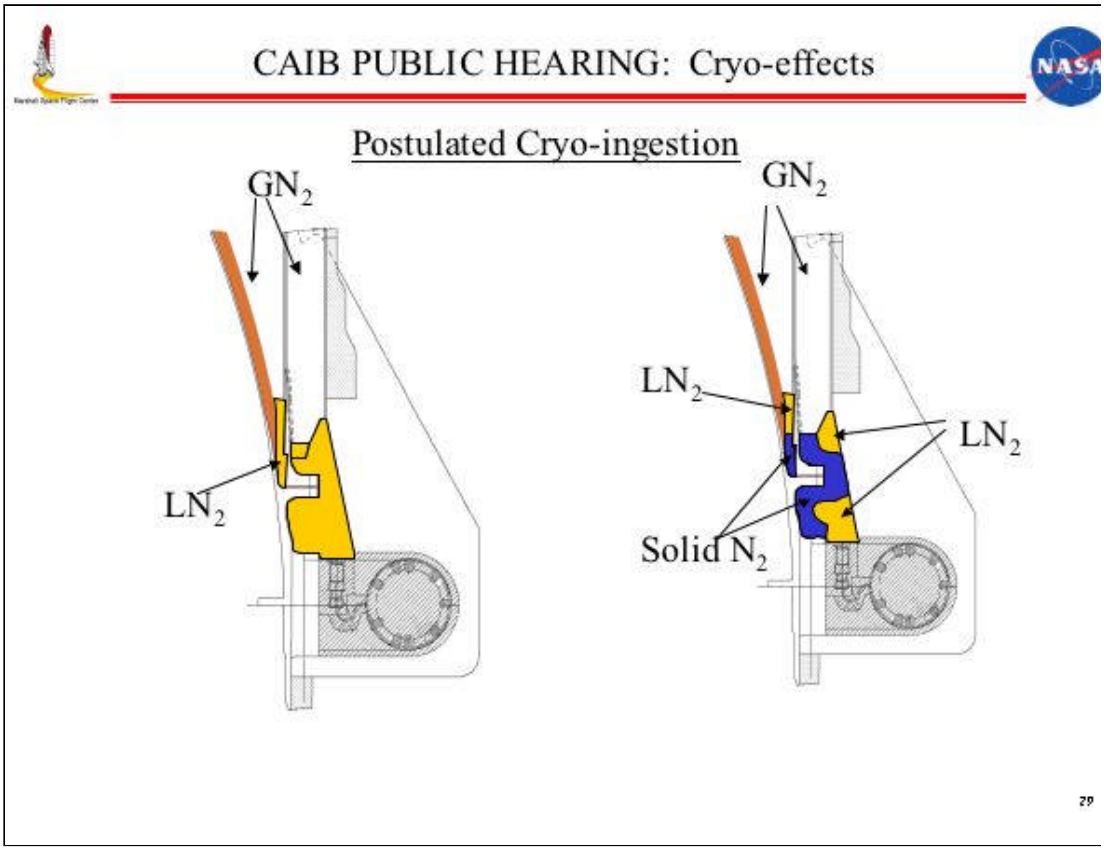
CAIB PUBLIC HEARING: Cryo-effects
Postulated Cryo-ingestion
GN2
GN2
LN2
LN2
LN2
Solid N2
29

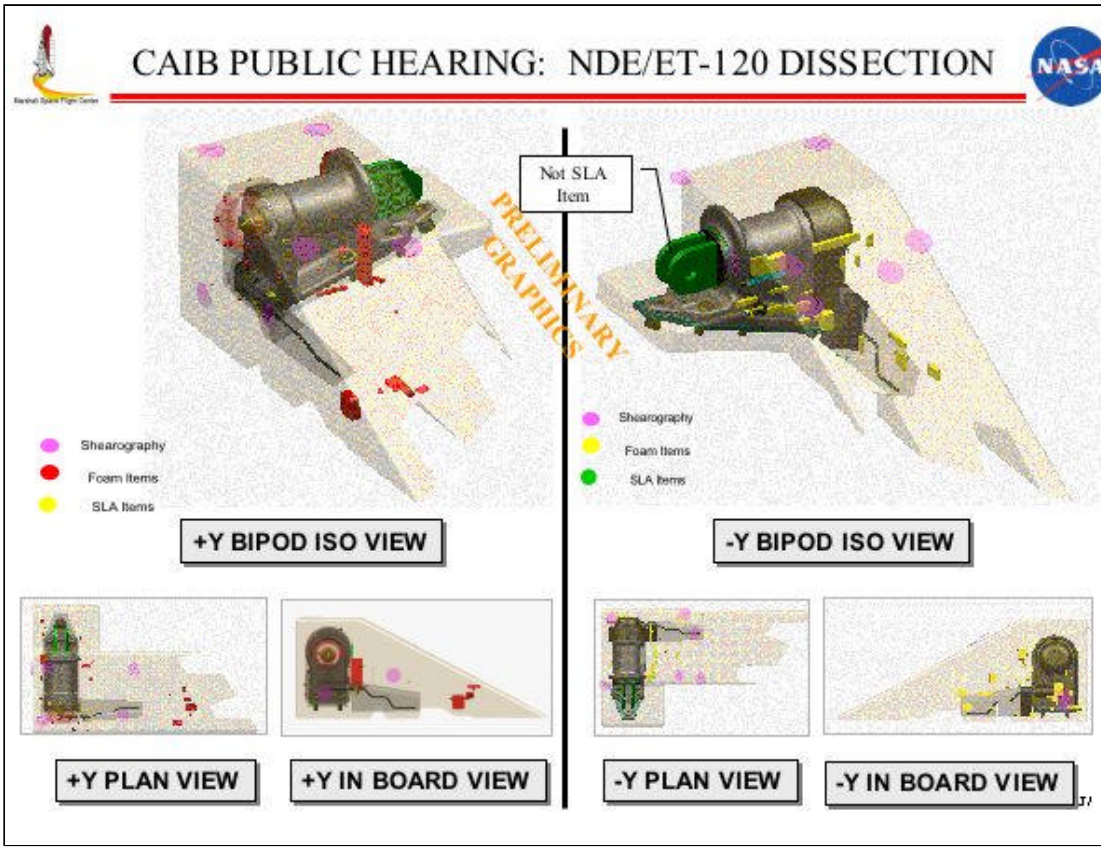
CAIB PUBLIC HEARING: NDE/ET-120 DISSECTION
NASA
Not SLA Item
PRELIMINARY GRAPHICS
Shearography
Foam Items
SLA Items
+Y BIPOD ISO VIEW
-Y BIPOD ISO VIEW
+Y PLAN VIEW
+Y IN BOARD VIEW
-Y PLAN VIEW
-Y IN BOARD VIEW

- ET120 +Y Bipod Results
  - Several indications noted post wedge removal which may be attributable to complex part geometry, density gradients, or defects
  - Dissection revealed no significant correlation between indicated regions and subsurface defects

- ET120 -Y Bipod Results
  - Several indications were noted pre and post wedge removal which may be attributable to complex part geometry, density gradients, or defects

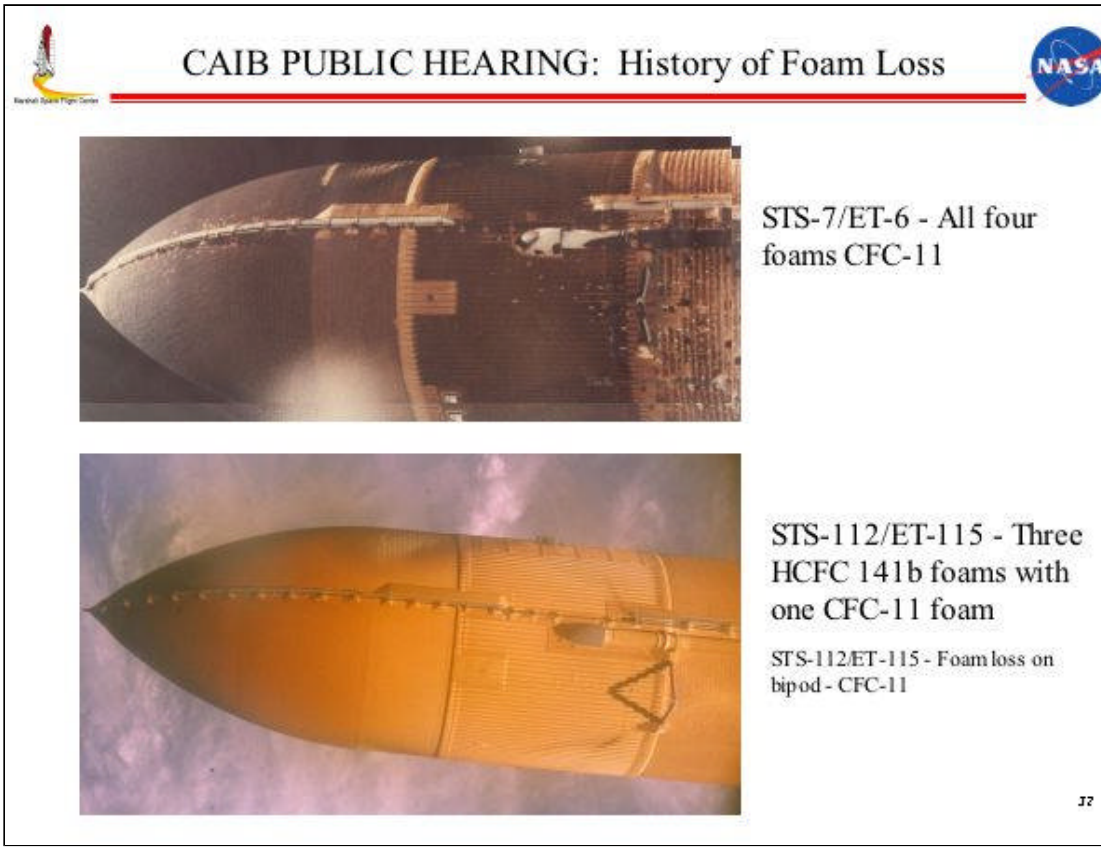
CAIB PUBLIC HEARING: History of Foam Loss
NASA
STS-7/ET-6 - All four foams CFC-11
STS-112/ET-115 - Three HCFC 141b foams with one CFC-11 foam
STS-112/ET-115 - Foam loss on bipod - CFC-11
J2

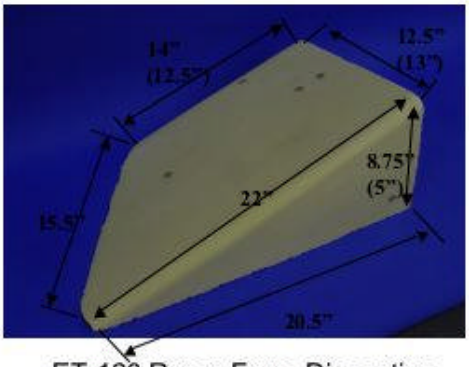
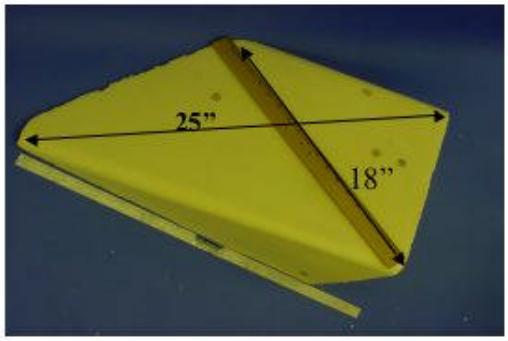
ET-120 Ramp From Dissection

- Measured Weight - 1.02 lbs
