STS-107 Image Analysis Team Final Report

This Appendix contains NSTS-37384, STS-107 Image Analysis Team Final Report in support of the *Columbia* Accident Investigation, 30 June 2003.

STS-107 Image Analysis Team
Final Report
in support of the
***Columbia* Accident Investigation**

June 30, 2003

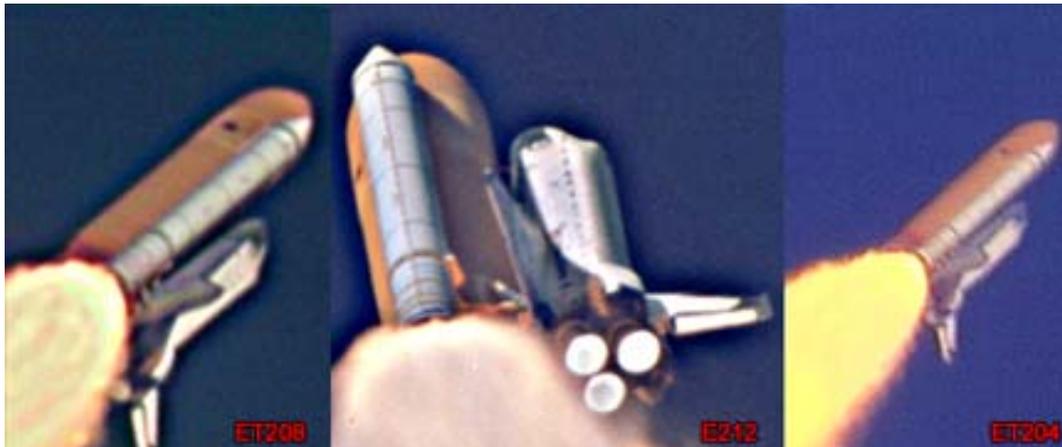
The ET-208 video camera provided the best view of the underside of the left wing and the debris strike area (Figure 4.1.1b). However, the moment of impact was not recorded due to insufficient time resolution of the imagery, limited by the camera frame rate. The

Figure 4.1.1b Frames from ET-208, E-212 and ET-204 cameras showing the respective views

The 35 mm film camera E-212 imaged the top side of the Orbiter's left wing, and provided the best high-resolution view of the debris before it disappeared behind the left wing prior to impact. The E-212 views show the debris as it is first seen originating from the vicinity of the External Tank (ET)/Orbiter -Y bipod attach area, and show the post-impact debris cloud and debris fragments.

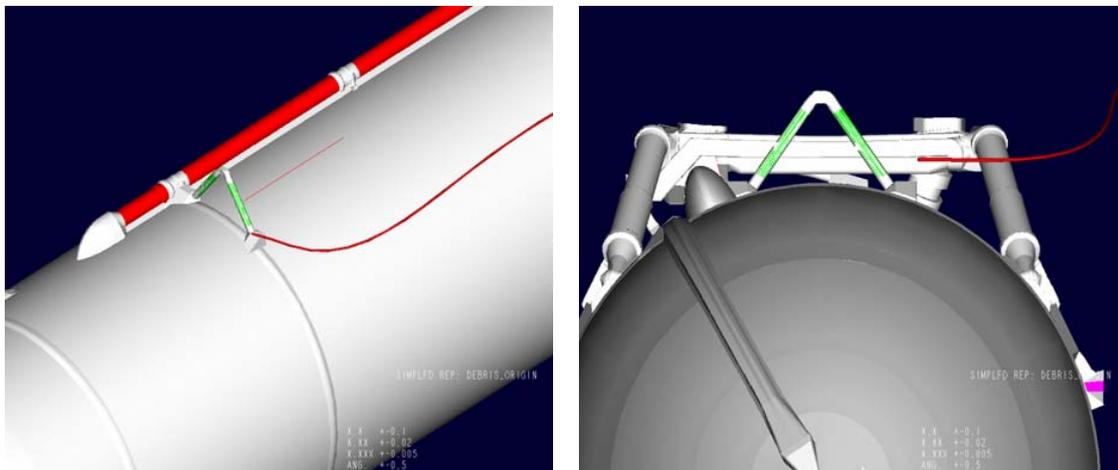
Figure 4.3.2.2b 3-D model of the debris trajectory (red curve) relative to the external tank, based upon ET-208 and E-212 camera imagery

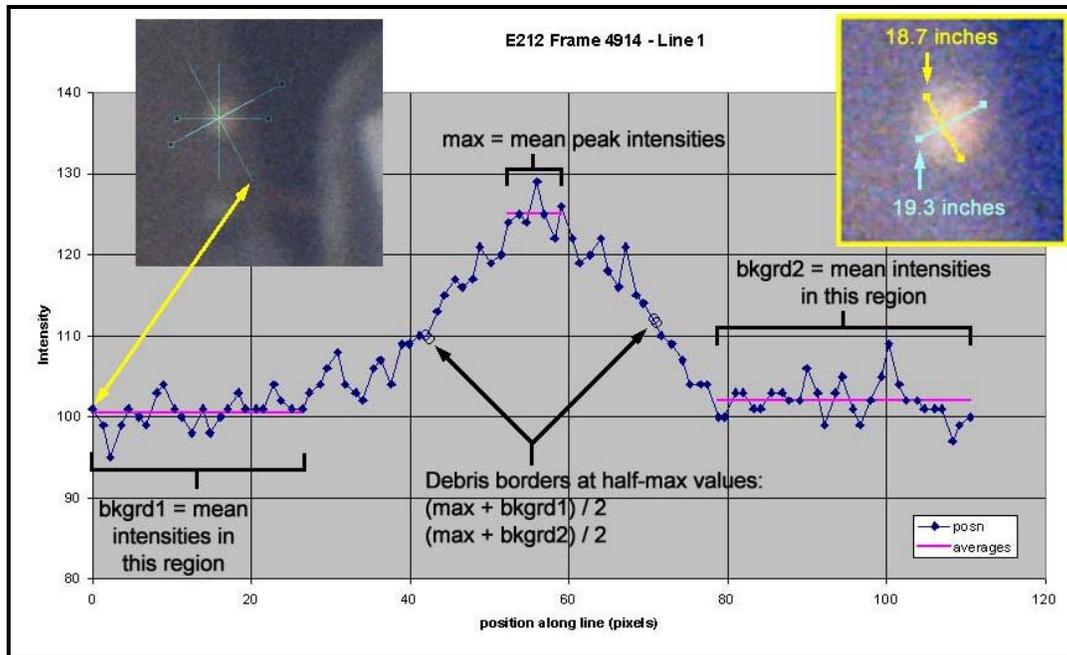
The uncertainty in the debris size measurements of approximately +/- 3 inches was derived from a +/- 2-pixel uncertainty in locating the debris borders at half-maximum values.

Figure 4.3.2.3 Debris size measurement methodology full width at half maximum intensity profile. The curve represents the image intensity values for a transect across the debris in one frame 4914, illustrated in the upper left image.

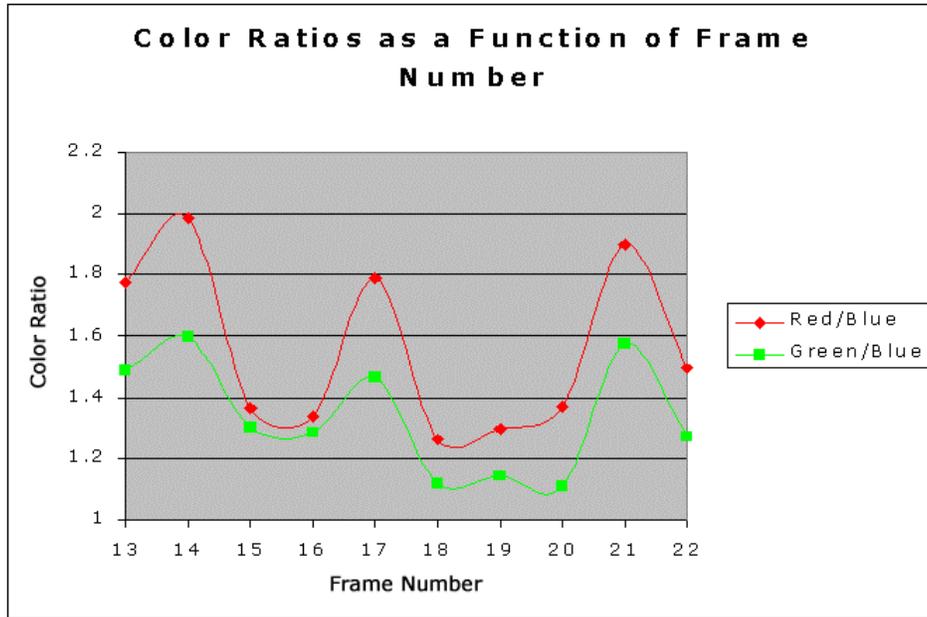
To begin the analysis, the red, green, and blue color channels of the debris were recorded for each frame on E-212 in which the debris was observed prior to impact. Ratios of the green to blue and red to blue were then calculated and plotted as a function of time (see Figure 4.3.2.4). The use of color ratios reduces the effect of variations in illumination and makes the analysis more sensitive to color change. The plot shows a definite sinusoidal pattern with a frequency of approximately 18 Hz. Details of this analysis are given in Appendix 4.3.2D. In the absence of any other data for measuring rotation, the best estimate of the debris rotation rate based upon the imagery is approximately 18 Hz.

Figure 4.3.2.4 Color ratio analysis of debris from E-212 frames

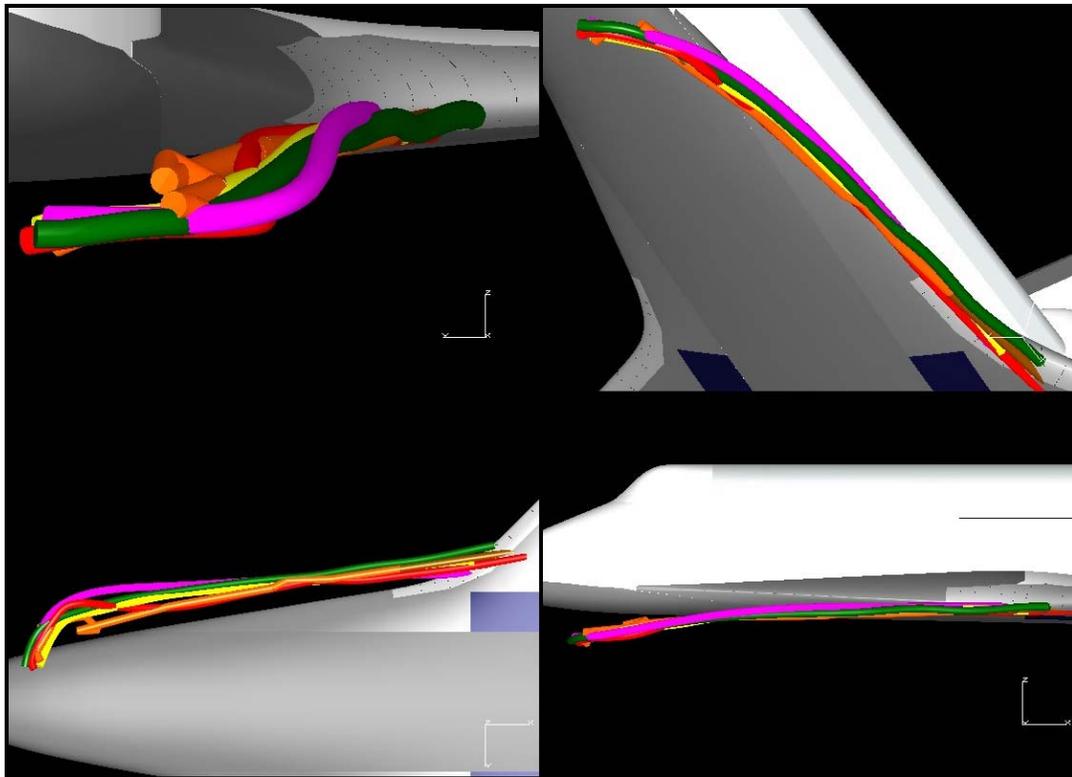
- not seeing the debris on E-212 as it passed behind the wing just prior to impact;
- uncertainty in timing offsets between E-212 and ET-208. This was less of a concern for the CAD surface intersection methods, but a major issue for the methods that relied on intersecting vectors from multiple cameras extending from each camera to the debris at discrete points in time.

Figure 4.3.2.5a Debris trajectories derived by separate independent analyses.

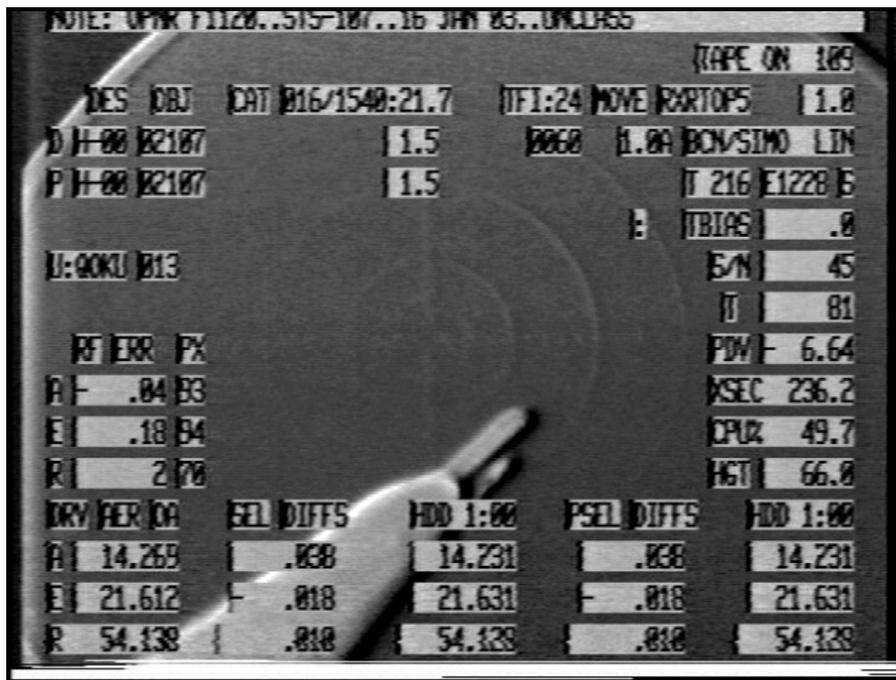
Figure 4.4.2 Patrick AFB 0.14 radar boresite view taken at the time of debris strike event approximately 81 seconds after launch.

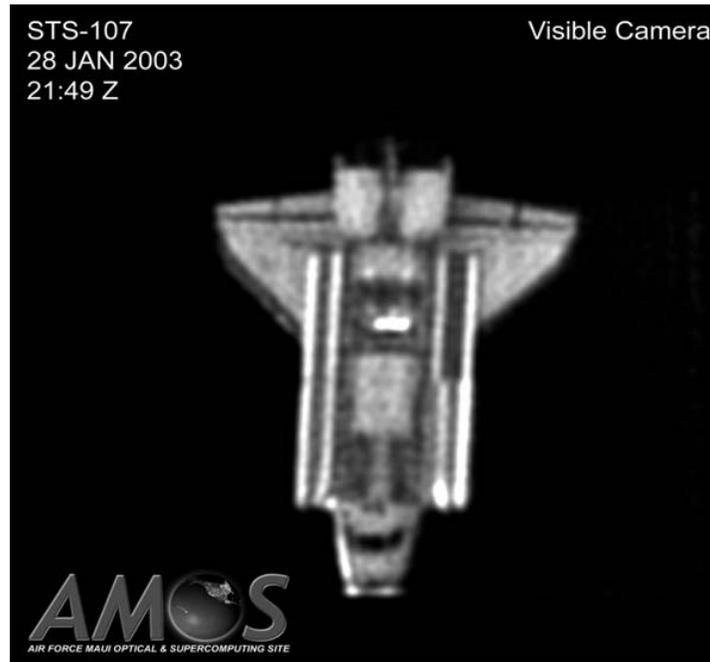
Figure 5.3.2.1 AMOS image of Columbia (taken January 28, 2003)

The Air Force Maui Optical and Supercomputing Site (AMOS) acquired photographs of Columbia while on-orbit during the STS-107 mission (Figure 5.3.2.1). The pictures were taken at approximately 21:49 UTC on January 28, 2003. All of the AMOS views are grainy and only major features of the Orbiter upper (+Z) surface are visible.

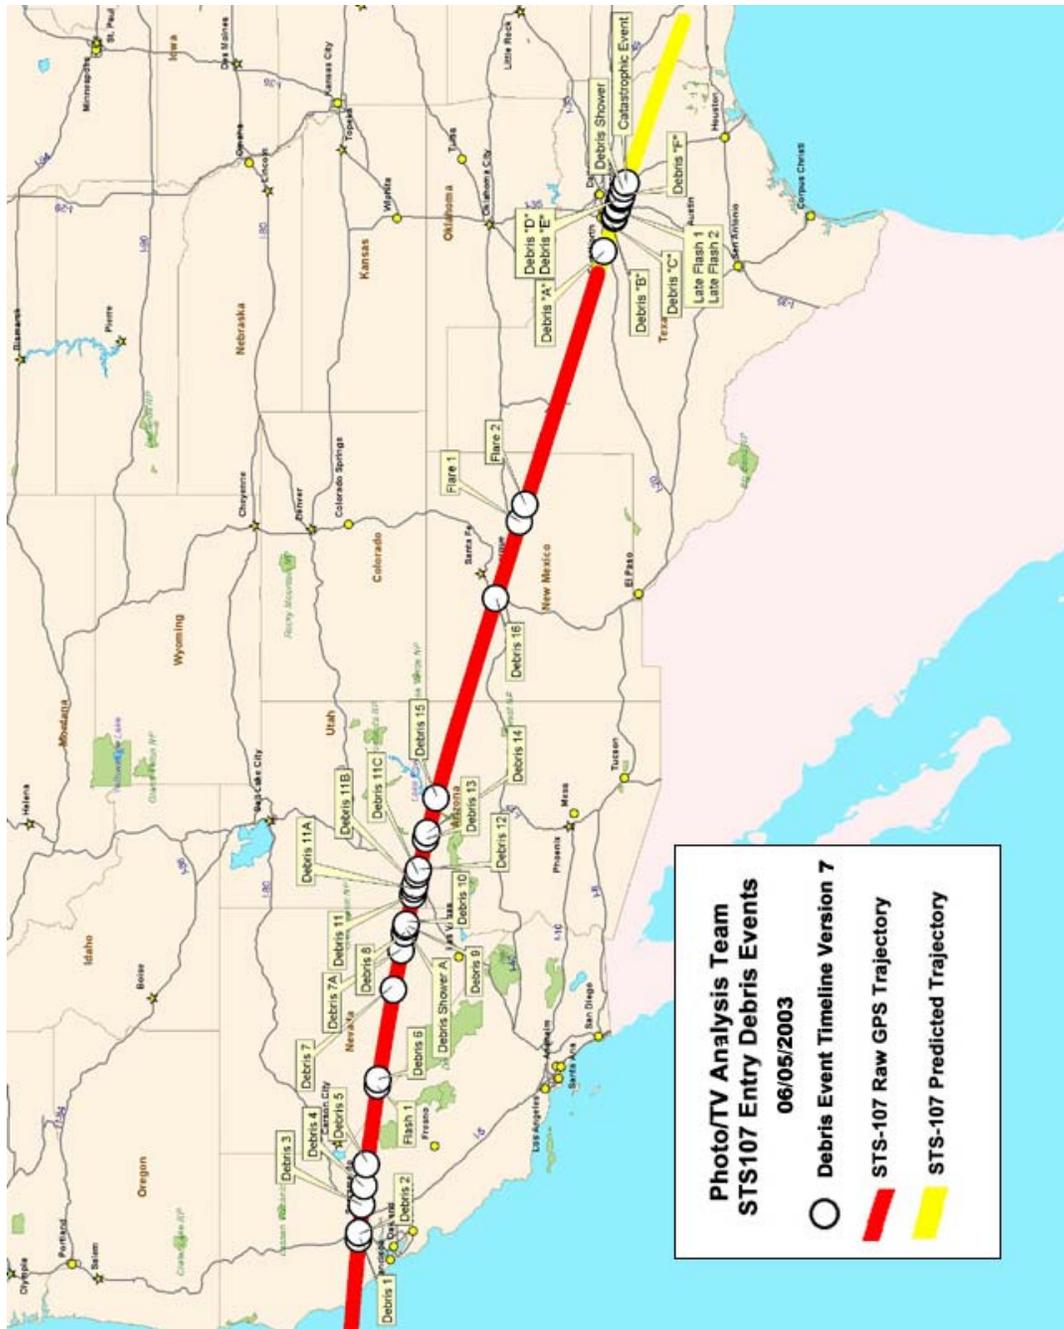
Figure 6.3.2a Map summarizing locations of observed debris events during STS-107 re-entry. Details for each event are found in Table 6.3.2.

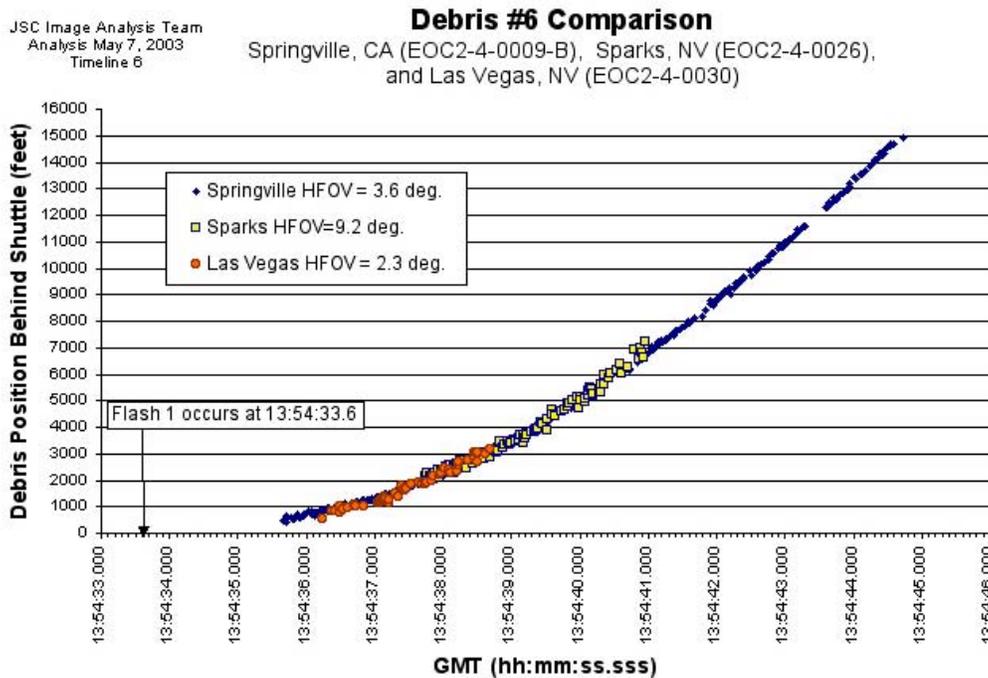
the debris, and the ballistic coefficient of the debris (which is directly related to its deceleration). The debris decelerations were then used by the Image Analysis Team's Luminosity Working Group to calculate debris mass. While Figure 6.3.4a shows very good agreement in the relative motion for Debris 6 for the three separate videos analyzed for this event, there was some disagreement for the motion of Debris 14 (Figure 6.3.4b) for the four videos analyzed for this event. Possible explanations for the Debris 14 discrepancy include the following: errors in the in the assumed focal lengths (fields-of-view) for some observers; errors in the precise timing of the videos; significant motion of the debris out of the Orbiter trajectory path causing an unmeasured component of its motion to be missed by observers in Utah. The last explanation is based on the fact that observers from Utah were directly under the Columbia flight path and were looking eastward, so if the debris dropped enough in altitude, it might appear to move away more slowly relative to observations from Flagstaff. Details about the relative motion analyses including determination of the camera fields-of-view are discussed in Section 6.2, Methods.

Figure 6.3.4.a Debris 6 position relative to Orbiter as measured from three videos, identified by their EOC number.

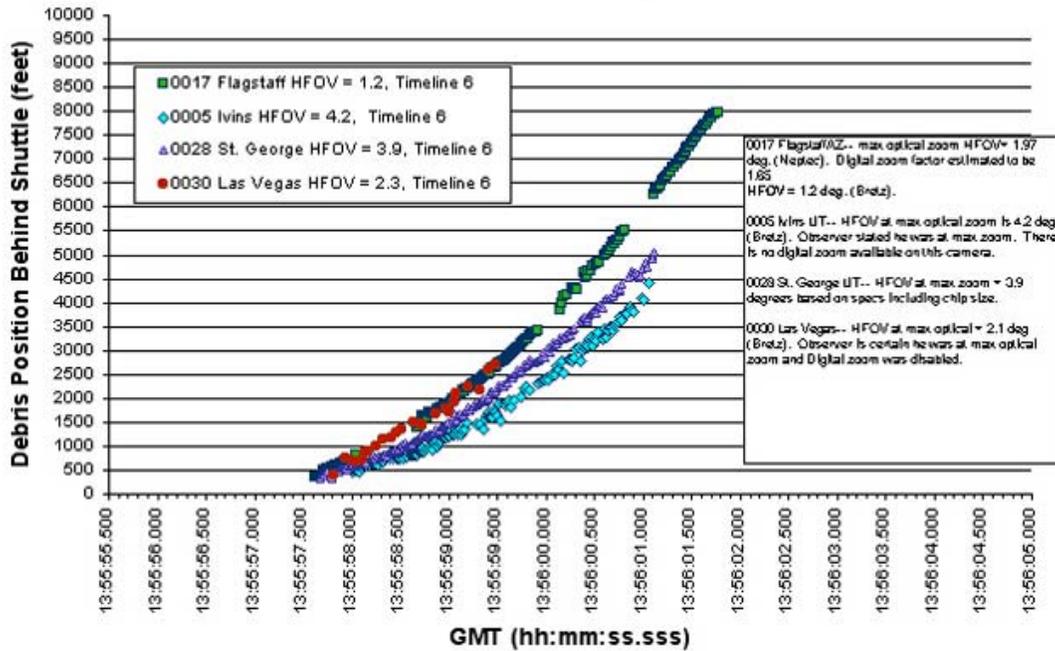
Figure 6.3.4b Debris 14 position relative to Orbiter, measured from four videos, identified by their EOC number.

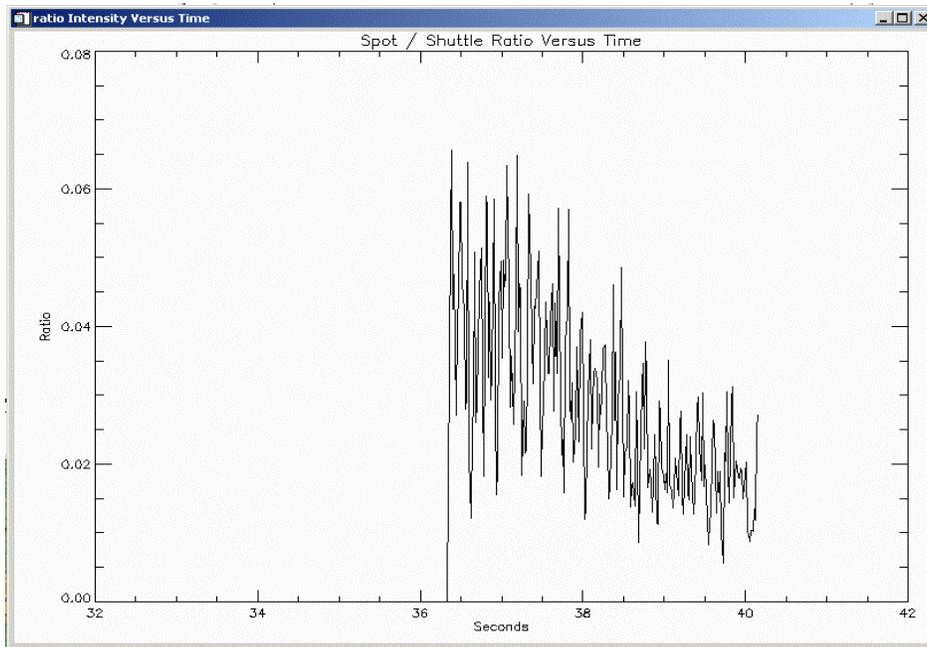
Figure 6.3.5b Field-by-field Debris 6/Shuttle intensity ratio versus times (seconds after 13:54:00 UTC)
