### 3 ASSESSMENT OF THE CAIB RECOMMENDATIONS

### 3.1 CAIB Recommendation 3.2-1 – External Tank Debris Shedding

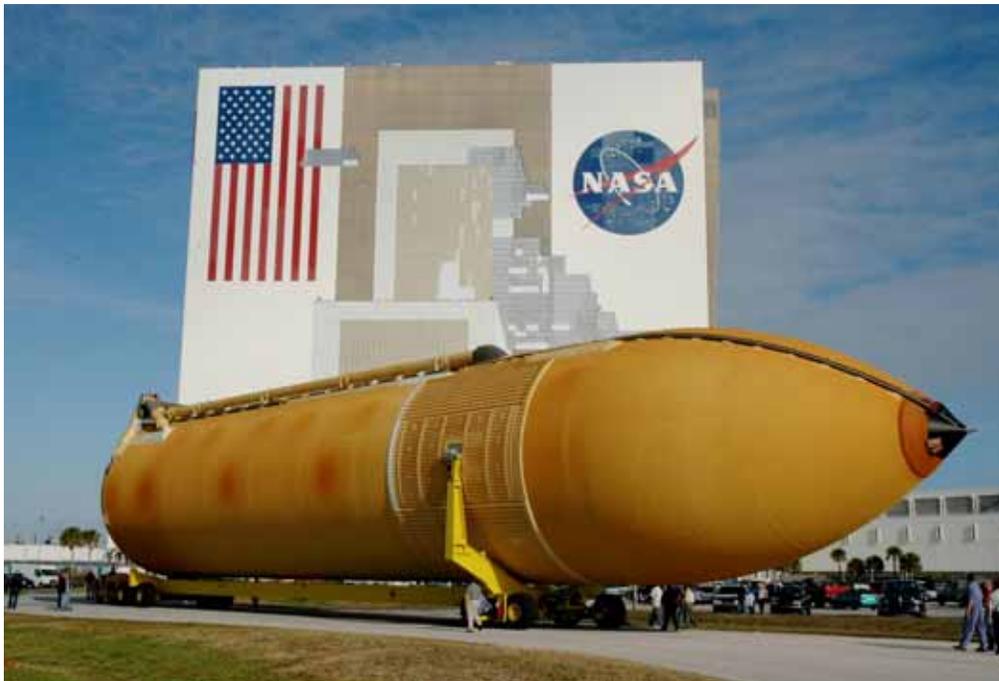
ET-120, the External Tank originally scheduled for use on STS-114, arrives at the Kennedy Space Center. Various anomalies with this tank forced the program to switch to ET-121, the tank originally scheduled for STS-121.

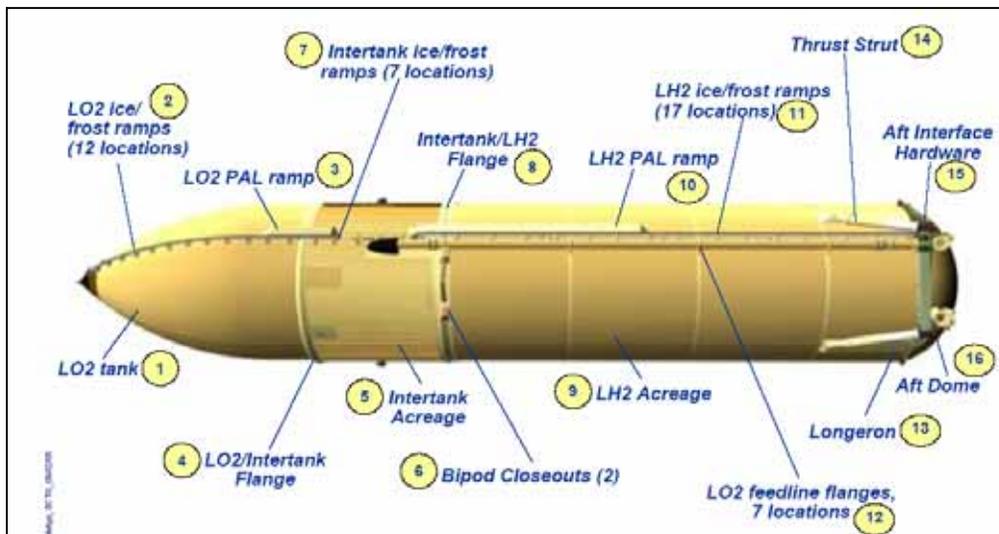
NASA evaluated 16 areas of the ET thermal protection system for debris shedding. Eventually five areas of foam (numbers 5, 6, 8, 10, 13) plus a source of ice debris at the LO2 feedline bellows (not shown) were selected for improvement or redesign based on their likelihood to liberate critical debris.

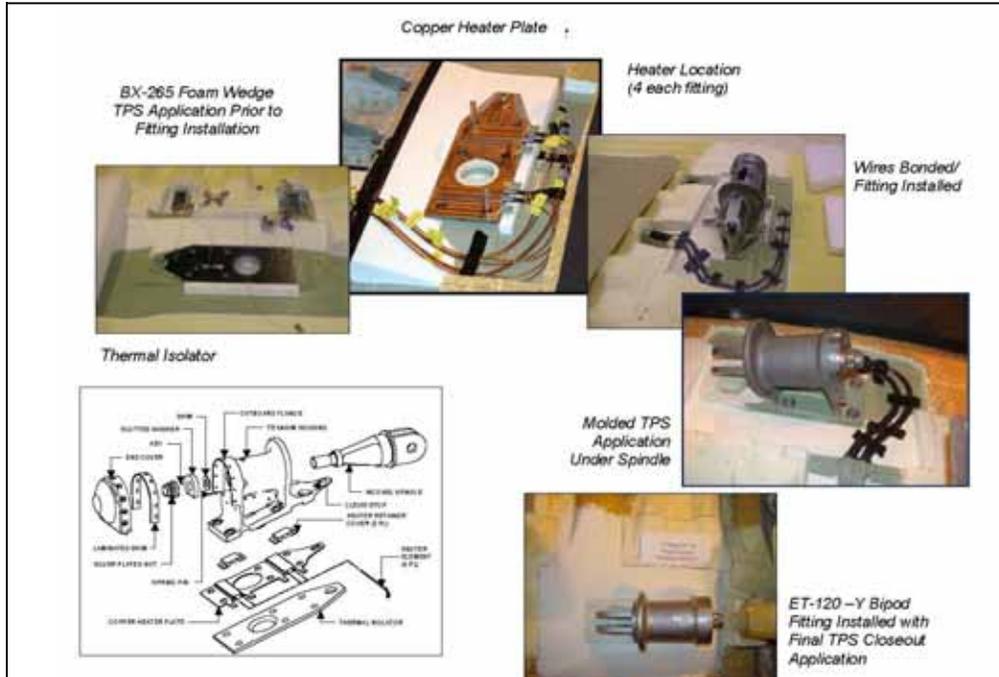
The most visible change to the External Tank was the elimination of the bipod ramps on the forward ET attach point and the installation of heaters in the same area. The loss of one of these foam ramps was responsible for the loss of *Columbia*.

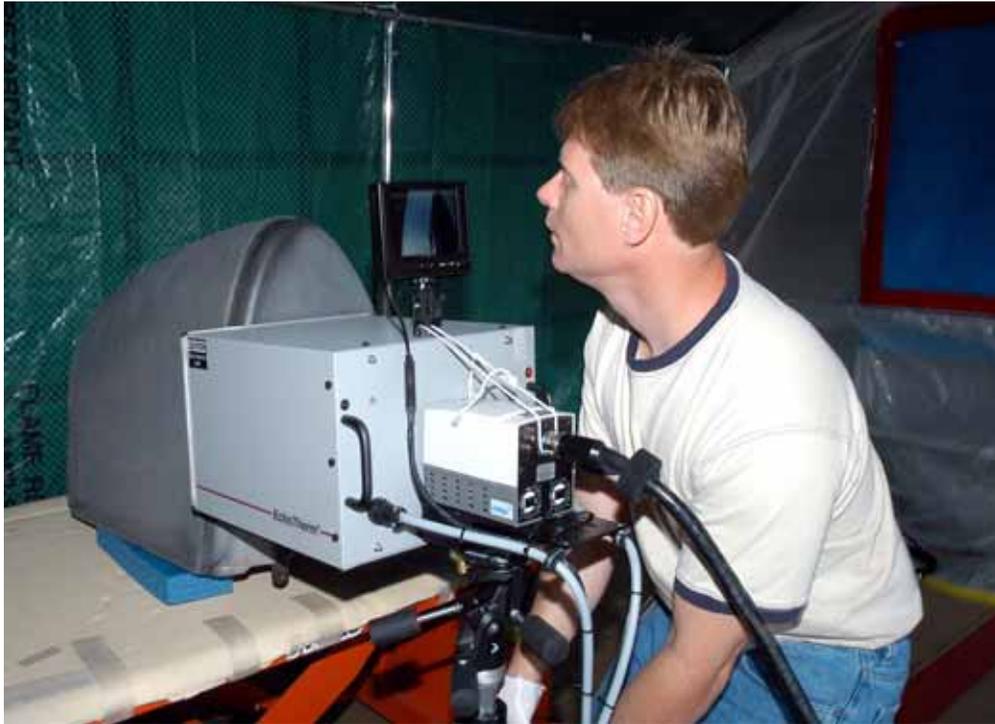
Jim Landy, a specialist with United Space Alliance, examines a wing leading edge carbon-carbon panel using flash thermography. A relatively new procedure at KSC, thermography uses high intensity light to heat areas of the panels. The panels are then immediately scanned with an infrared camera. As the panels cool, any internal flaws are revealed.

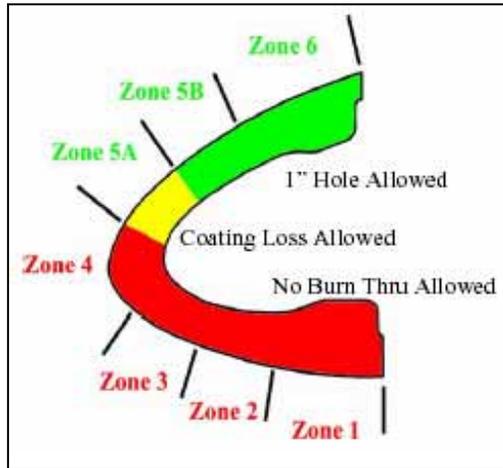
Each RCC panel was split into seven zones, and the level of damage that could be tolerated was evaluated for each zone. The zones on the bottom of the panel and the apex cannot tolerate any substantial damage due to the thermal environment these areas are subjected to during entry.
