Other Factors Considered

4.1 FAULT TREE

4.2 REMAINING FACTORS

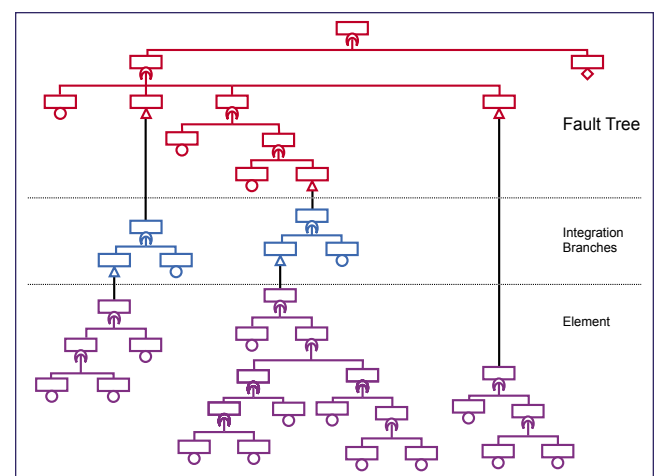
The NASA Accident Investigation Team investigated the accident using “fault trees,” a common organizational tool in systems engineering. Fault trees are graphical representations of every conceivable sequence of events that could cause a system to fail. The fault tree’s uppermost level illustrates the events that could have directly caused the loss of *Columbia* by aerodynamic breakup during re-entry. Subsequent levels comprise all individual elements or factors that could cause the failure described immediately above it. In this way, all potential chains of causation that lead ultimately to the loss of *Columbia* can be diagrammed, and the behavior of every subsystem that was not a precipitating cause can be eliminated from consideration. Figure 4.1-1 depicts the fault tree structure for the *Columbia* accident investigation.

Figure 4.1-1. Accident investigation fault tree structure.

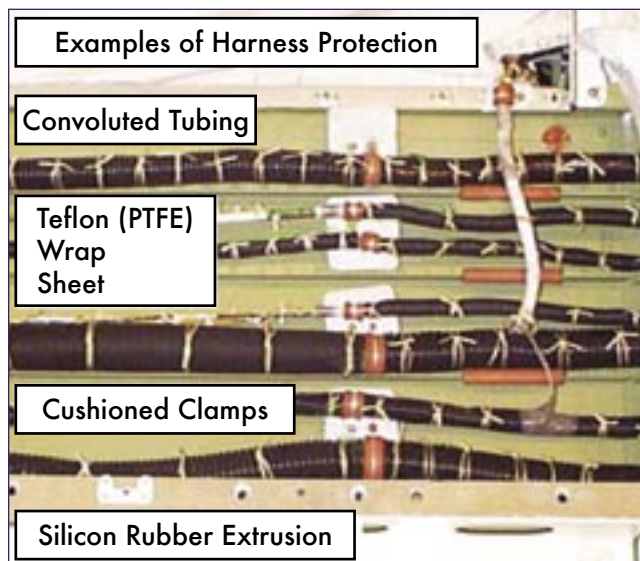
A typical wiring bundle is shown in Figure 4.2-3. Wiring nonconformances are corrected by rerouting, reclamping, or installing additional insulation such as convoluted tubing, insulating tape, insulating sheets, heat shrink sleeving, and abrasion pads (see Figure 4.2-4). Testing has shown that wiring bundles usually stop arc tracking when wires are physically separated from one another. Further testing under conditions simulating the Shuttle's wiring environment demonstrated that arc tracking does not progress beyond six inches. Based on these results, Boeing recommended that NASA separate all critical paths from larger wire bundles and individually protect them for a minimum of six inches beyond their separation points.⁴ This recommendation is being adopted through modifications performed during scheduled Orbiter Major Modifications. For example, analysis of telemetered data from 14 of *Columbia's* left wing sensors (hydraulic line/wing skin/wheel temperatures, tire pressures, and landing gear downlock position indication) provided failure signatures supporting the scenario of left-wing thermal intrusion, as opposed to a catastrophic failure (extensive arc tracking) of Kapton wiring. Actual NASA testing in the months following the accident, during which wiring bundles were subjected to intense heat (ovens, blowtorch, and arc jet), verified the failure signature analyses. Finally, extensive testing and analysis in years prior to STS-107 showed that, with the low currents and low voltages associated with the Orbiter's instrumentation system (such as those in the left wing), the probability of arc tracking is commensurately low.

Figure 4.2-4. Typical wiring harness protection methods.

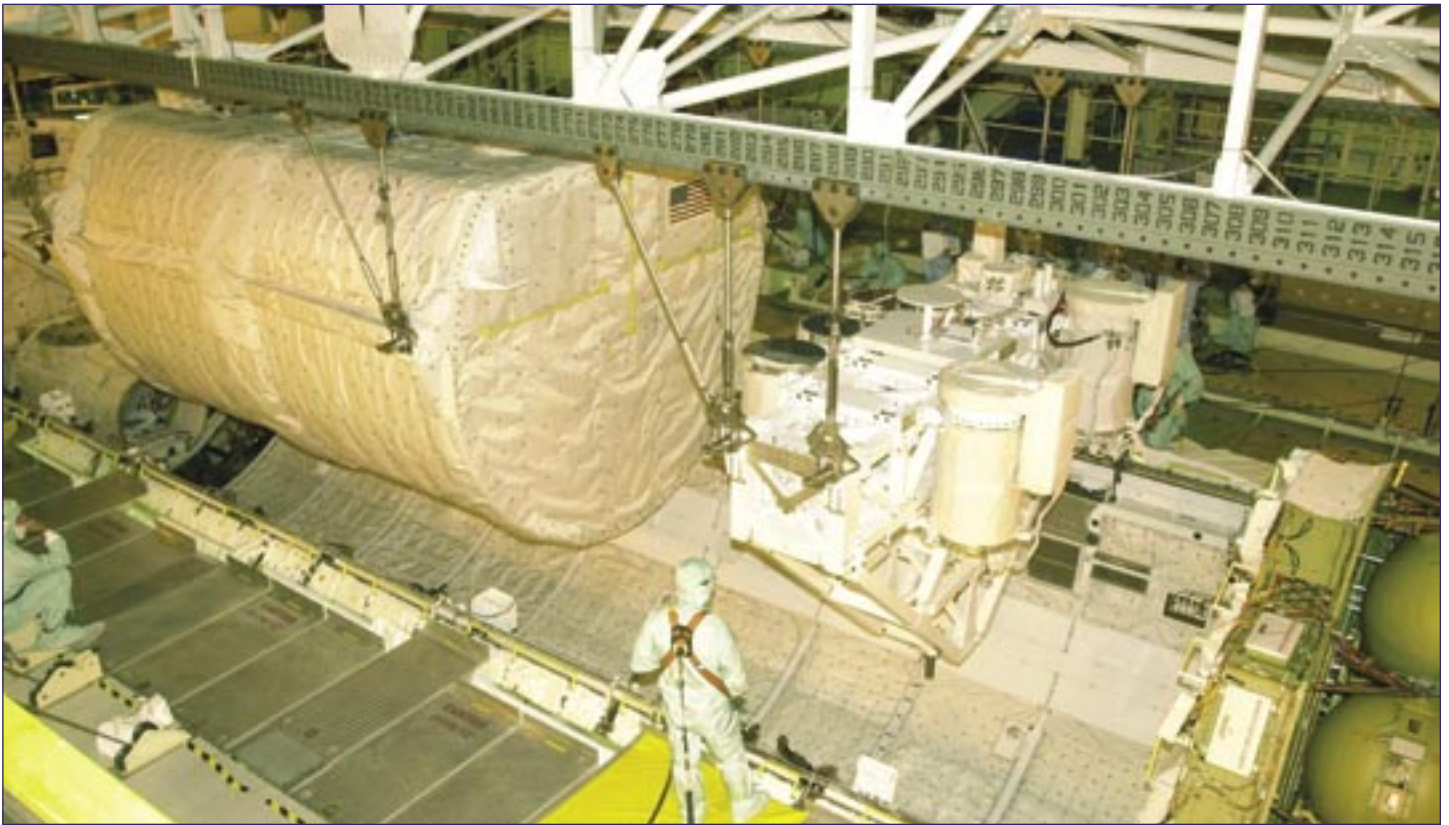
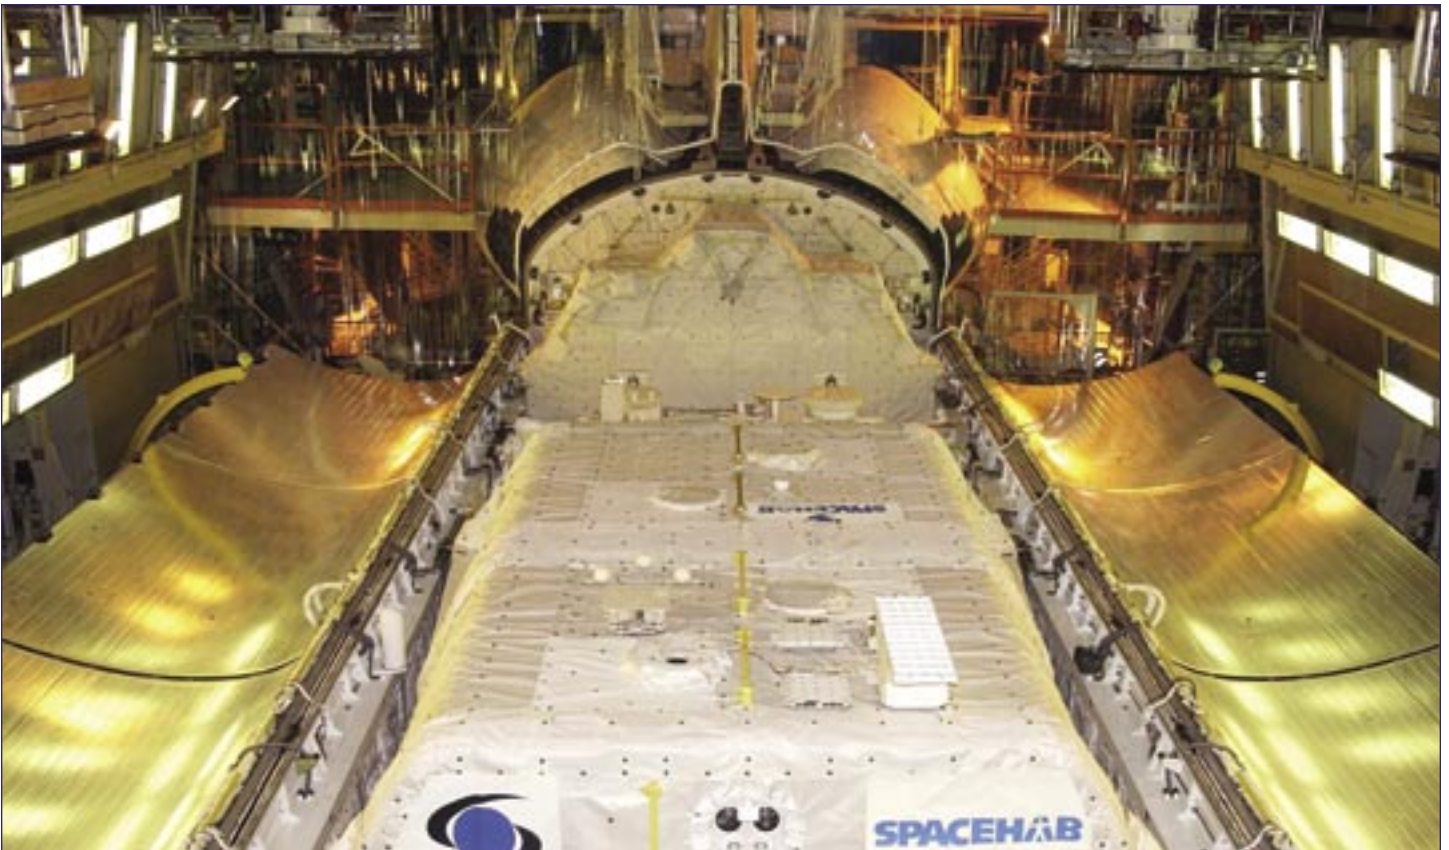
The Board explored whether the pressurized SPACEHAB module may have ruptured during re-entry. A rupture could breach the fuselage of the Orbiter or force open the payload bay doors, allowing hot gases to enter the Orbiter. All downlinked payload telemetry indicates that there was no decompression of SPACEHAB prior to loss of signal, and

(Above) The SPACEHAB Research Double Module (left) and Hitchhiker Carrier are lowered toward Columbia's payload bay on May 23, 2002. The Fast Reaction Experiments Enabling Science, Technology, Applications and Research (FREESTAR) is on the Hitchhiker Carrier.

(Below) Columbia's payload bay doors are ready to be closed over the SPACEHAB Research Double Module on June 14, 2002.

no dramatic increase in internal temperature or change in the air composition. This analysis suggests that the pressurized SPACEHAB module did not rupture during re-entry (see Appendix D.6.).

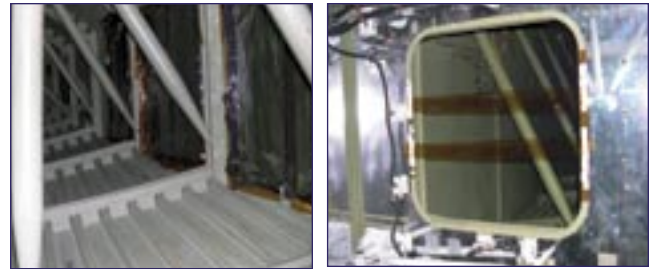
The processes in place to detect anything unusual on the Orbiter, from a planted explosive to a bolt incorrectly torqued, make it likely that anything unusual would be caught during the many checks that employees perform as the Orbiter nears final closeout (closing and sealing panels that have been left open for inspection) prior to launch. In addition, the process of securing various panels before launch and taking closeout photos of hardware (see Figure 4.2-5) almost always requires the presence of more than one person, which means a saboteur would need the complicity of at least one other employee, if not more.

Figure 4.2-5. At left, a wing section open for inspection; at right, wing access closed off after inspection.
