Volume IV

Appendix F.2

“Follow the TPS”: An Analysis of What Occurred to the Thermal Protection System (TPS) During the Flight of Shuttle Columbia on STS 107

Executive Summary

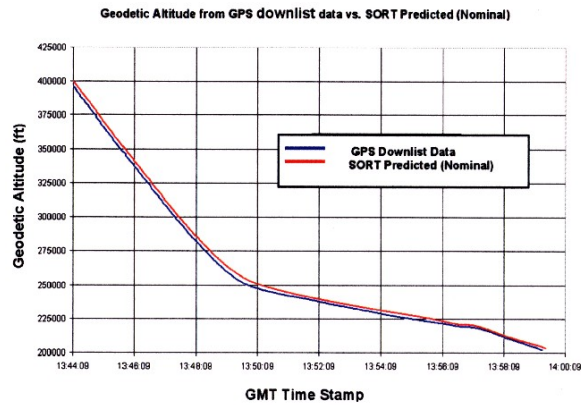
Figure 1(a): Normal Entry: Geodetic Altitude vs. GMT. Entry Interface (EI) at 400,000 ft. Angle of Attack: 40 Degrees.

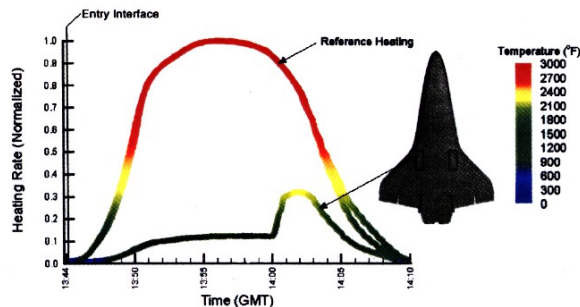
Figure 1(b) shows a plot of expected heating rates, normalized to the stagnation point near the nose of the vehicle versus GMT. Here, one can see that the heating rate is nearly constant at a maximum for about 9 minutes. The heating rate on the landing gear door area in the wing is considerably lower than that at the nose of the vehicle. Color-coding on the figure shows TPS surface temperatures caused by these heating rates.

Figure 1(b): Normal Entry: Normalized Heating Rates vs. GMT. Entry Interface (EI) at Altitude: 400,000 ft, Angle of Attack: 40 Degrees.

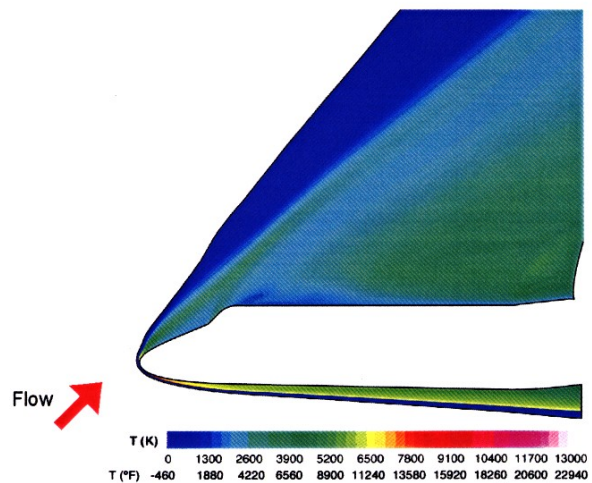
Figure 2(a) shows temperature contours within the shock layer that forms about the Space Shuttle during entry. Flow is from lower left to upper right. A view in the pitch plane at the centerline of the vehicle is shown for conditions at 227,424 ft and an angle of attack of 39.59 degrees. The outer, blue envelope representing free stream or ambient air is outside of the shock front, within the computational grid. The rapid change in color represents the shock front. One can see that gas temperatures in the forebody, nose region of the shock layer, behind the shock front exceed 20,000 °F (red -> magenta). As the gases expand in the shock layer, cooling occurs, and the forebody gas temperatures drop into the area of 12,000 -> 9000 °F (yellow -> green) along the windward side or underbelly of the vehicle. In the leeward portion of the flow, gas temperatures are much cooler (4,000 - 2,000 °F) as shown by the blue-green color.

Figure 2 (a): Gas Temperatures from CFD Solution Pitch Plane, Near Peak Heating. Angle of Attack: 39.59 degrees, Altitude: 227,424 ft (69.319 km), Mach: 22.91, Velocity: 22,505 ft/sec (6.8595 km/sec) at 13:54:24. Reynolds Number based on length: 1.18 million.

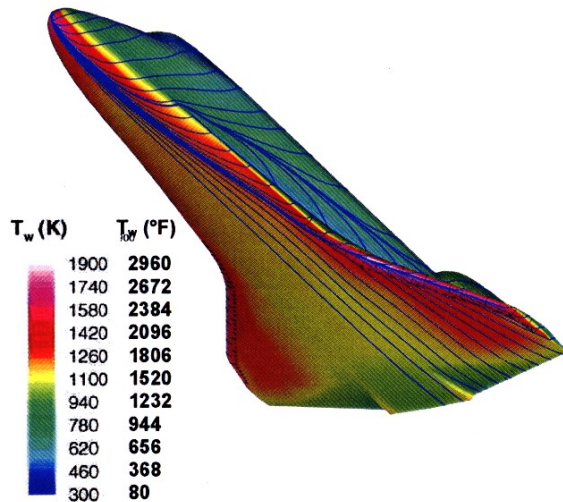
Owing to cooling of the shock layer gases in the boundary layer formed over the Space Shuttle and the TPS material response, the surface of the vehicle operates at temperatures (denoted by T_w) considerably lower than those in the shock layer. These data are displayed in Figure 2 (b). These temperatures depend upon the response of the TPS and typically range from 3,000 - 2,900 °F on the nose and in the area of the shock-shock interaction on the wing leading edge. The shock-shock interaction arises from the merging of the body shock with the shock layer formed on the wing leading edge. This merging causes enhanced pressure and aeroconvective heating in this region.

Figure 2 (b): CFD Solution for Surface Temperatures (T_w) with Streamtraces. Conditions as in Figure 2 (a).

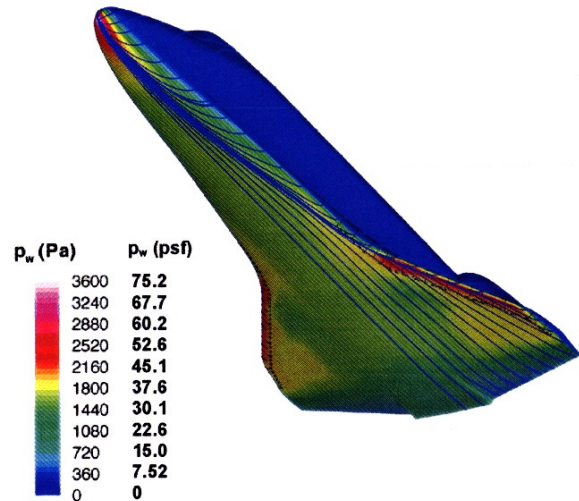
From Figure 2 (c) displaying surface pressure, it is noted that the stagnation pressure near the vehicle's nose is 75 pounds per square foot (psf), dropping down to about 34 - 24 psf at the mid fuselage and aft fuselage locations, respectively. The shock-shock area, where the nose shock intersects the wing, runs at higher pressures (64 psf) than on the mid-belly region. Pressures on the top surfaces of the wings and fuselage sidewalls are near or below the free stream static pressure of 0.12 psf.

Figure 2 (c): Surface Pressure with Streamtraces. Conditions as in Figure 2 (a).

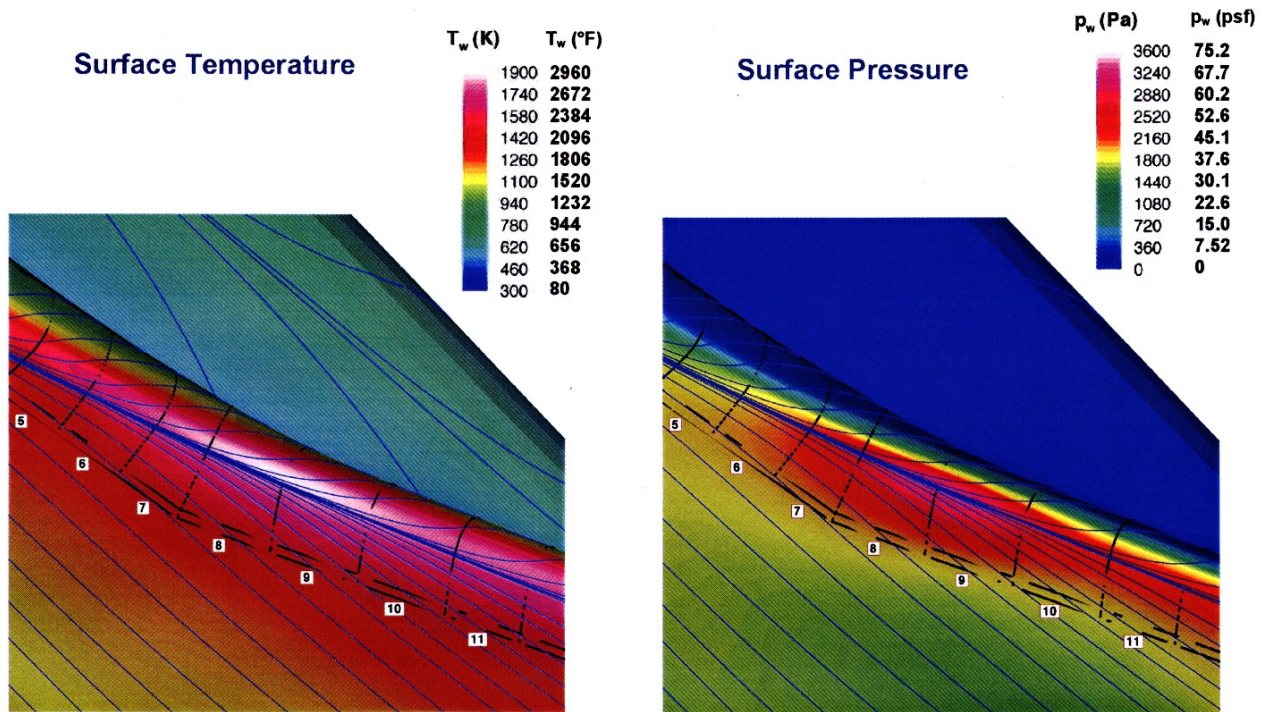
Figure 3 is based on the CFD results from Figure 2. Here one sees zoom-in views of wall temperature and surface pressure distributions in the left wing leading edge area. Also shown are RCC panel locations. As can be seen, there is an attachment line along the wing leading edge where the flow divides, part going over the wing and part going below the wing. In both instances the flow is expanding into lower pressure locations. Along and near the attachment line, the principal direction of the flow at the surface is along the wing, in the outboard direction.

Figure 3: Zoom-in on CFD Solutions from Figure 2 in the Regions of RCC Panels 5-11.

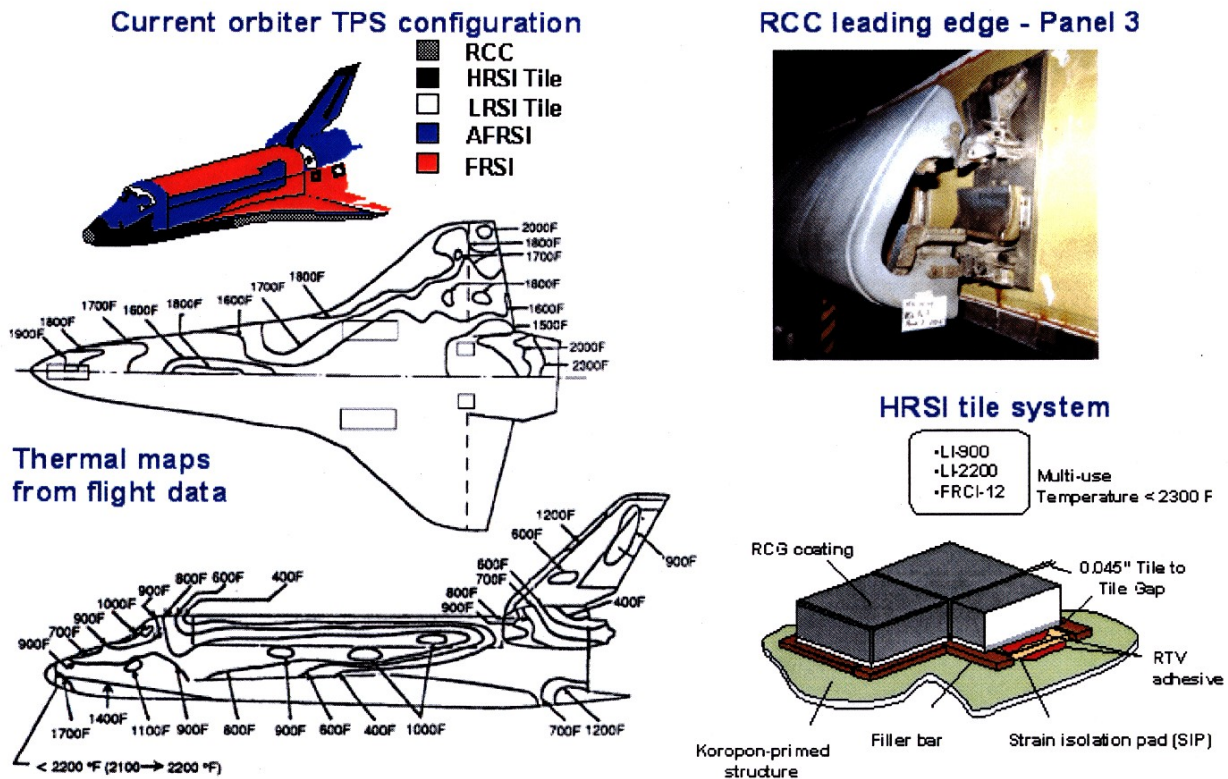
Figure 4: Overview of the Shuttle Thermal Protection System.

Thermal maps obtained from Orbiter Experiments (OEX) data early in the Shuttle Program, are shown in Figure 4. Also shown is a depiction of how the tiles are bonded to the Shuttle's aluminum skin. A photograph of a RCC wing panel (Panel 3) with the insulation, mounting attachments and the aluminum wing spar is also shown. Not used in the Panel 3 area are metal beams that span the open end of the RCC, from the top to bottom attachment points. These spanners are used in the Panel 8/9 area to provide additional strength. Note that there is a cavity behind the RCC and insulation between the RCC and the wing spar. This insulation protects the spar against radiation from the inside of the RCC. Not shown in this picture is the insulation that covers all internal metal surfaces ensuring that no structure is exposed to the radiation from the RCC. RCC has a very high thermal conductivity and therefore its inside surface is nearly as hot as the outer surface exposed to aeroconvective heating. During reentry, at an angle of attack of 40 degrees, the lower portion of the RCC panels receive most of the aeroconvective heating. The higher temperature lower panels are cooled by internal radiation through the cavity behind the RCC to the cooler top of the panels, which in turn radiates off to space. There are 22 RCC panels on each wing, and the gaps between them are

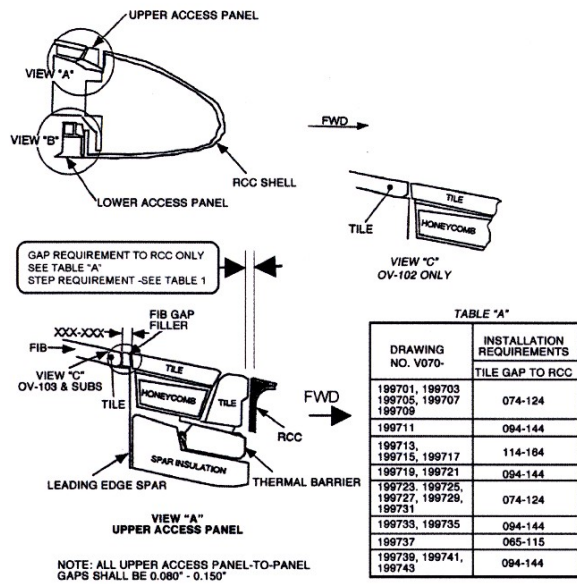
To understand the events that occurred on STS 107, to be discussed below, it is important to note that the RCC-LESS cavity is vented. The venting is accomplished by a gap, ranging in width from 0.065 to 0.164 inches between the upper back edge of the RCC panels and the upper wing tiles. This gap runs the entire length of all RCC panels, giving a total vent area of 47 to 74 square inches depending on the actual gap widths. The smaller area corresponds to using the minimum allowable, installed gap width requirements and the larger area corresponds to using the maximum allowable, installed gap width requirements. Details of the gap design and width specifications are shown in Figure 5. The location of the gap was chosen because of the low heating rates and pressures that exist there as listed in Table 2. As can be seen, the pressure ratio peaks at RCC Panel 10 and falls off gradually in both the inboard and outboard directions. The fluid physics of the wing flow provides an extremely large driver pressure differential for a breach through the wing leading edge as illustrated by these pressure ratios.

Figure 5: Details of Wing Leading Edge Subsystem Vent Design. Orbiter Vehicle (OV) 102 is named Columbia.

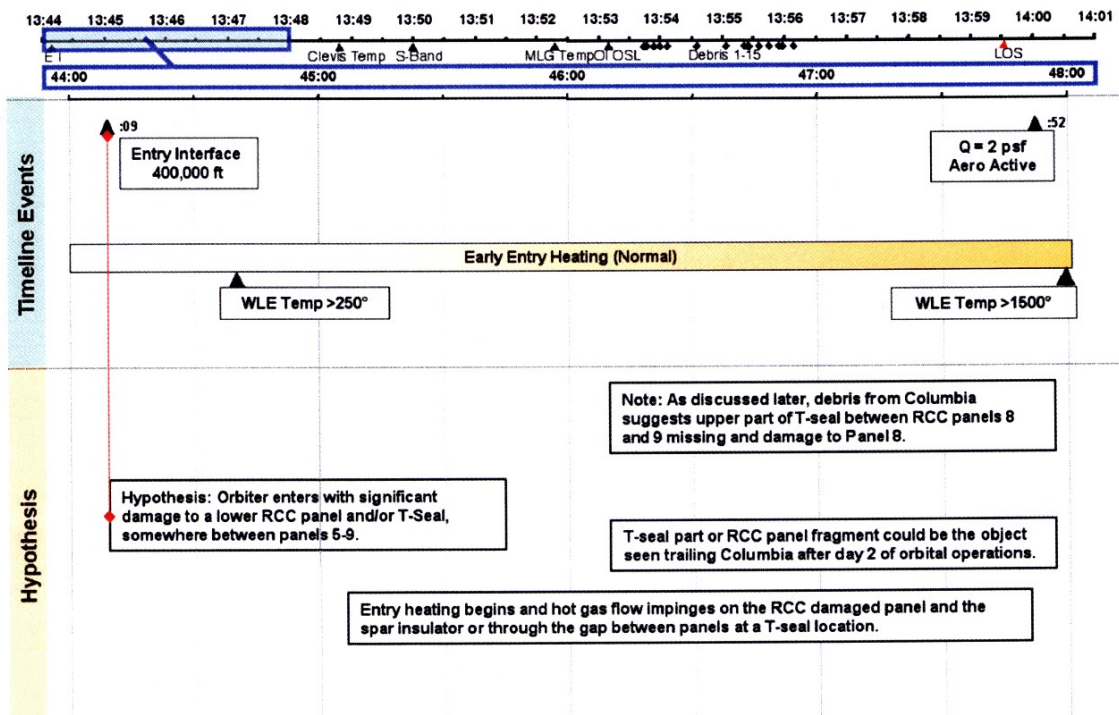
Figure 8: Timeline From EI 13:44:09 -> 13:47:30.

Figure 8 shows the comparison of timeline events from EI 13:44:09 to 13:47:30 to the hypothesis. This format, developed by NASA's Working Scenario Team (Reference 13), was adopted by the present authors. The format highlights portions of the entire sequence from EI through loss of signal (LOS) GMT 13:44:09 -> 13:59:32 shown at the top of the figure. The period being studied is highlighted with the blue rectangles, in this case 3 minutes and 21 seconds after EI.

Timeline events (tested and adopted as being "truth") appear on the upper half of the figure while those in the hypothesis (or scenario) are displayed in the lower portion of the figure. This figure shows the entry interface timing and wing leading edge heat-up for a normal wing during the expected STS 107 entry. In the lower part of the figure, the hypothesized damage to the lower RCC Panel 5-8 region as depicted in Figure 6 is noted, as is the beginning of the thermal attack on the wing leading edge subsystem. As discussed later, the debris recovered from Columbia strongly suggests the initial breach was in Panel 8, and the upper part of the T-seal between Panel 8 and 9 was missing or displaced.

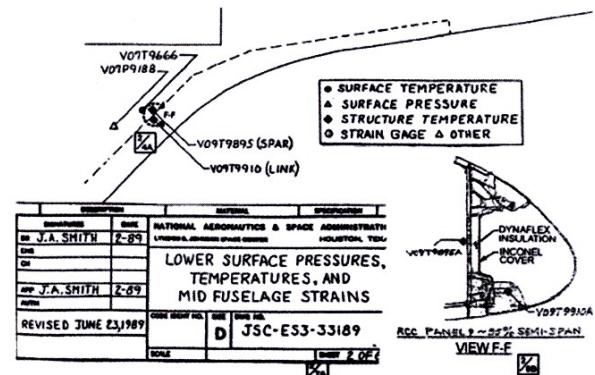
To help visualize the geometric location of the sensors, Figure 10 shows portions of an engineering drawing from a document describing the OEX instrumentation. As can be seen, top and side views are shown along with a key identifying the type of sensor.

Figure 10: Portion of an Engineering Drawing Depicting the Location of OEX Sensors.

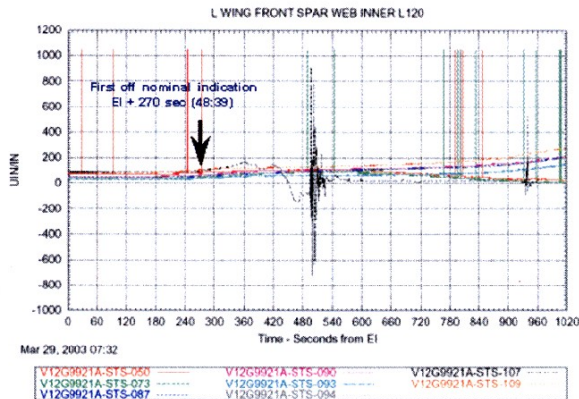
Figures 11 through 13 show data from the two sensors (one strain and one temperature) discussed in Figures 9 and 10. The information from these sensors is very significant in determining the progression of events as the thermal damage from the initial breach progressed to burn a hole through the wing spar. In addition to the data

obtained on STS 107, sensor traces taken on other flights, with similar entries are displayed with different color codes. Other investigators have made detailed analyses of these signals and data from many more sensors, but herein, only major events, appropriate to our “Follow the TPS” theme are discussed. In each plot, there is an indication of the first off-nominal or “out-of-family” event that will later be used in comparing flight data to the hypothesized events causing loss of vehicle and crew. The units in Figure 11, measured by the temperature compensated strain gage are micro inches/inch.

Figure 11: OEX/MADS STS-107 Flight Data.

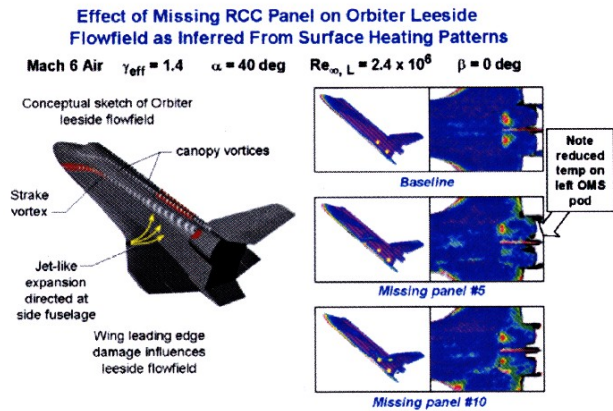
Figure 14, prepared by NASA (Reference 14) shows the results of wind tunnel tests from Langley Research Center. Data were obtained in a Mach 6 air stream at the conditions specified on the figure. The three boxes on the right of the figure show the results of a thermally sensitive coating on a model of the Shuttle. As noted, for the results of RCC Panels 5 and 10 missing, there is a definite temperature decrease from the baseline on the left OMS pod location, noted by the absence (missing panel number 5) or dimming of the red dot on the forward location of the OMS pod. The conceptual sketch, also shown in Figure 14, suggests that the jet-like expansion directed from a damaged wing influences the leeside flow field, reducing OMS heating if there is a disturbance in the Panel 5-10 RCC area.

Figure 14: NASA Langley Wind Tunnel Test Data Help Explain Below Nominal Temperatures Recorded on the Left OMS Pod.

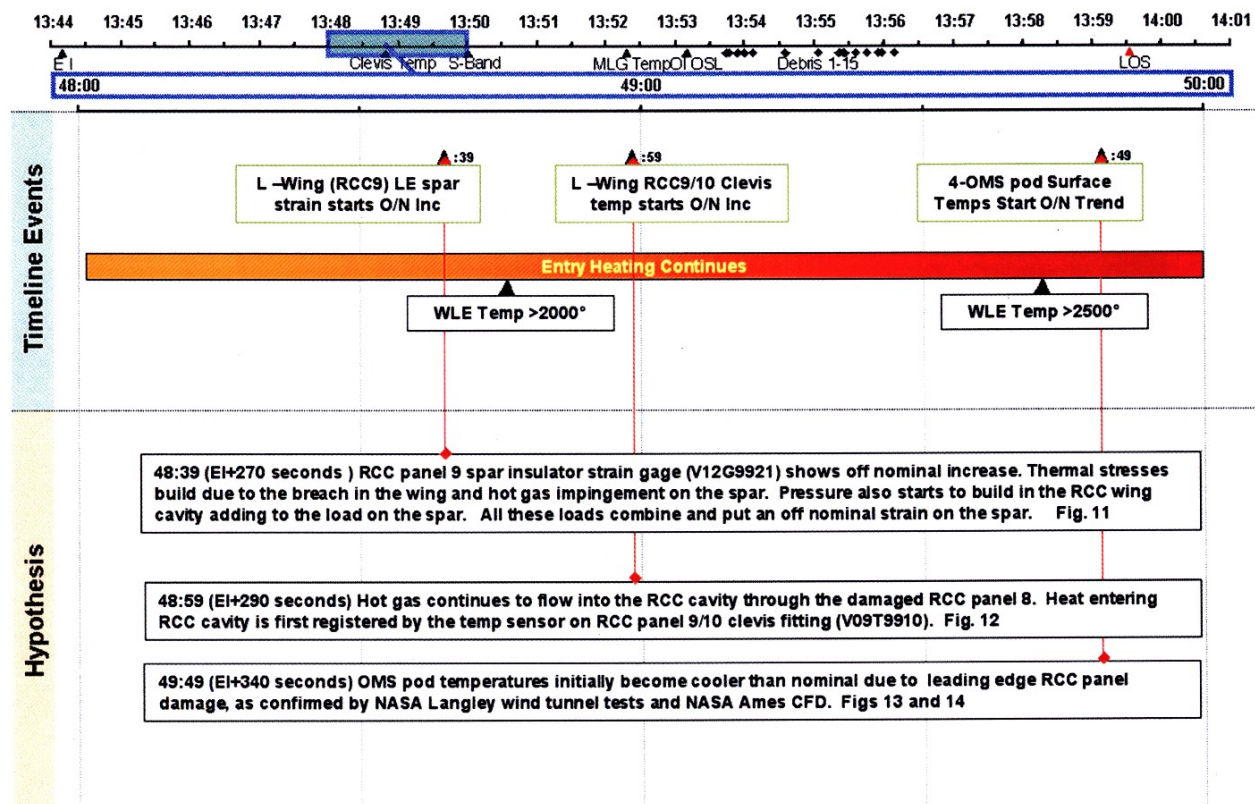
Figure 15 graphically depicts the timing of events recorded by the OEX sensors. The captions are self-explanatory. The MADS/OEX off-nominal data in the wing leading edge and spar are additional evidence that a breach existed in the RCC at the EL. The below nominal temperature on the OMS pod is consistent with the hypothesized damage in the wing leading edge in the RCC Panel 5 - 8 area.

Figure 15: Timeline Versus Hypothesized Events 13:48:00 -> 13:50:00.

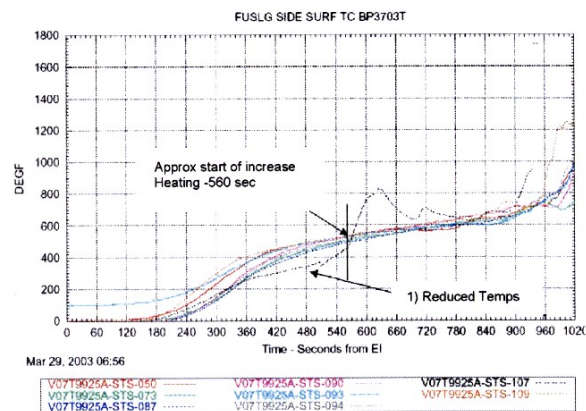
Figure 17 displays the left fuselage sidewall thermal profile for thermocouple VO7T9925A in the standard MADS/OEX format wherein the data for STS 107 are compared to those from other, similar entries of Columbia. As can be seen, there is an out-of-family lower temperature trend at EI + 360 seconds, correlating to GMT 13:50:09. This early below nominal, and later, above nominal temperature observation on the fuselage sidewall, for a number of thermocouples has been explained by the NASA team led by J. Caram (Reference 16) to arise from flow disturbances propagated from the wing leading edge. The study depends upon a combination of hypersonic wind tunnel data and CFD analysis. The reader interested in detail is referenced to this report and the Aerothermodynamics section of the CAIB report (Reference 17).

Figure 17: Representative Fuselage Sidewall Thermocouple Data.

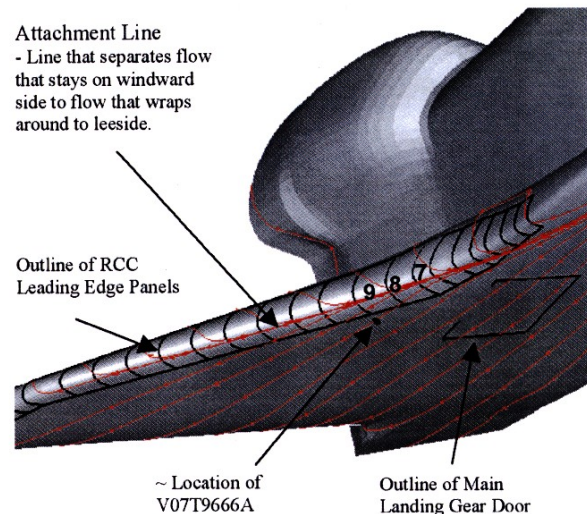
As shown in Figure 19, thermocouple V07T9666A is in the flow area affected by Panel 8 (Reference 18). Specifically, as shown in the figure, the streamline, which passes over the junction of the lower Panel 8/9, also intersects the approximate location of this thermocouple. As will be discussed below, the forensic analysis shows compelling evidence that there was an outflow from the aforementioned 8/9 RCC lower panel junction that probably caused the above nominal readings of V07T9666A that started at EI + 370 seconds and continued till the spar breach occurred. This CFD solution by Gnoffo, Alter and Thompson (Reference 18), was the starting point of studies of flow into the breach, as will be discussed below.

Figure 19: Orbiter Surface Streamlines. 13:50:53 (EI + 404), Mach: 24.9, Altitude: 243 k ft and Location of Thermocouple in Tile. CFD Solution from NASA (Reference 18).

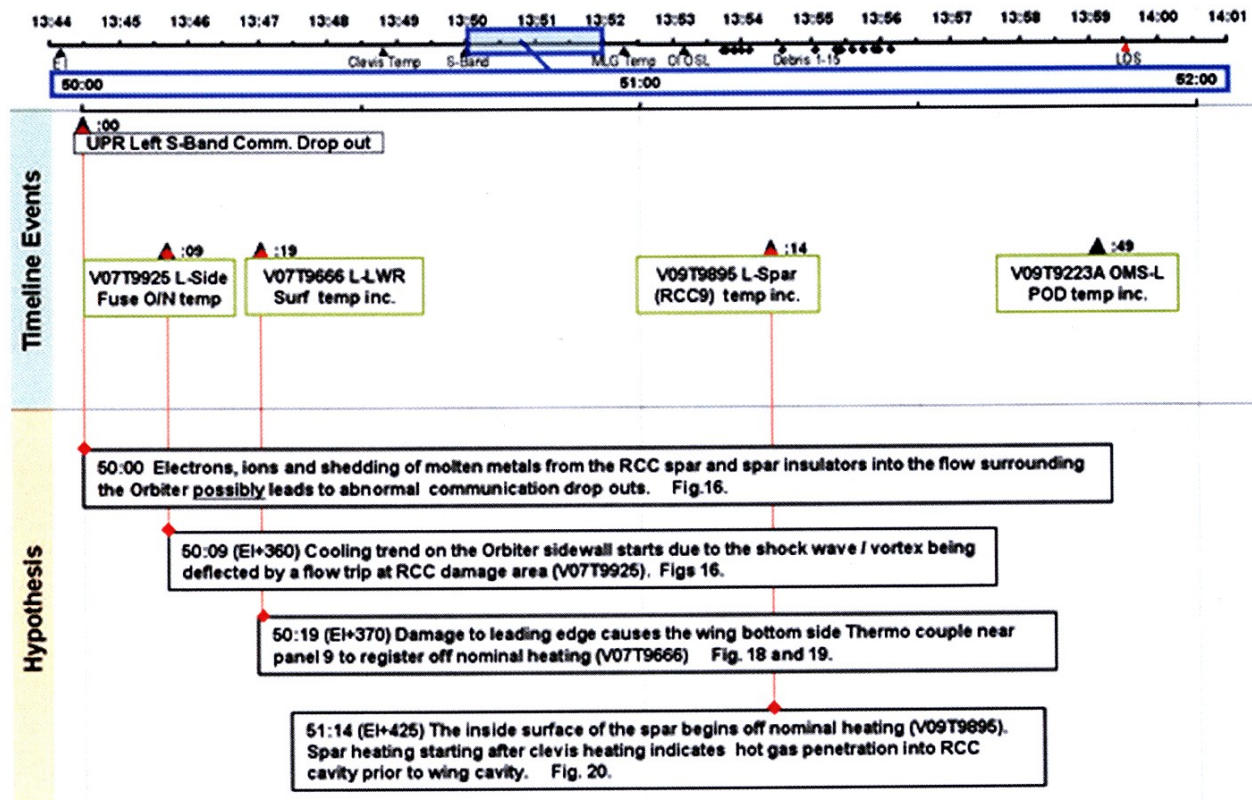
Figure 21 graphically depicts the timing of communication drop out and additional events recorded by the OEX sensors. The captions are self-explanatory. The MADS/OEX off-nominal data in the wing leading edge and spar are additional evidence that a breach existed in the RCC at the EI. The below nominal temperatures recorded on the fuselage sidewall is consistent with the hypothesized damage in the wing leading edge in the RCC Panel 5-8 area. The spatial correlation by the streamline analysis in Figure 19, showing how the outflow from the lower juncture of RCC Panel 8 and 9 can affect the lower tile thermocouple behind Panel 9 and the above nominal behavior of thermocouple V07T966, is additional and compelling evidence for the existence of a breach in the Panel 8/9 area. It is clear from this figure that the temporal evolution of the heat flow shows that the hot gas penetration began in the cavity in the wing leading edge prior to heating in the wing box behind the spar.

Figure 21: Timeline Versus Hypothesized Events – 13:50:00 to 13:52:00.

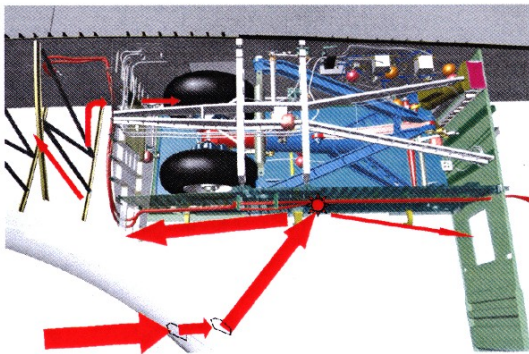
Figure 22 and 23 are artist's concepts of the burn-through and hot gases filling the wing box.

Figure 23: Hot Gas Begins to Fill Wing Box.

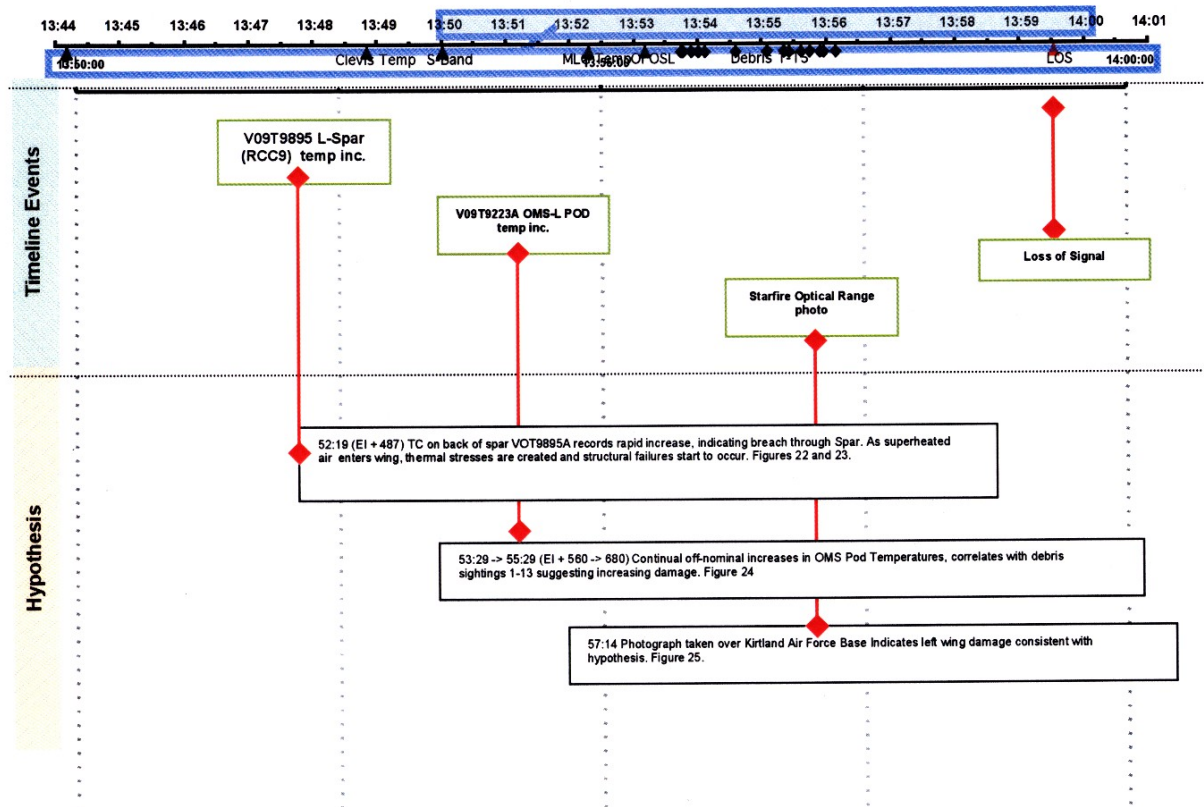
The captions within Figure 26 displaying the comparison to the hypothesis and the timeline between GMT 13:52:00 and 14:00:00 are self-explanatory. During this time, the breach through the spar and internal heating to the wing box and wheel well have rendered the loss of the vehicle inevitable. The temporal progression of damage to the TPS has been outlined herein with the exception of the shedding of tiles and RCC panels/parts. Geographic locations of the recovered TPS debris and ballistic analysis suggest that much of this occurred over Texas. Others have written in detail on the analysis of debris sightings, sensor readings, etc. and it is outside the scope of the "Follow the TPS" charter to dwell further on these topics.

Figure 26: Timeline from 13:50:00 Through Loss of Signal 13:59:32 Versus Hypothesized Events.

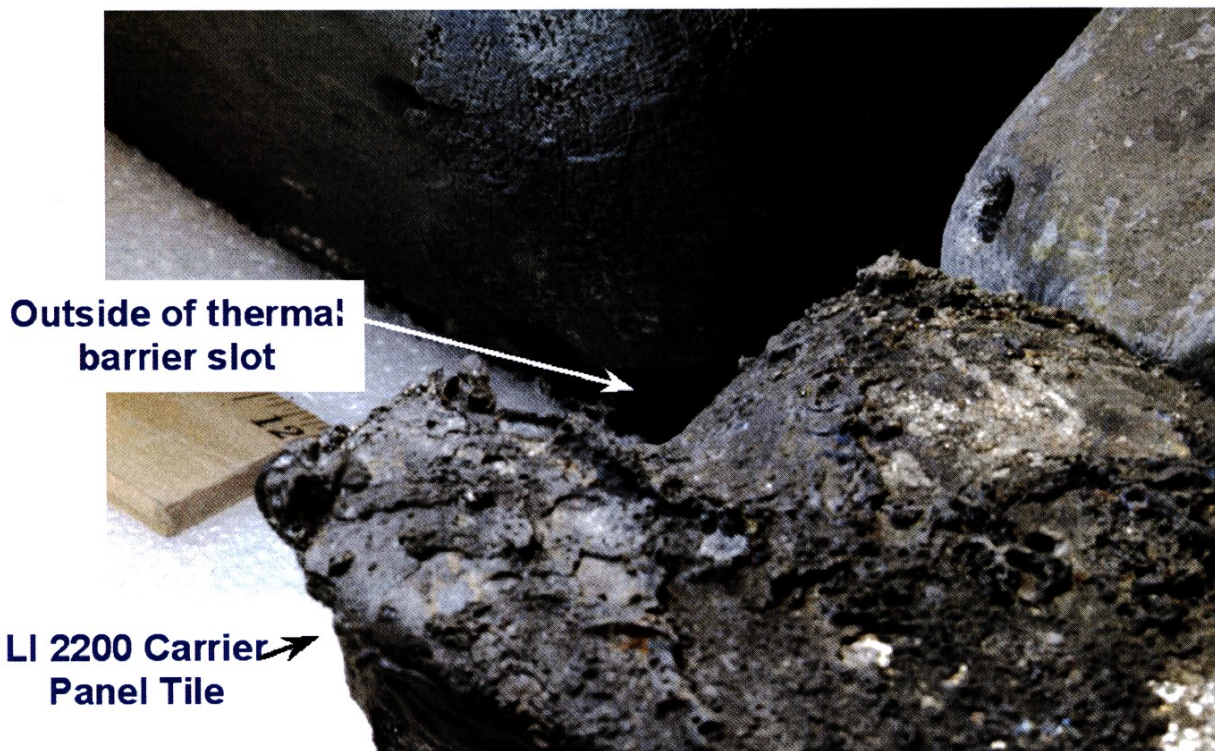
The photograph in Figure 31 is a close-up of the slot in the heel of the outside, lower Panel 8 rib, manufactured there to accept an internal thermal barrier for the wing leading edge system. When hot flow existed inside the wing at the Panel 8 area, it created a “sneak” flow out of the wing causing the flow patterning on the Panel 9 lower carrier panel tiles previously described. There is also flow patterning on the side of the tiles facing the inner, lower part of RCC Panel 9 suggesting a channel flow there. This is not shown in this photograph.

Figure 31: Close-up of Flow Location Affecting Panel 9 Carrier Panel Tiles

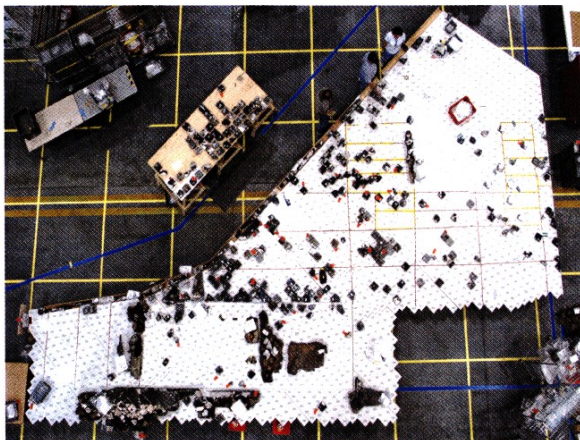
Figures 35 and 36 show photographs of recovered tiles affixed to a 110 percent scale drawing of the left wing tile field. Here, a key of circular dots was used: Red means a tile is not in its final location, blue means a tile is in its final location and has been positively identified. Yellow means the tile failed at the densified layer, near the bond line and green means the tile failed owing to internal heating. In this case the Koropon/SIP failed or the Strain Insulation Pad (SIP) failed due to overheating. Koropon is the primer coating the aluminum skin.

There is a distinct pattern of RCG coated tiles, in the general X-direction downstream of Panels 8 and 9, outboard of the wheel well where the tiles appear to have little of the dark metal deposit (aluminum - rich) generally seen on the recovered tiles. These normal-appearing tiles all have been identified to have failure at the tile/Koropon bond line and departed from the wing surface prior to a major outflow of molten aluminum. This is indicative of extreme heat, inside the wing behind Panel 8. It then seems probable from this observation that the breach in the wing spar occurred at the Panel 8 location, and this is consistent with the observations discussed above. Ballistic analyses of the trajectories and the geographic location of the recovered tiles (both those detached owing to bond failure and those that did not) suggest they came off from about 100 nautical miles west of their recovery location in Texas.

Figure 35: Overview of Tile Table. Left Wing, Lower Surface Tiles.

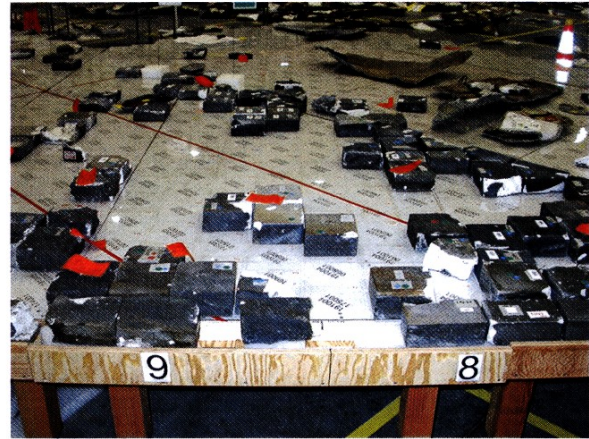
Figure 36: View of Tile Table from RCC Panel 8/9 Area.

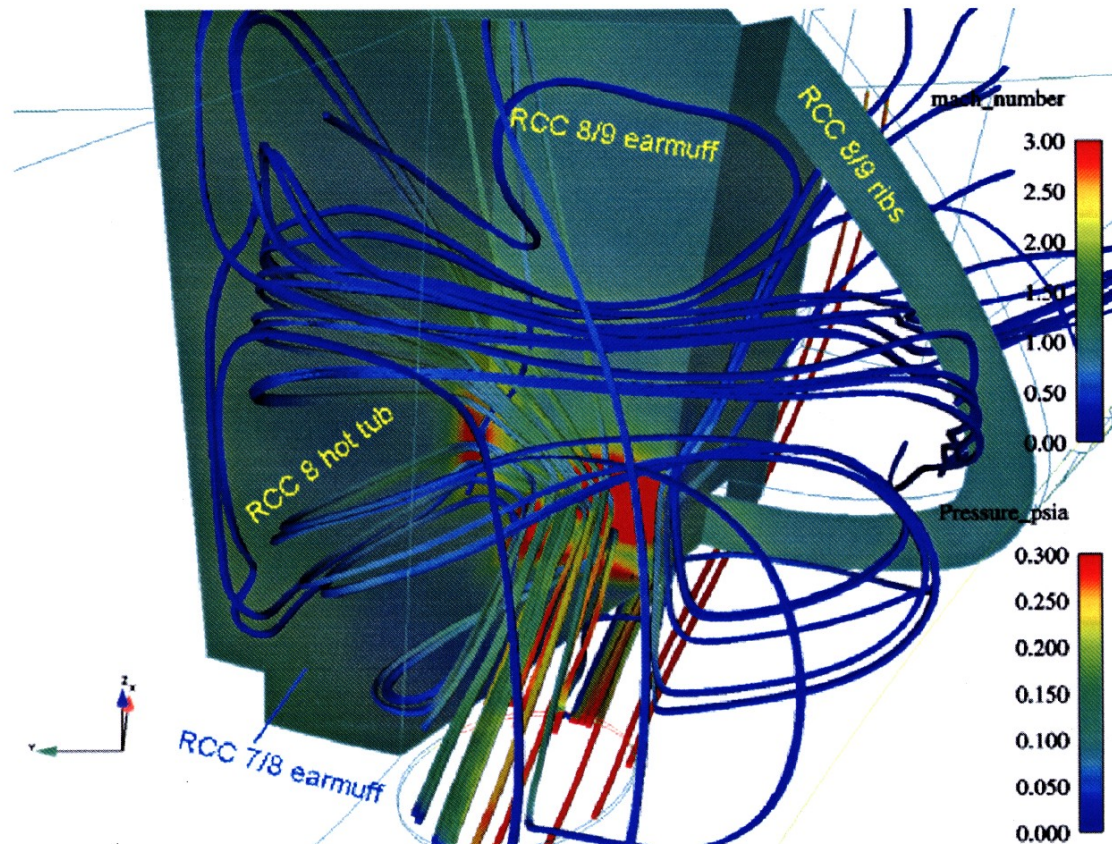
Figure 37 depicts a view of the CFD results (Reference 22) from the front of the leading edge with the acreage of the panels rendered transparent. The hole in RCC Panel 8 is outlined on the lower left corner of the figure. Streamlines are color coded by Mach number and pressures on the earmuff and spar insulation “hot tub” are displayed by the color-coding shown in the figure. As can be seen, the subsonic flow is complex and the jet creates a significant high-pressure zone on the RCC 8/9 earmuff.

Figure 37: Results Adopted From Reference 22, Showing Streamlines From a 10" Diameter Hole in RCC Panel 8 (the Hole is Shown at the Lower Left). Acreage of RCC is Rendered Transparent. View is From Front of the RCC WLESS. Flight Conditions are Mach: 24.9, Altitude: 243 k ft, as in Figure 19. Pressure of 0.30 psia is Equal to 43.2 psf.

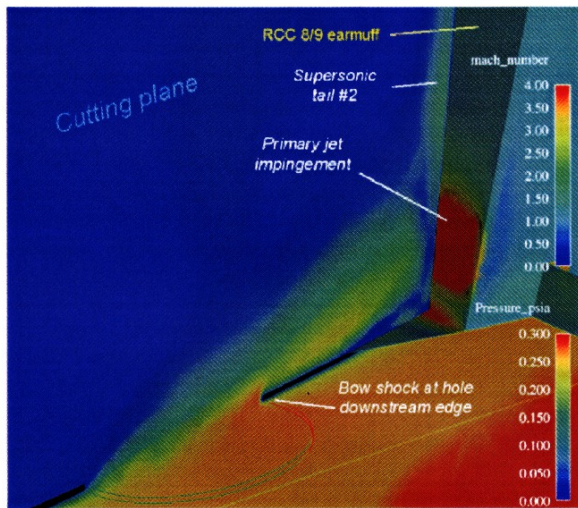
Figure 38 (a): CFD Predictions for Wall Static Pressure and Mach Number for a 10" Hole in RCC Panel 8, Corresponding to Solution in Figure 37. Static Pressure is Color Coded on Walls and Mach Number Distribution is Shown on the Cutting Plane.

Figure 38 (a) from the Boeing Propulsion and Power group depicts the static pressure on the WLESS internal walls and the Mach number on the cutting plane, which passes through the 10 inch diameter hole. The results indicate that all of the external boundary layer and some of the local inviscid (freestream) flow is ingested into the WLESS channel. The primary jet strikes the earmuff at a near-normal incidence (80°). Its stagnation pressure exceeds the freestream-shock pressure because of a precompression by the oblique vehicle shock.

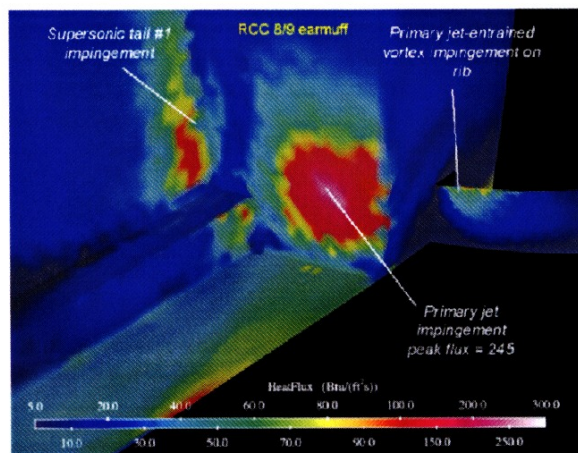
Figure 38 (b): CDF Predictions for Convective Heat Flux on Hot Tubs, Earmuff and Rib for a 10" Hole in RCC Panel 8, Corresponding to the Solution in Figure 37.

Figure 38 (b) shows CFD predictions for convective heat transfer to the spar insulation (hot tub), spanner insulation (earmuff) and the RCC outboard rib corresponding to the solutions shown in Figures 37 and 38 (a). The heat fluxes on the earmuff at the center of the jet impingement are significantly higher than that of an undamaged wing, immediately upstream of the breach in Panel 8 with a finite catalytic wall (Reference 18) (300 vs. 27.3 Btu/ft²s).

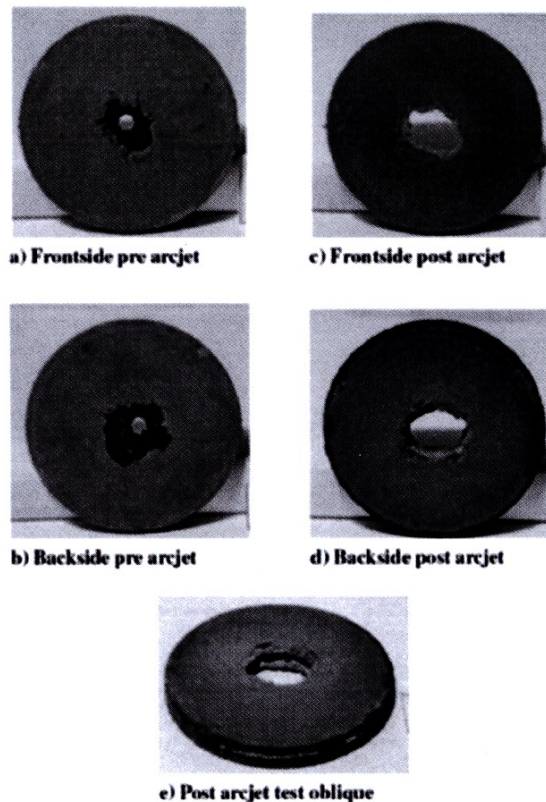
Figure 40 displays photographs of the test article number 1159 pre and post arc jet test. Test conditions resulted in a surface temperature and pressure on test article number 1159 of 2500 °F and 50 psf, respectively. The exposure was for 450 seconds. Figures 40 c) -> 40 e) show that in this case, the hole growth grew by oxidation of the exposed carbon-carbon substrate. The oblique view in Figure 40 e) illustrates the “dishing out” of the carbon sandwiched between the SiC front and back coating. For these test conditions, Curry, et. al., did not expect hole growth owing to loss of the SiC coating because of its stability up to temperatures in the range of 2800-3000 °F and this was confirmed by the tests.

Figure 40: NASA/JSC Model Number 1159, Pre and Post Arc Jet Exposure at 2500 °F and 50 psf, 400 Second Exposure. (Reference 5).

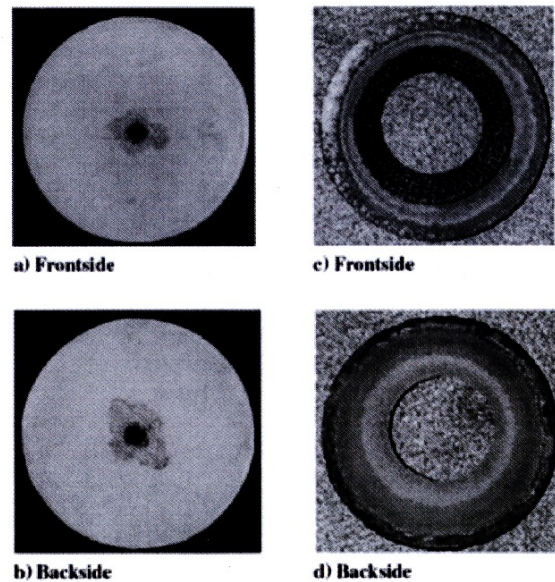
Figure 41 displays photographs of test article number 1151, pre and post test. The temperature of exposed carbon at the SiC edge reached 3,250 °F +. For this test condition (2800 °F and 100 psf), there was significant front face SiC coating erosion as shown in Figures 41 c) and d). Curry, et. al., noted that in general, the front face of the damaged region grew faster than the backside of the specimen, resulting in a conical, or “sharpened shape,” typical of all of their testing at a nominal temperature of 2800 °F.

Figure 41: NASA/JSC Model Number 1151, Pre and Post Arc Jet Exposure at 2800 °F and 100 psf, 450 Second Exposure. (Reference 5).

It can be concluded from these tests that the dominant mechanism for the ablation of RCC with the coating removed is diffusion-controlled oxidation. At the higher temperatures, SiC coating loss is expected. This result, which causes “knife edging” for a circular hole suggests that if RCC was damaged in a linear fashion, one would see formation of knife-edges in superheated air heating environments existing for hundreds of seconds in conditions like those in the arc jet tests discussed in Reference 5. This observation was the basis for the discussion of the “knife edging” seen in the RCC Panel 8/9 debris from Columbia.

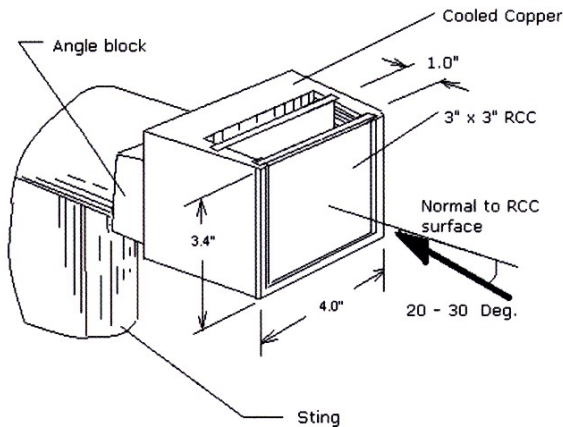
The first test, with two parallel plates shown in Figure 42 with flow impinging at 70 degrees to the flat face was intended to simulate the flow inside the wing impinging on RCC ribs. The results of the test on the parallel plates was inconclusive, because the surface temperatures attainable, without damaging the model holder, were not high enough to cause ablation of the SiC coating.

Figure 42: NASA/JSC Arc Jet Test Set-up for Linear Knife-edge Tests at Large Angle of Incidence (70°). Test to Simulate Flow Impingement on RCC Ribs.

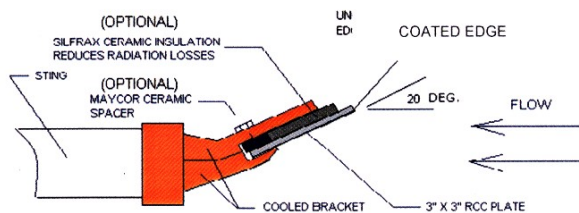
The second test article, shown in Figure 43, was intended to simulate flow on the windward lip of a hole in Panel 8. This test, with a flow angle on the single plate at 20 degrees incidence showed that knife edging would occur when the temperature on the coated leading edge of the plate was above 3250 °F. Table 3 specifies the test conditions thought to simulate the enthalpy and impact pressure present in the damaged wing during Columbia's entry on STS 107.

Figure 43: NASA/JSC Arc Jet Test Set-up for Simulation of RCC Knife-edge Erosion at Low Angle of Incidence (20°). Test Intended to Simulate Flow on Lip of Hole in RCC Panel.

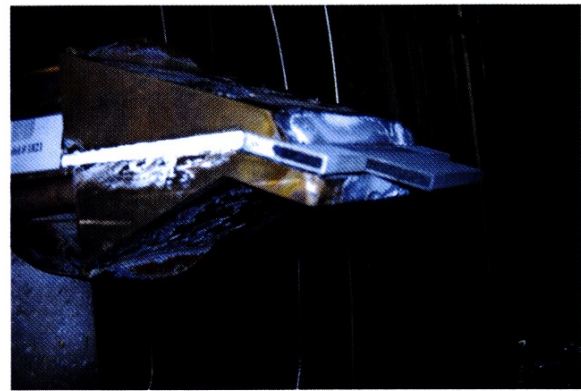
Figure 44 (a) is a pre-test photograph of the test article. Note that the coated edge of RCC is facing the flow for both the RCC sample and the RCC closeout pieces placed on either side.

Figure 44 (a): Pre-test Photograph. Angle of Incidence: 20°, Coated Edge Facing Flow.
