Volume IV Appendix F.5

Space Shuttle STS-107 Columbia Accident Investigation, External Tank Working Group Final Report – Volume 1

This report summarizes the results of the analysis, design, production, and performance of External Tank (ET-93), performed by the External Tank (ET) Working Group (ETWG), as part of the STS-107 *Columbia* Accident Investigation.

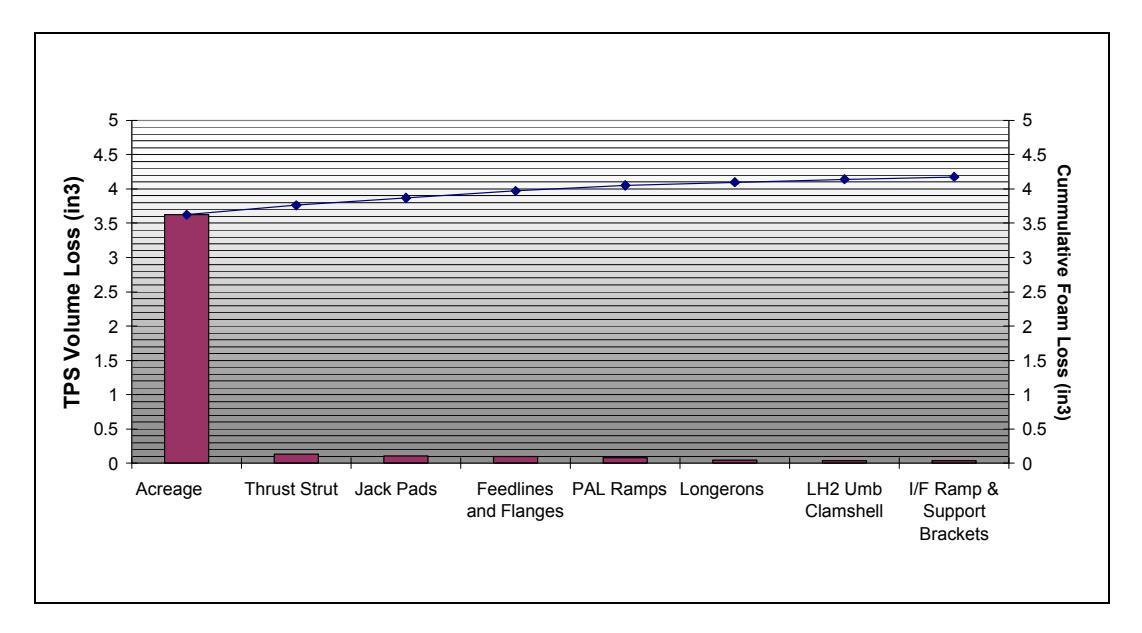
Figure 5.3.2.2-1. Areas of Observed Loss

Of the 113 Space Shuttle flights, 79 flights had useable imagery of the +Z axis from these cameras. The data collected during the STS-107 accident investigation were aggregated into major areas of TPS loss (Volume III). TPS loss has been observed on 82% of the missions with useable imagery. Areas of observed loss are shown in Figure 5.3.2.2-1. Recent material changes and configuration changes were also reviewed in an attempt to further assess TPS loss. Foam loss over time is shown in Figure 5.3.2.2-2. The loss of acreage TPS is primarily related to an increase in intertank acreage TPS loss attributed to a recent material change (the blowing agent, HCFC 141b) in the intertank acreage TPS. The TPS loss phenomenon observed since this material change was subsequently mitigated through venting of the TPS to allow entrapped pressure to outgas. Although intertank TPS loss, through 'popcorn-type' divots, still occurs, the size and quantity of the divots has been greatly reduced.

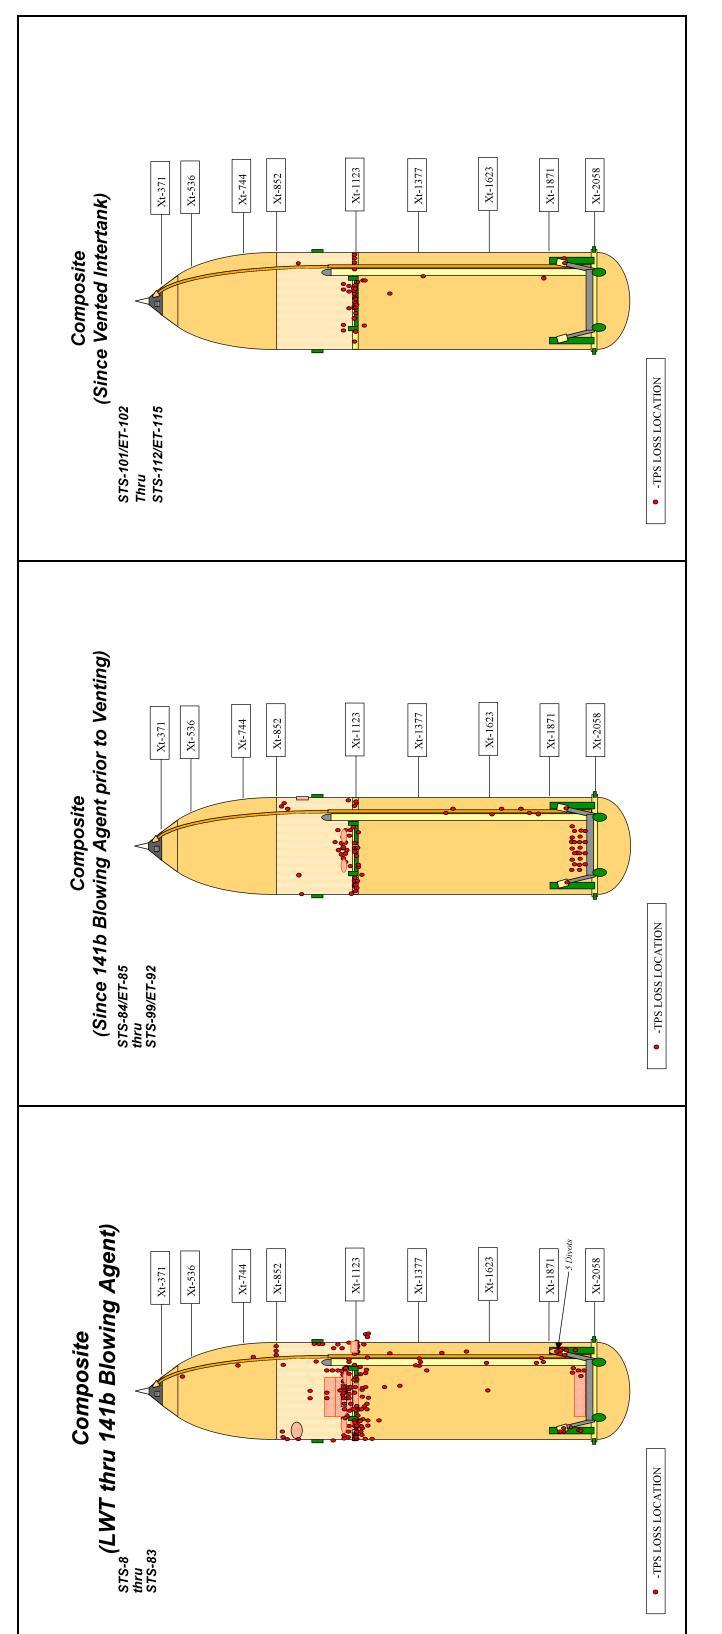
Figure 5.3.2-7. Schematic of Aggregate Foam Loss

Historically, initiatives on the ET have gradually resulted in reduced foam loss over time. A progression of the aggregate of foam loss, as categorized by major TPS changes, is shown in Figure 5.3.2.2-7.

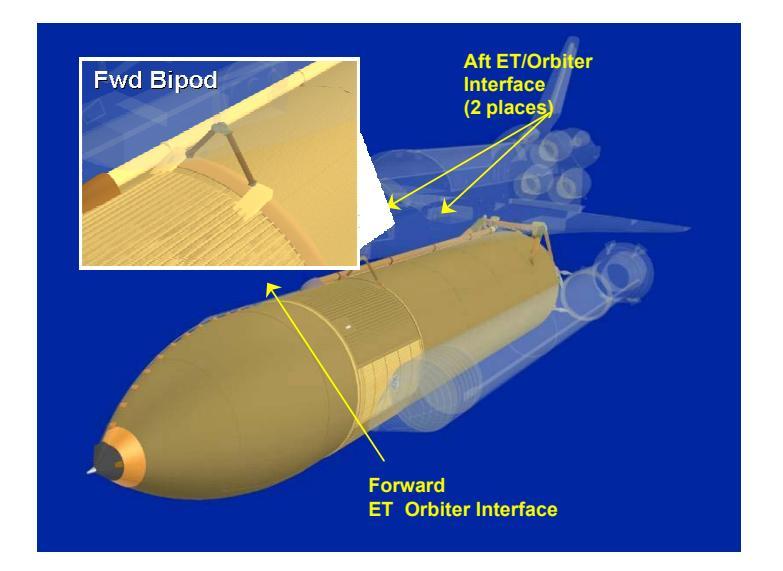
Figure 5.3.3.3-1. ET/Orbiter Interfaces

The bipod ramp design has been stable since early in the ET program. There have been no changes in material and minimal changes to configuration, processing, and personnel certification/training. The BX-250 ramp angle, as described below, has been constant since ET-14:

30° maximum with a 5.0- ±1.0-in. radius at the forward edge (from 45° ±5.0, no radius). This was changed as a result of suspected foam debris (STS-7/ET-6).

• A 5.0- ±1.0 in. radius at the forward edge was eliminated at ET-76.

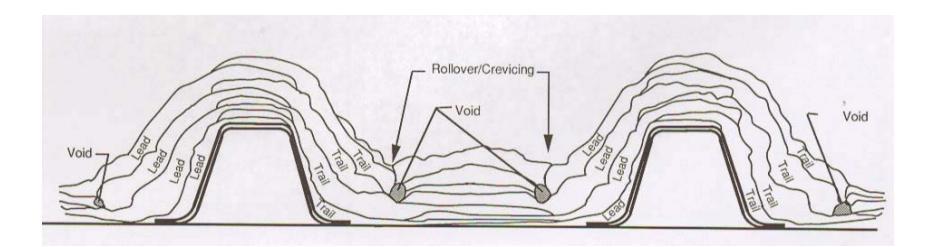
Figure 5.3.3.5-8. Rollover/Crevicing Phenomenon

The most probable cause of this TPS loss was not conclusively determined. The most likely scenario is rollover/crevicing anomalies in the TPS (Figure 5.3.3.5-8), and the effects in the flight environment. Differential pressure caused by aeroheating, flight loads, and panel flexure may have caused anomalies to propagate along the TPS knitlines (area between TPS spray passes), with shallow divots as the result.

No immediate corrective actions were implemented. An application process enhancement was implemented to minimize or eliminate the occurrence of rollover or crevicing. This enhancement would reduce the

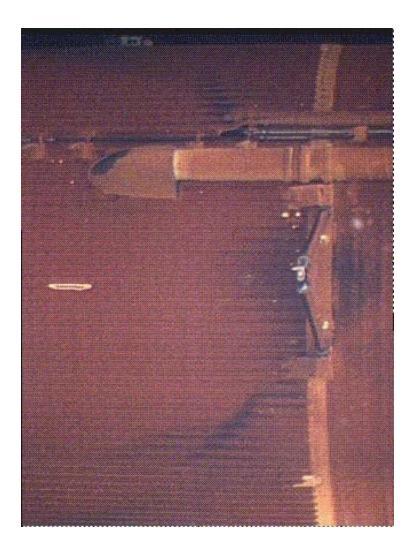
Figure 5.3.3.5-9. STS-58/ET-57 Post-Separation Photograph

The most probable cause of the jack pad closeout was cryopumping of a subsurface void under the PDL pour TPS closeout. Following this jack pad closeout TPS loss occurrence, a tool was developed to allow spray around the holes masking the jack pad tooling holes, leaving four 1-in. diameter holes on each side of the closeout to eliminate the large closeout/repair area (6 in. x 6 in. square). The jack pad itself is now closed out in conjunction with the flange closeout.

The most probable cause and corrective actions to preclude recurrence were presented/approved at the Level II PRCB (PRCBD S044897L) on May 23, 1994.

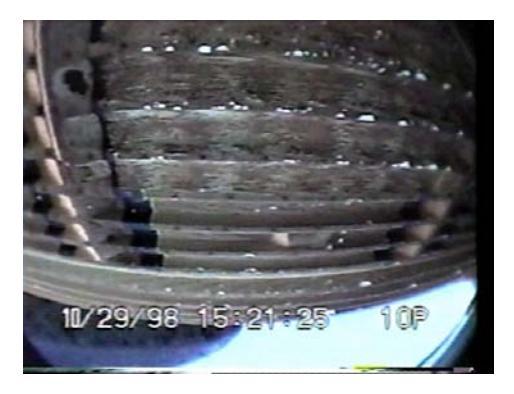
Figure 5.3.3.5-11. STS-95/ET-98 Post-SRB-Separation Photography

A study to gain an understanding of the TPS loss event ensued; the first data gathering exercise included the installation of a camera on one SRB of STS–95/ET-98. This camera imaged the ET intertank thrust panel during flight and provided the first opportunity to view TPS loss up close and in real time (Figure 5.3.3.5-11). The camera showed TPS loss initiating approximately 92 sec into the flight and continuing until SRB separation, at which time the view was lost.

TPS loss was seen to be most severe on the tops and sides of the thrust panel ribs but was not limited to these areas. Some material loss was also observed on the skin-stringer areas of the intertank. From a visual standpoint, the TPS loss closely resembled the phenomenon known as 'popcorning', which has been observed in thermal-vacuum testing at MSFC and MAF test facilities.

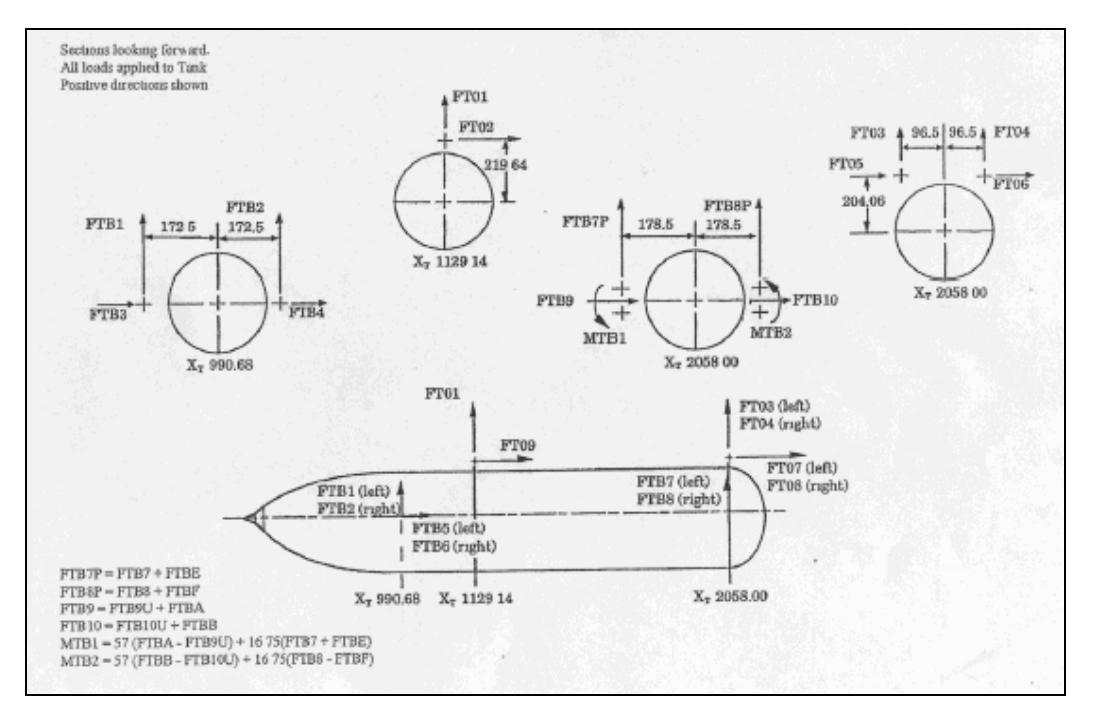
Figure 7.2.3.8.1.2-2. ET Interface Load Indicators

No loads issues were found with any phase of operations. All indicators were well within design limits. The flex body loads reconstruction was actually less than the BET reconstruction, so they did not affect the evaluation. All of the analysis to date shows no evidence of excessive or anomalous loading.
