Return to Flight Task Group

Executive Summary

June 28, 2005

Final Report of the Return to Flight Task Group

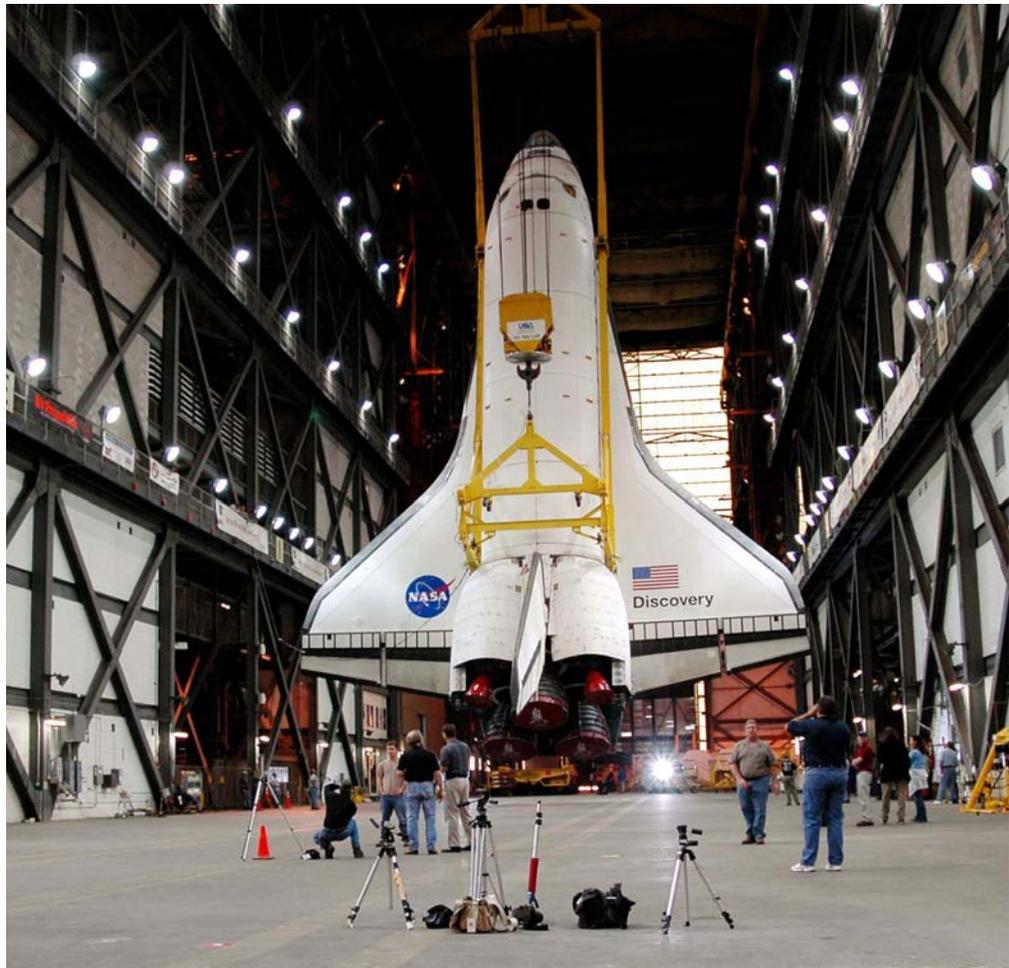
Before a crowd of photographers, *Discovery* is hoisted into a vertical position in the transfer aisle of the Vehicle Assembly Building at the Kennedy Space Center. After this the Orbiter was lifted into a High Bay to be mated with a waiting set of Solid Rocket Boosters and an External Tank.
